Preliminary Tree Report

**Kottinger Senior Housing Project
Pleasanton, CA**

Prepared for:
**MidPen Housing Corp.
303 Vintage Park Dr. Suite 250
Foster City, CA 94404**

July 3, 2013

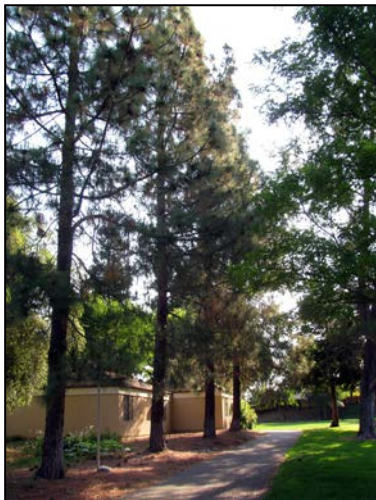
Canary Island pine was the most common species present, with 20 trees (12% of the population). They were planted around structures and along pedestrian pathways adjacent to Kottinger Village Park (photo 1). The trees ranged in condition from fair to good, some with somewhat thin canopies. The majority of the trees was tall and upright exhibiting good form and structure, and averaged 18" in diameter. Within the group were 15 Heritage trees.

Photo 1: Canary Island pines along path bordering Kottinger Village Park. #55-58 are Heritage trees.

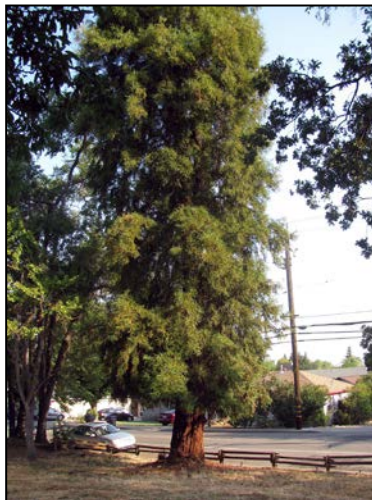
Photo 2: Heritage coast redwood #162 located at 4138 Vineyard Ave.

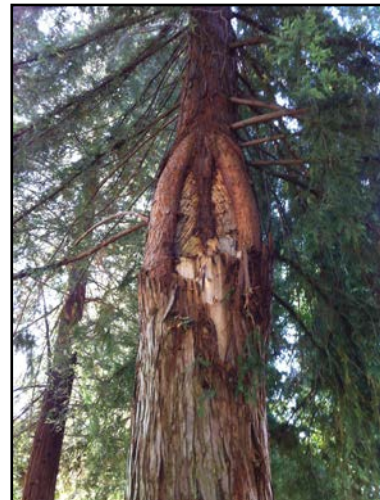
Coast redwood was the second most common species with 14 trees (8% of the population). Averaging 30" in diameter, 11 trees were in good or excellent condition, and 12 were large enough to qualify as Heritage trees (Photo 2). Off-site trees (#62, 63, 66-68, 70, 71, 75 and 76) were located on the east side of Kottinger Place in Kottinger Village Park along the edge of a pedestrian path. Coast redwood #70 was distinctive among the off-site trees, with an extensive wound resulting from a codominant stem failure (Photo 3).

Photo 3: Heritage coast redwood #70 was located in the park on the outside of a pedestrian path. It had a large trunk wound created when the codominant stem failed several years ago.

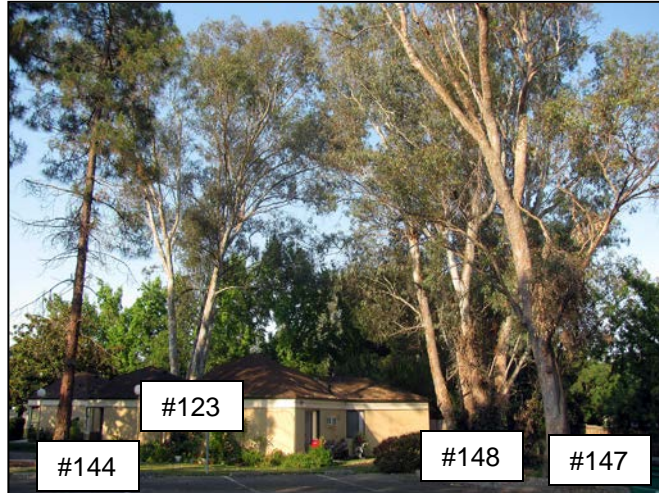
Two eucalyptus species were present; river red gum and silver dollar gum. Many were multi-trunked trees, inter-planted in a linear plane along the western perimeter of Kottinger Place and Regalia House. The red river gum was represented by nine trees (5% of the population) and the silver dollar gum by six trees (less than 4% of the population). As a group, eucalyptus ranged from fair to good, and was predominately characterized by poor structure, multiple attachments, branch failure, and wound decay. All eucalyptus trees with the exception of silver dollar gum #109 had Heritage status.

Photo 4: Heritage river red gums were the largest trees on the site. These were located on the northeast corner of Kottinger Place.

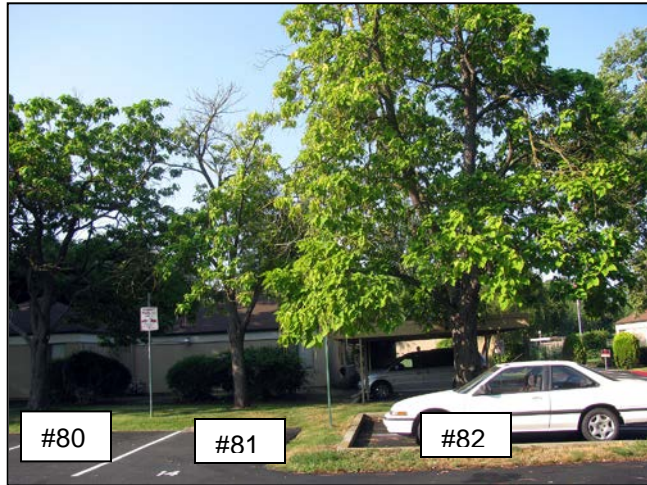
Photo 5: Catalpas #80 (Heritage) and 81 were in poor condition due to extensive branch dieback and trunk decay. Heritage tree #82 was in fair condition.

Located primarily inside the pedestrian pathway in Kottinger Place, the *Catalpa* species was represented by eight trees (less than 4% of the population). All the trees had a single trunk, with the exception of tree #52, which was multi-trunked. Large in stature (average diameter 22"), all but one of the trees had Heritage status and an average. It was noteworthy that trees #77, 80 and 81 exhibited extensive trunk and branch wounds, dieback and decay (Photo 5).

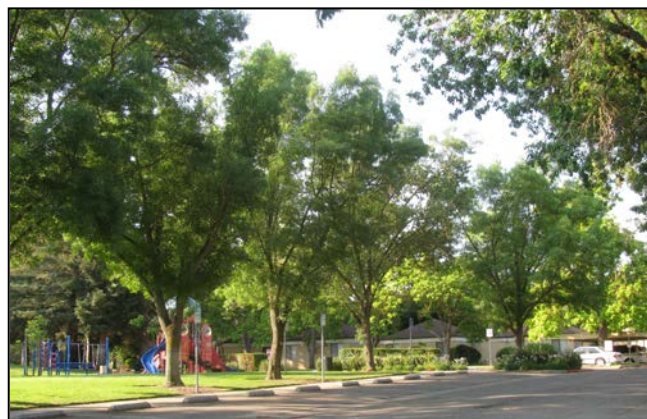
Photo 6. Raywood ash #175-177, 161 (left to right).

Eight Raywood ash were present that were in good to fair condition (Photo 6). Several had symptoms of Ash Dieback, a disease caused by the fungus *Botryosphaeria*. All were located along the parking area between Regalia House and the park.

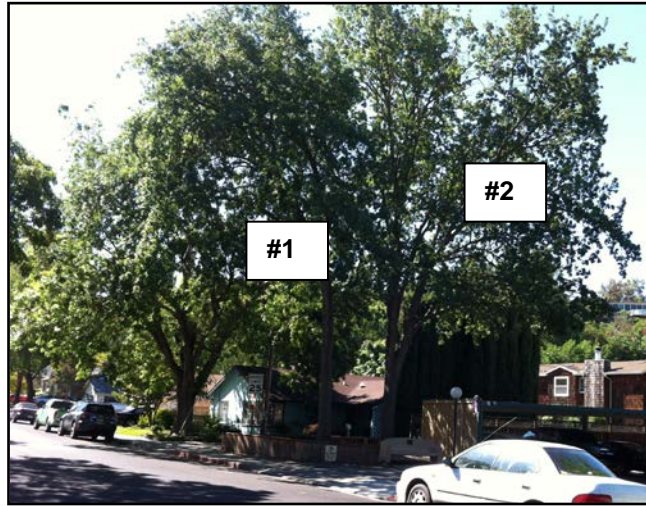
Photo 7. Valley oaks #1 and #2 have grown next to each other and now form one canopy.

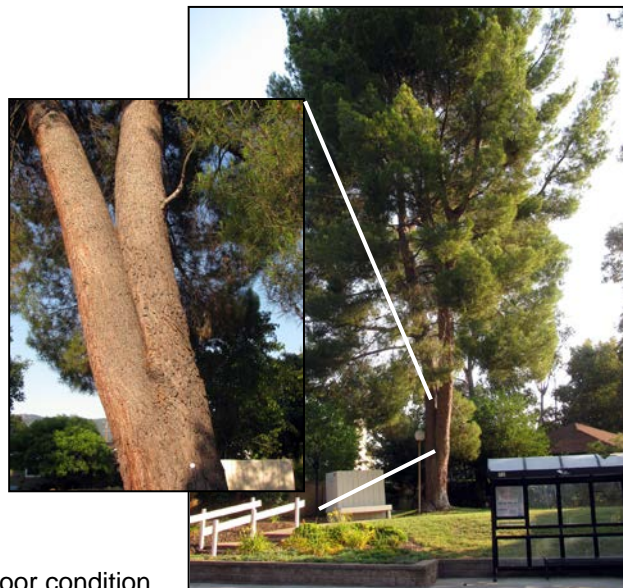
Photo 8. Aleppo pine #90 had codominant stems with included bark (see inset). This is a structurally weak condition that is likely to result in tree failure. A cable had been installed between the two stems to provide some support.

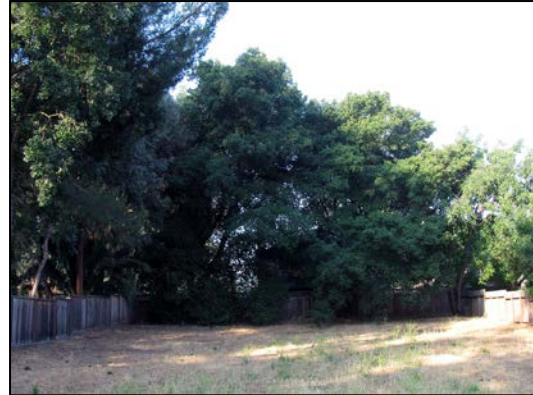
- Coast live oak #164 in good condition, albeit with codominant trunks, and #165 in excellent condition were both heritage trees (Photo 9). These are naturally-occurring trees native to Pleasanton. The canopies extended to the ground as is typical of the species. This form shades the root system and helps the trees survive the long dry summer. They were located at the west end of 4138 Vineyard Ave.
- Ginkgo #7 was a good young tree in Pleasanton Gardens (Photo 10), and moderate-sized #163 in the Vineyard Ave. was suppressed in form and in fair condition.
- Zelkova #51 was in fair condition because of multiple branch attachments and presence of a girdling root. Zelkova #132 was in good condition.

Photo 9. The canopy of Heritage coast live oaks #164 and 165 occupied the west end of the Vineyard Ave. property.

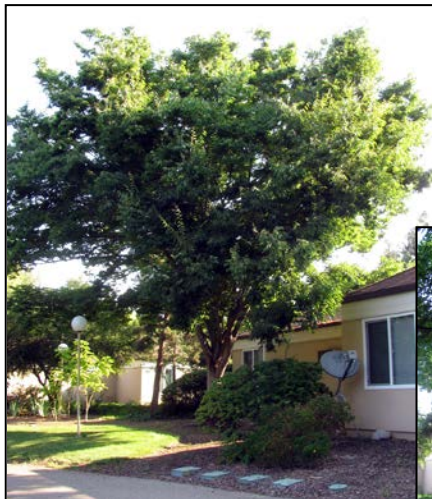
Photo 10 (left). Zelkova with multiple branch attachments (inset).

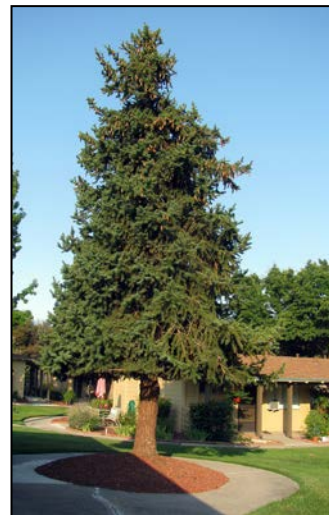
Photo 11 (right). Colorado spruce with good form and health.

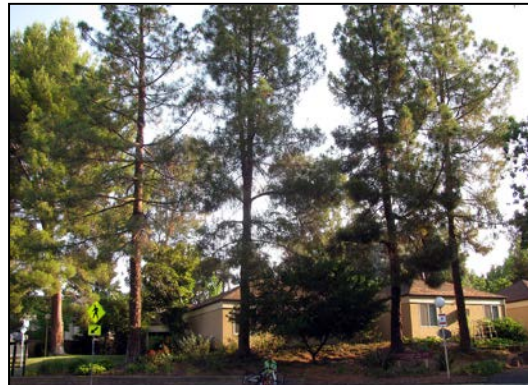
Photo 12. Canary Island pines #83-86 are located at the Kottenger Dr. entrance to Kottenger Place. They are good candidates for retention. They are in the “possibly preserve” category (Table 4). We recommend accurately locating the trunks and designing for their preservation.
