## **Arborist Report**

**Stoneridge Corporate Plaza  
Pleasanton, CA**

**PREPARED BY:  
HortScience, Inc.  
325 Ray St.  
Pleasanton, CA 94566**

**April 2014**

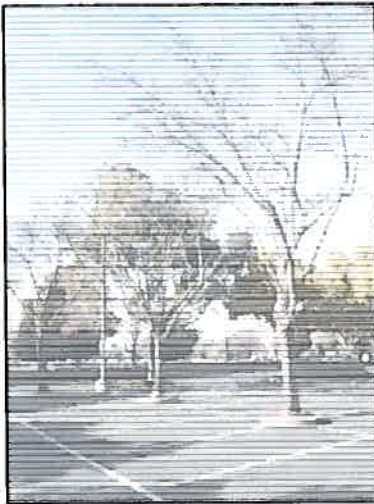
The most common species assessed was Raywood ash (77 trees). These trees were mostly in fair condition (49 trees) with 15 trees in good condition and 13 trees in poor. Raywood ashes ranged from young (7" DBH) to mature (27" DBH) with an average diameter of 15". The majority of trees had multiple attachments between 6 and 10 feet and many were in small planters (Photo 1, following page). The species is susceptible to Raywood ash decline, resulting in dieback of branches and eventually the entire crown due to infection by the fungus *Botryosphaeria*. Dieback consistent with Raywood ash decline was present throughout the population.

**Photo 1:** Raywood ashes demonstrating multiple attachment form and small island growing space typical of this site.

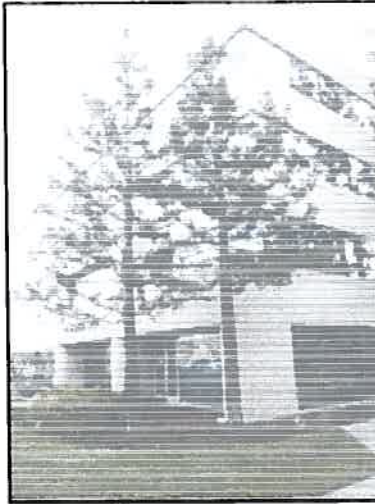
The second most common species assessed was coast redwood (72 trees). Redwoods were mostly in fair condition (52 trees) with 19 trees in good condition and two (2) in poor. They varied from young (8" in diameter) to mature (36" in diameter), with an average diameter of 21". The redwoods tended to have good form but had thin canopies (Photo 2, following page). Most redwoods had their canopies raised by removal of lower branches.

**Photo 2:** Coast redwoods on site tended to have thin canopies and be pruned up to 15 feet.

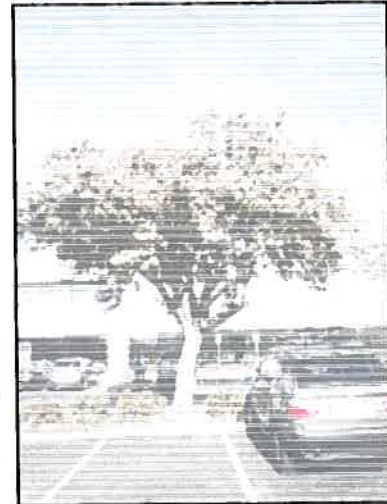
Sixty-seven (67) Brazilian peppers were assessed. Thirty-six (36) of the peppers were in fair condition, with 19 in good condition and 12 in poor. The Brazilian peppers tended to be semi-mature (12" average diameter) but ranged from 6 to 22" in diameter. Brazilian peppers were concentrated in the parking lots, with many in parking lot islands too small for the size of the trees at maturity (Photo 3, following page).

**Photo 3:** Brazilian peppers had been planted in parking lot islands.

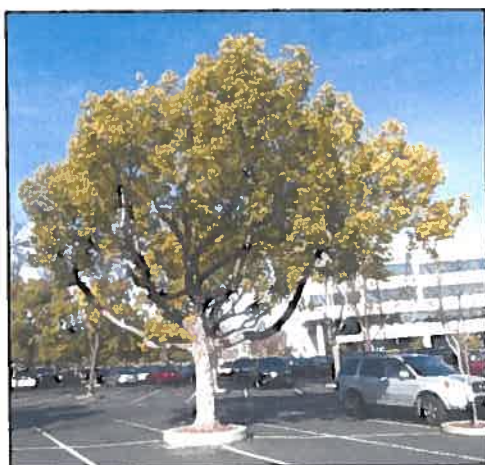
Fifty-four (54) camphors were assessed. Thirty-one (31) camphors were in fair condition, with 15 in poor condition and 8 in good. They ranged from young (7" DBH) to semi-mature (18" DBH) with an average diameter of 12". Camphors tended to have multiple attachments near six feet, with wide spreading canopies. Similar to the Brazilian peppers, camphors were often planted in parking lot islands too small for the species (Photo 4, following page).

**Photo 4:** Camphors typically had spreading crowns but had been planted in small parking lot islands.

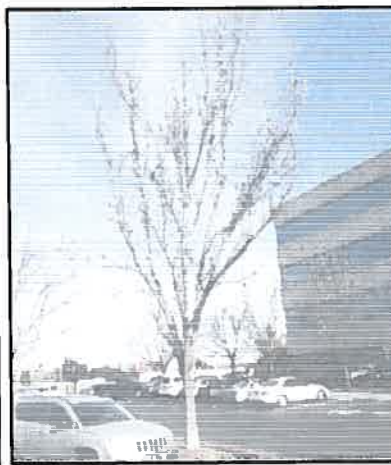
Thirty-five (35) Callery pears were present on-site. They were in fair (25 trees) to good (10 trees) condition with no trees in poor health. They ranged from young (7" DBH) to semi-mature (19" DBH) with an average diameter of 12". Many pears had multiple attachments at six feet and sprouts along trunks and branches, indicative of stress (Photo 5, following page).

**Photo 5:** Gallery pear demonstrating epicormic growth and multiple attachments at six feet.

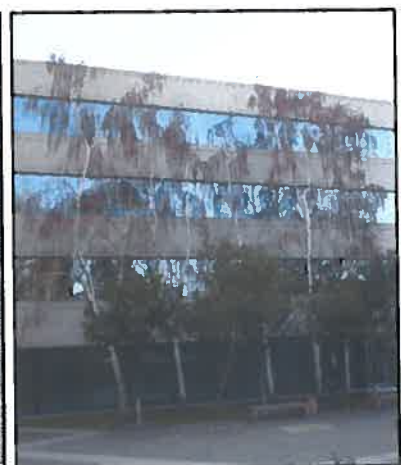
Thirty (30) European white birches were present on the site. The birches were primarily in fair condition (22 trees), with 7 in good condition and one (1) in poor. They were generally young, ranging in from 6 to 13" in diameter with an average of 9". Many of the birches were leaning, crowded and suffering from twig dieback, indicative of drought stress (Photo 6, following page).

**Photo 6:** European white birches growing along an office building.

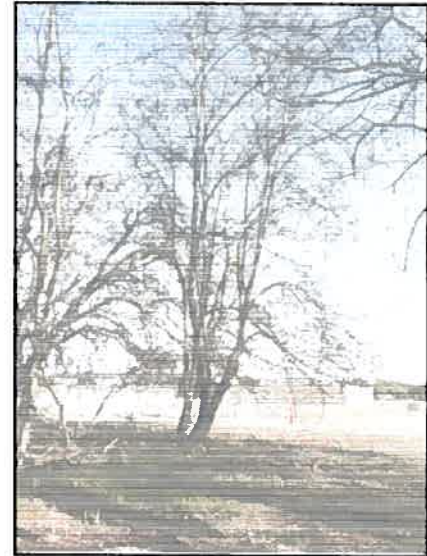
**Photo 1:** A multi-stemmed black locust at the edge of the stand.

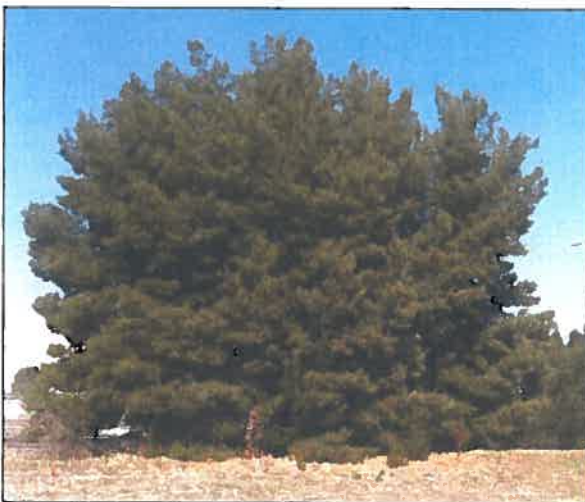
**Photo 2:** A dense stand of black wood acacias.

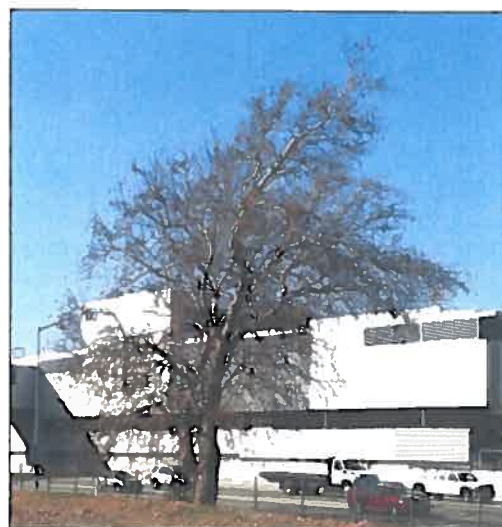
**Photo 3:** Large western sycamore growing on Caltrans ROW.
