Updated Arborist Report

**BART Remainder Parcel
Pleasanton, CA**

**PREPARED FOR
Workday, Inc.
6230 Stoneridge Mall Road
Pleasanton, CA 94588**

**PREPARED BY:
HortScience, Inc.
325 Ray St.
Pleasanton, CA 94566**

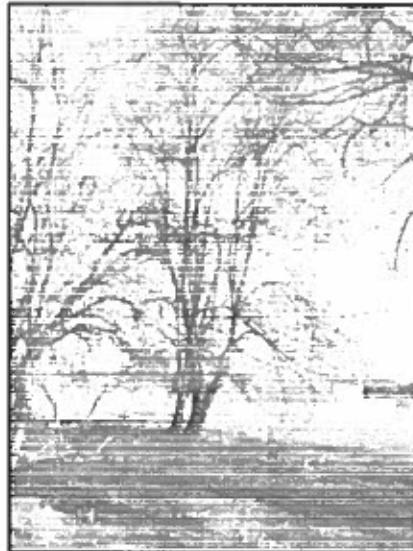
The majority of the trees on-site (75 trees or 71% of the population) were black locust. These made up a dense stand of tall narrow trees in the vacant lot east of the West Dublin Pleasanton BART station parking garage. They tended to be in fair condition (56 trees) with 16 in poor condition and three (3) in good. Almost all of the black locusts had multiple trunks originating from the base or were individual trees growing close together (Photo 1, following page).

Photo 1: A multi-stemmed black locust at the edge of the stand.

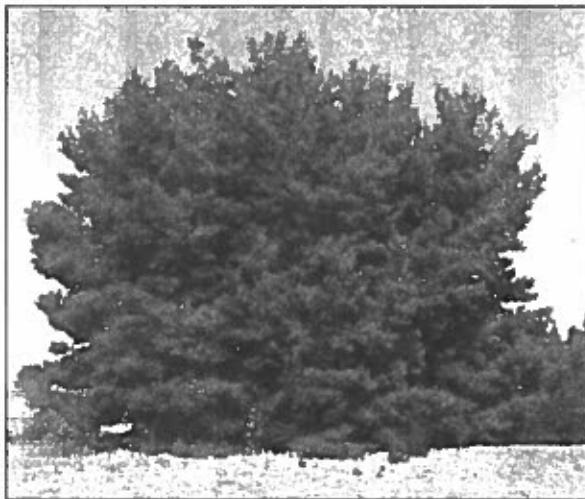
Seven (7) blackwood acacias were growing in a group along the fence line with the freeway (Photo 2). They were all in fair condition and were young, ranging in diameter from 6 to 10".

Photo 2: A dense stand of black wood acacias.

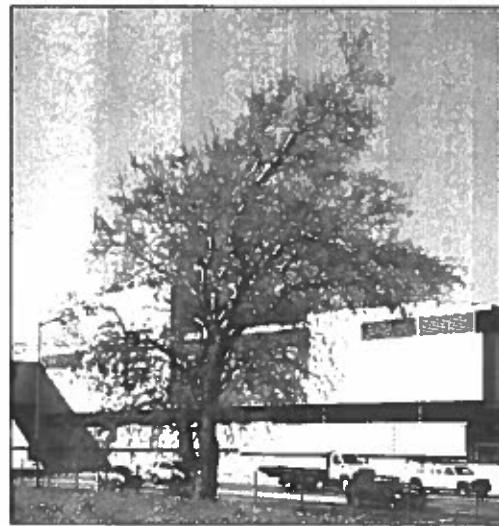
Photo 3: Large western sycamore growing on Caltrans ROW.

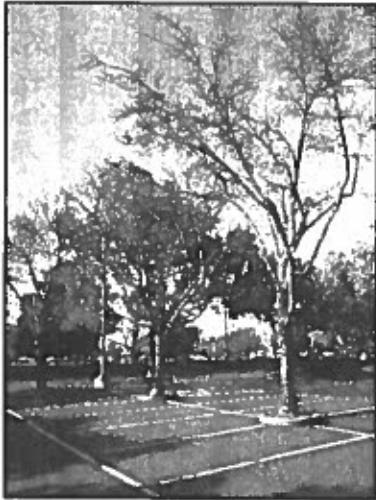
The most common species assessed was Raywood ash (77 trees). These trees were mostly in fair condition (49 trees) with 15 trees in good condition and 13 trees in poor. Raywood ashes ranged from young (7" DBH) to mature (27" DBH) with an average diameter of 15". The majority of trees had multiple attachments between 6 and 10 feet and many were in small planters (Photo 1, following page). The species is susceptible to Raywood ash decline, resulting in dieback of branches and eventually the entire crown due to infection by the fungus *Botrosphaeria*. Dieback consistent with Raywood ash decline was present throughout the population.

Photo 1: Raywood ashes demonstrating multiple attachment form and small island growing space typical of this site.

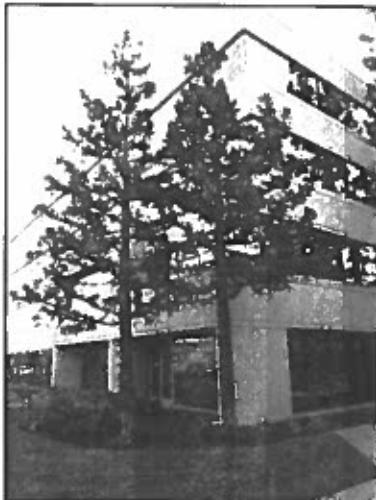
The second most common species assessed was coast redwood (72 trees). Redwoods were mostly in fair condition (52 trees) with 19 trees in good condition and two (2) in poor. They varied from young (8" in diameter) to mature (36" in diameter), with an average diameter of 21". The redwoods tended to have good form but had thin canopies (Photo 2, following page). Most redwoods had their canopies raised by removal of lower branches.

Photo 2: Coast redwoods on site tended to have thin canopies and be pruned up to 15 feet.

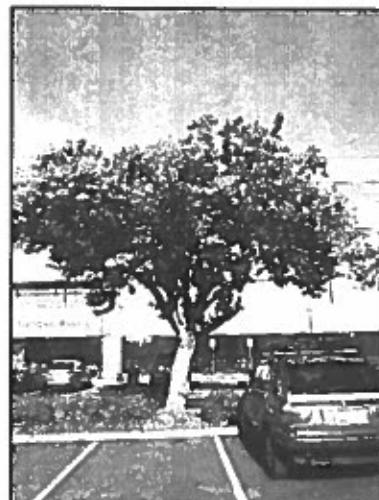
Sixty-seven (67) Brazilian peppers were assessed. Thirty-six (36) of the peppers were in fair condition, with 19 in good condition and 12 in poor. The Brazilian peppers tended to be semi-mature (12" average diameter) but ranged from 6 to 22" in diameter. Brazilian peppers were concentrated in the parking lots, with many in parking lot islands too small for the size of the trees at maturity (Photo 3, following page).

Photo 3: Brazilian peppers had been planted in parking lot islands.

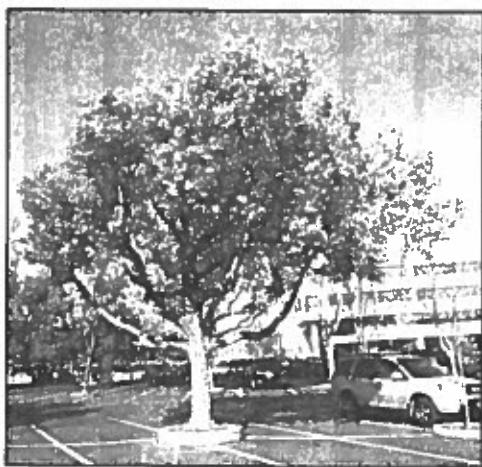
Fifty-four (54) camphors were assessed. Thirty-one (31) camphors were in fair condition, with 15 in poor condition and 8 in good. They ranged from young (7" DBH) to semi-mature (18" DBH) with an average diameter of 12". Camphors tended to have multiple attachments near six feet, with wide spreading canopies. Similar to the Brazilian peppers, camphors were often planted in parking lot islands too small for the species (Photo 4, following page).

Photo 4: Camphors typically had spreading crowns but had been planted in small parking lot islands.

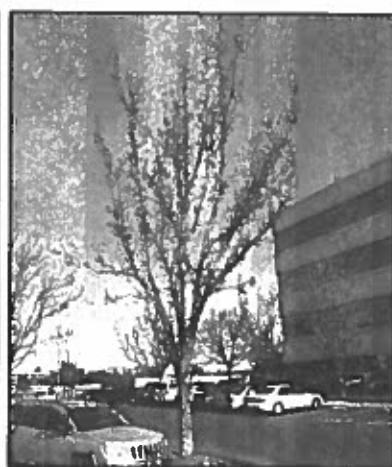
Thirty-five (35) Callery pears were present on-site. They were in fair (25 trees) to good (10 trees) condition with no trees in poor health. They ranged from young (7" DBH) to semi-mature (19" DBH) with an average diameter of 12". Many pears had multiple attachments at six feet and sprouts along trunks and branches, indicative of stress (Photo 5, following page).

Photo 5: Callery pear demonstrating epicormic growth and multiple attachments at six feet.
