HENRY JUSTINIANO & ASSOCIATES
GEOTECHNICAL ENGINEERING

Project No. S-180-01

February 27, 2018

SUBJECT: GEOTECHNICAL INVESTIGATION
Proposed Single Family Dwelling
481 Sycamore Road
Pleasanton, California

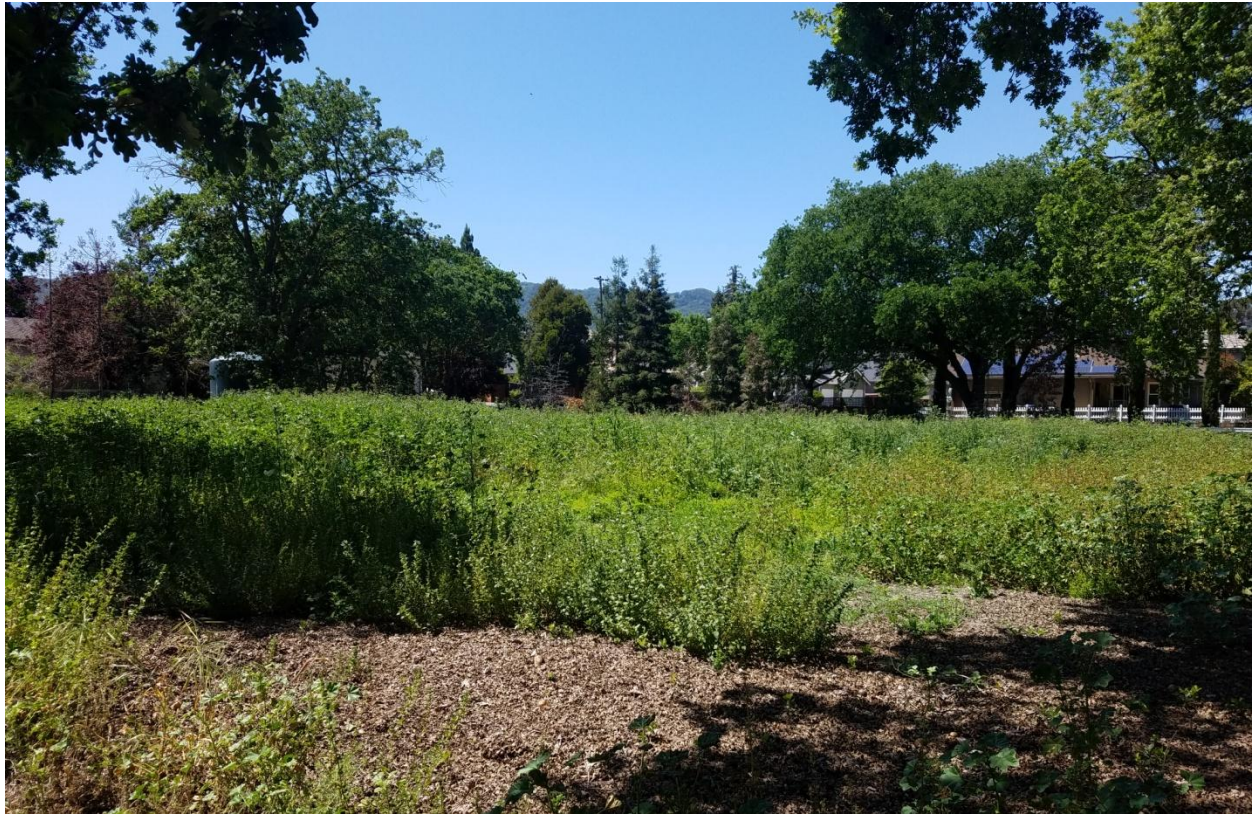
Figure 1. The rear/south half of the property is an open undeveloped field. Oak #13 can be seen at the upper left; I recommend removing it due to encroachment and excessive cankering (see photo below).

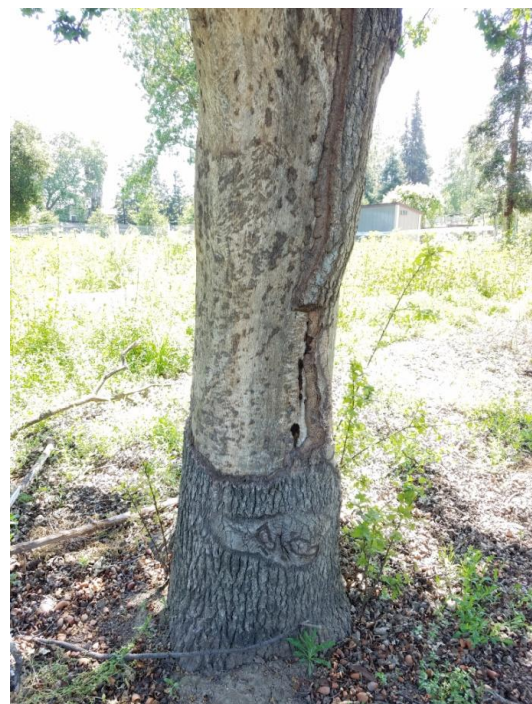
I also recommend removing the significantly drought-stressed, trunk-cankered redwoods (#6 & 7) along the west property line. Replacing these young trees will be more cost-effective than attempting to restore their health. Other trees (#2, 10-12, 33, 34 & 259) will be removed for proposed landscaping improvements.

Figure 2. Oak #13 is suffering from severe trunk cankers which recur and coalesce. It is also located 3' from the porch of the proposed home.

- Remove trees #2, 6, 7, 10-12, 13*, 33, 34, 259 (10 trees; asterisk indicates heritage tree). Dead trees A-Q & 15B will also be removed.
- Prior to construction or grading, contractor shall install fencing to construct a temporary a Tree Protection Zone (TPZ) around each tree or grove of trees as indicated on the tree protection plan. 6' tall chain-link fencing is recommended, though other types of fencing may be used with City approval.
- TPZ fencing shall remain in an upright sturdy manner from the start of grading until the completion of construction. Fencing shall not be adjusted or removed without consulting the project arborist (PA).

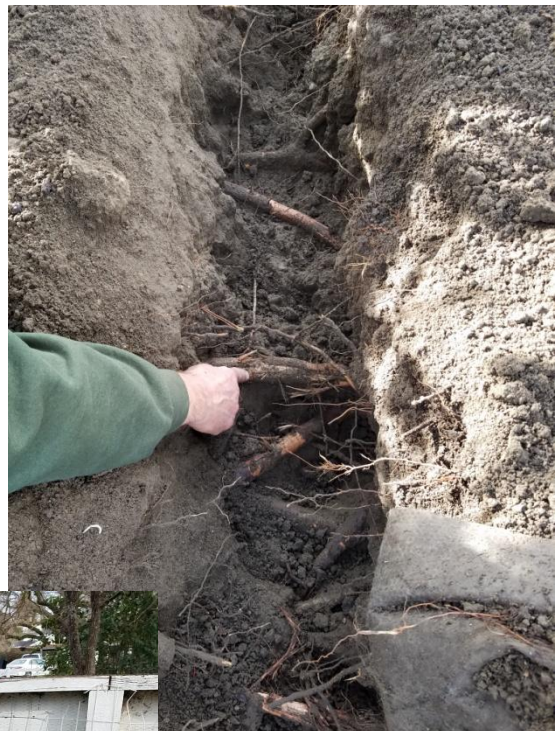
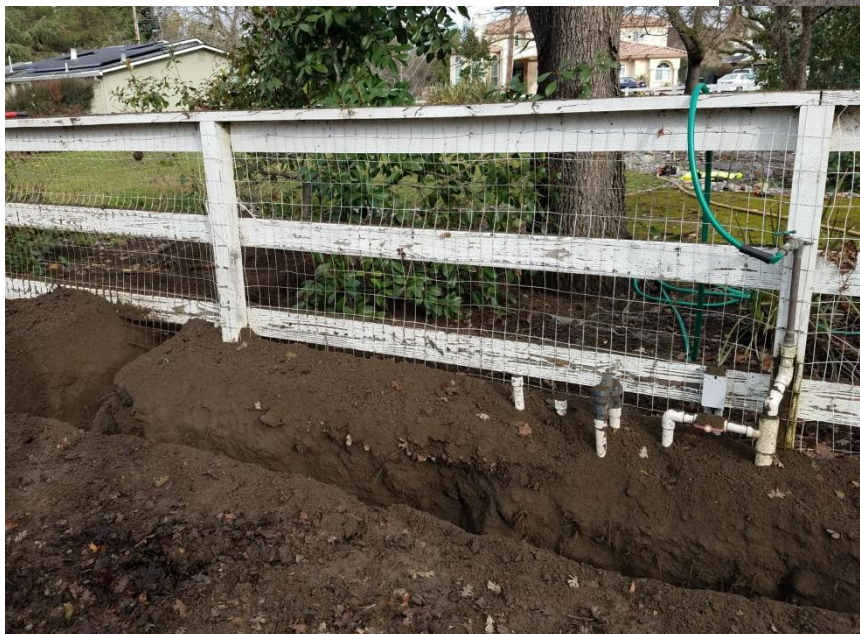
hardscape. The city requested it be saved, so Traverso Tree staff dug an exploratory trench along the proposed hardscape to locate and assess roots. Few significant roots were encountered – one 1.5" root was found to the south, but all other roots were 1" or smaller (Figure 3). Since encroachment is low, the pool and cabana design can be constructed as designed. Roots were pruned prior to trench backfilling. (revised 1/7/19)

Figure 3. Exploratory trench by tree #23 was dug by hand with air spade assistance. Largest root measured 1.5" in diameter (above); all other roots were 1" or smaller. Roots were cleanly pruned before trench was backfilled.
