September 15, 2020

Resurrection Greek Orthodox Church  
20104 Center Street  
Castro Valley CA 94546  
Attn: George Psefteas

Re.: Tree management  
Site: Dublin Canyon Rd., north of Laurel Creek Dr.  
City of Pleasanton File No.: P20-0549

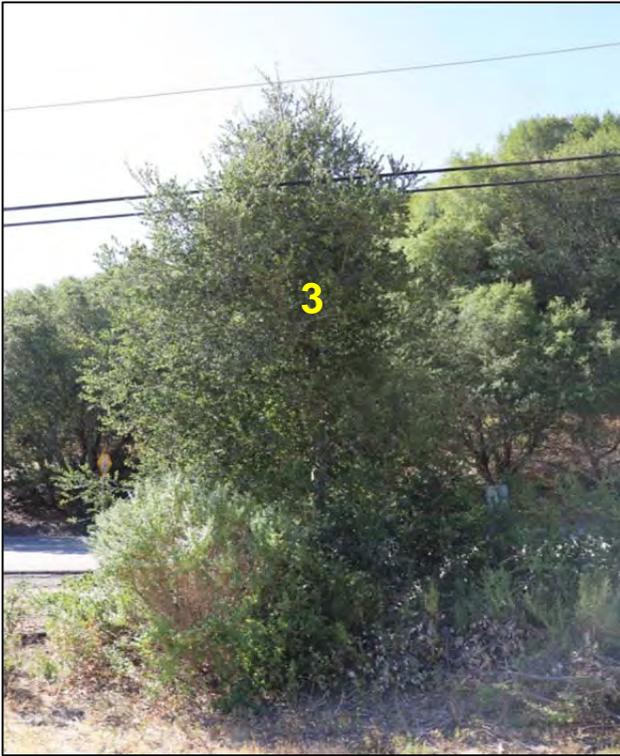
**Tree no. 3:** Code 5 (conflict with construction only). This small tree is a viable candidate for preservation, except that it is in conflict with the proposed pathway.

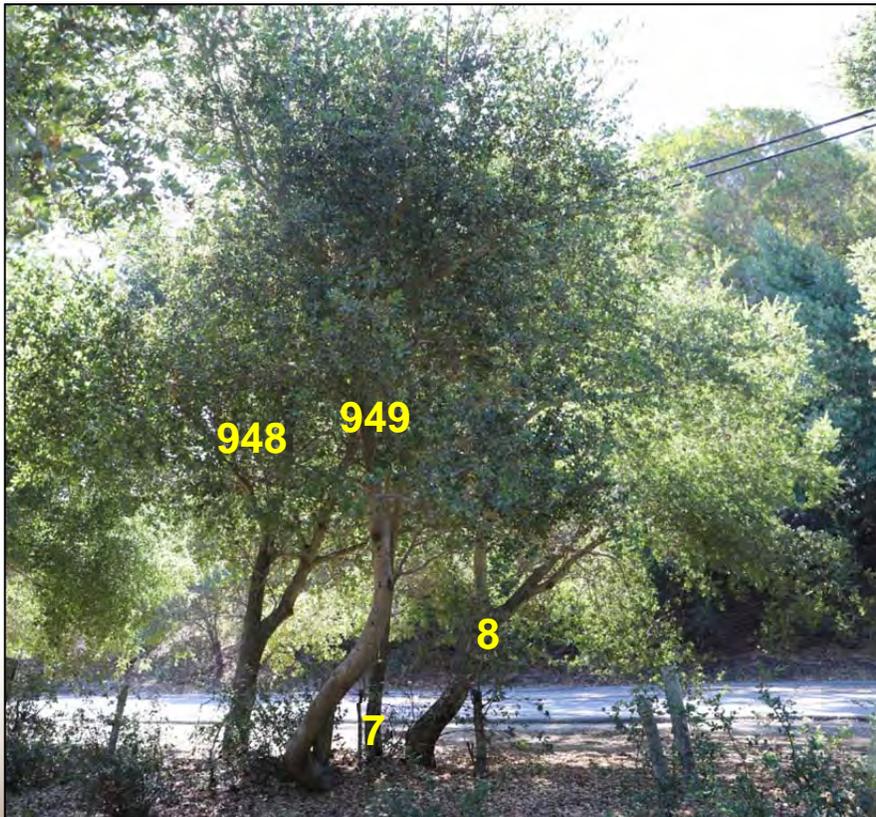
**Trees nos. 948 & 949:** Both are code 5 (conflict with construction).

**Trees nos. 7 & 8:** Both are code 2 (poor condition), but are also in conflict with the proposed pathway. These trees all exhibit poor architecture.

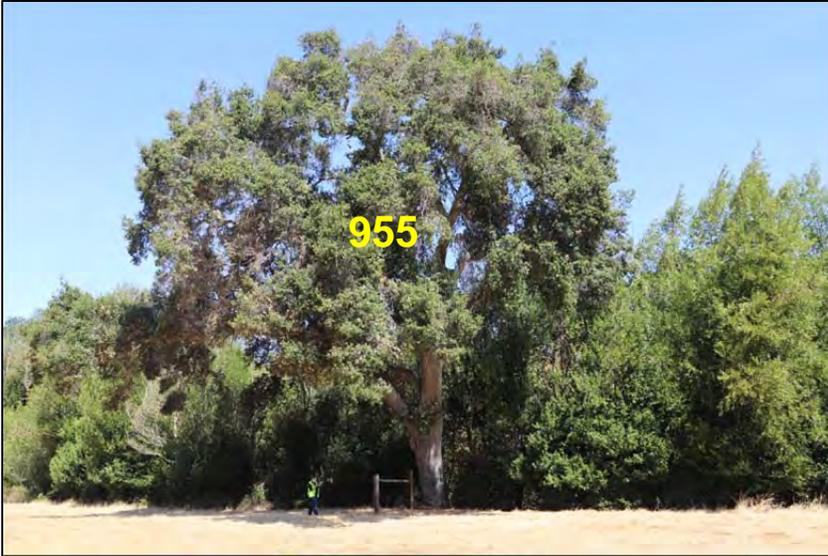
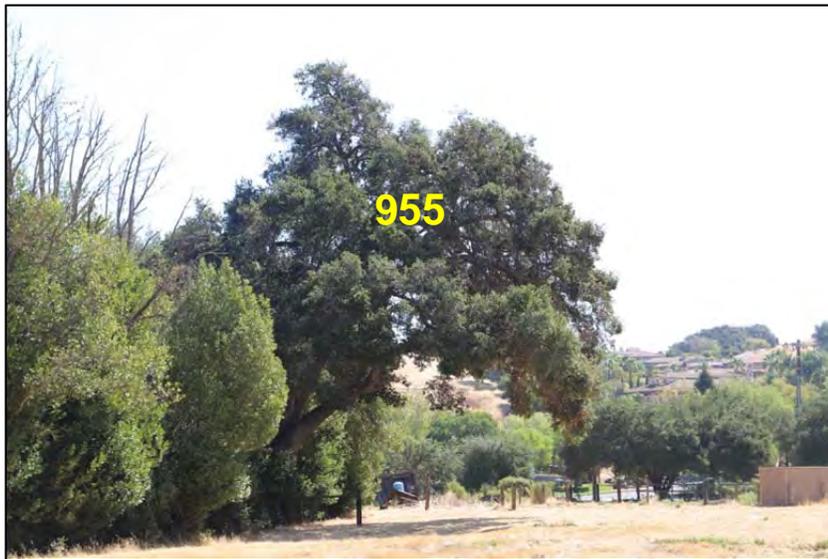
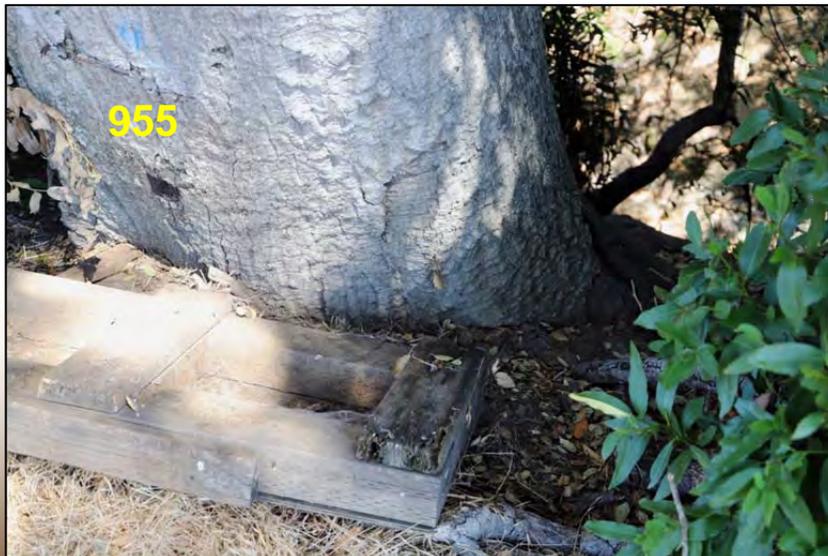
**Tree no.955:** Code 1 (Retain)  
Although aesthetically desirable, this tree leans severely to the south (towards development) and is very stunted (stressed) with significant excess soil over the root collar. Excavation and inspection of the root collar is recommended to determine condition before deciding to retain. If sound, to deter root disease and decay.

**Comments:** This large CA live oak originates in the Riparian Corridor, but its severe lean places most of its canopy within the Limit of Grading. A visual inspection suggests this tree is worth preservation. However, there is significant excess fill soil over the south side of the root collar that could be covering significant root disease and decay. The tree is also significantly stunted, with no measurable increase in trunk diameter and poor twig growth<sup>H</sup> over the last 5 years.

1. Perform a root collar excavation and inspection before a decision to preserve this tree.
2. If the root collar is sound, extend the protective fencing to the south as far from the trunk as possible (at least at the dripline).

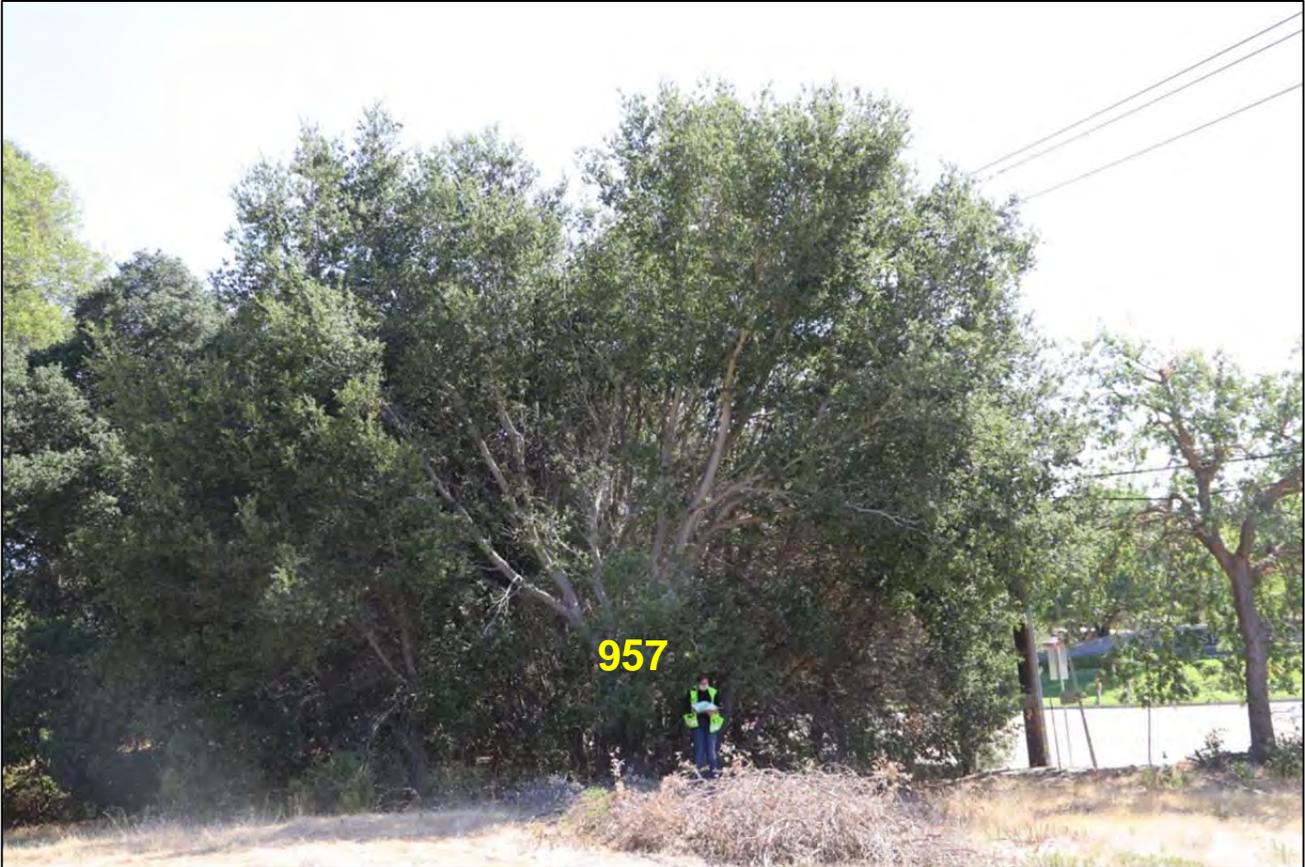
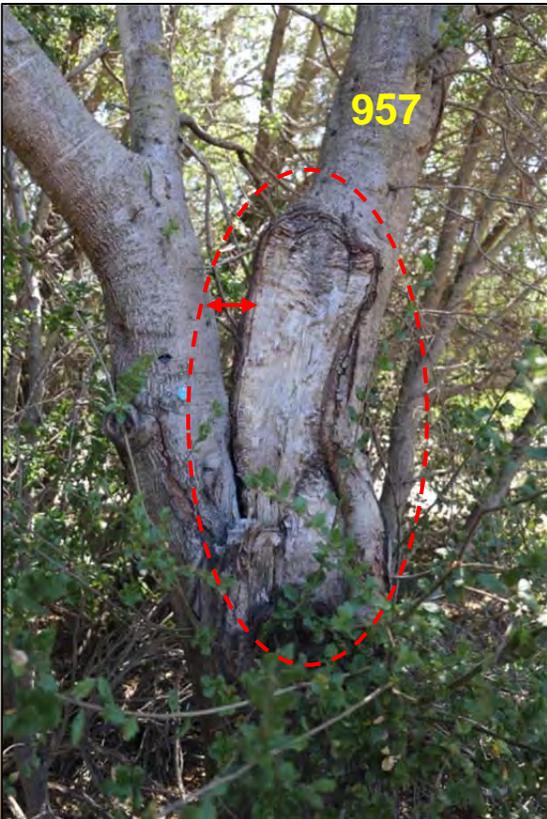
**Tree no. 957:** Code 4 (remove due to condition) – Major failure resulted in loss of ~40% of canopy. Codominant stems with weak attachment.

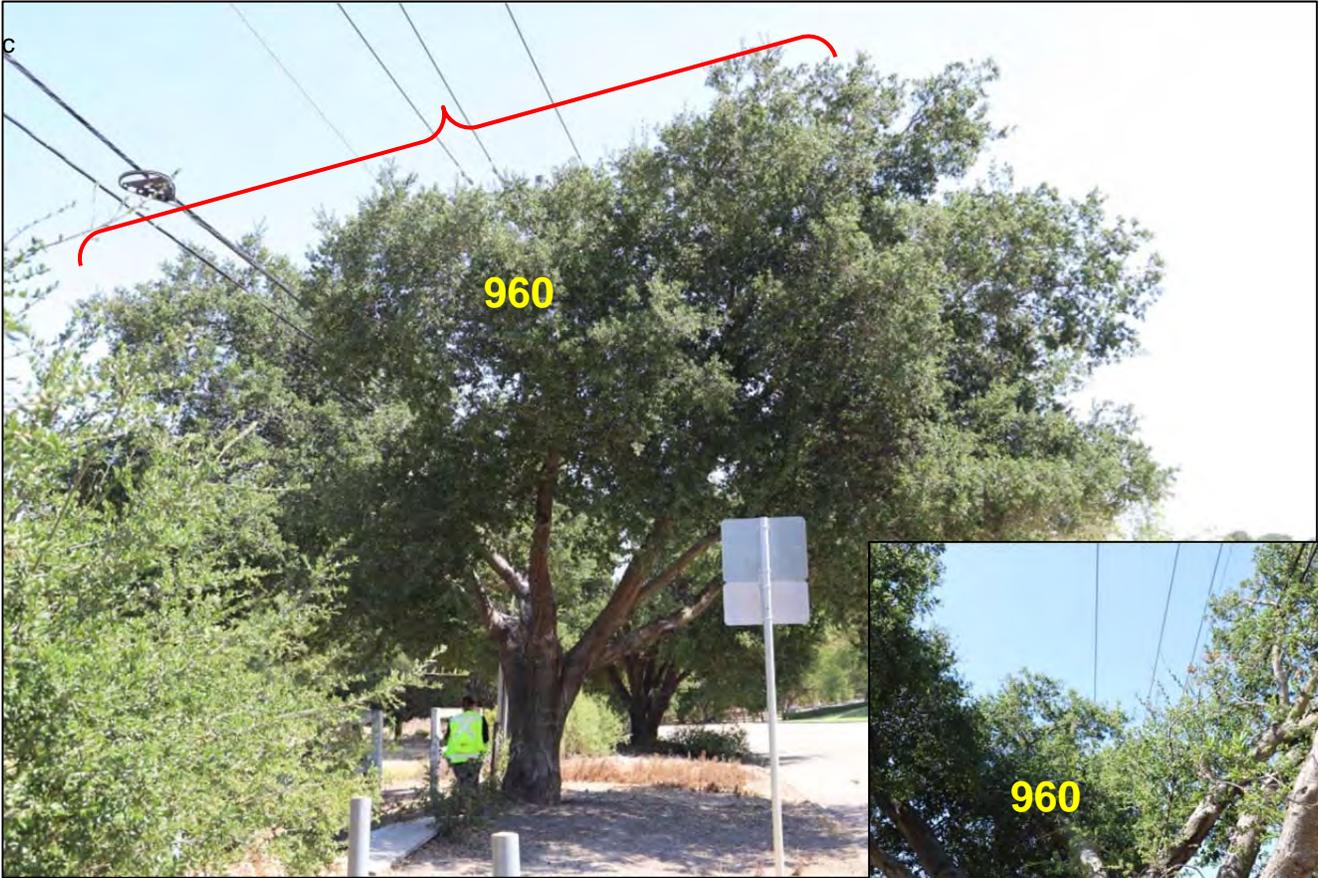
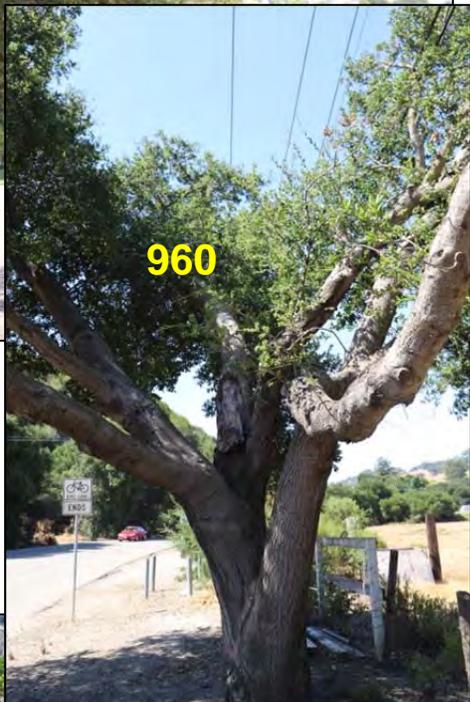
**Tree no. 960:** Code 2 (poor condition) – Major failure, repeated topping for utility lines, multiple stems with weak attachments, large basal wound, excess soil over root collar.

I understand the overhead utility lines are planned for undergrounding (G. Houston), but many of these trees have been topped for clearance, some repeatedly and severely. Others exhibit inherent and irreparable structural weaknesses and prior failures of major parts (nos. 957, 960). For these reasons and in consideration of proximity to future development and activity, I judged 7 of these 19 trees as poor candidates for preservation based upon their condition. Eight of this group could be retained based upon their condition, but their proximity to the adjacent pathway renders that ill advised. Where the trees are not immediately in the line of the pathway, it falls immediately next to trunks, which will result in significant root loss and hardscape displacement in the future. Two trees (nos. 2 & 957) are of such poor condition that removal is recommended regardless of construction impacts.

**Recommendations:** It is my opinion that the project and the community would be better served by replacing all 19 trees with new trees, located for maximum growing space, which can thrive for decades. In the absence of overhead utility lines and allowing for sufficient growing space, replacing with CA coast live oaks (*Quercus agrifolia*) is reasonable.

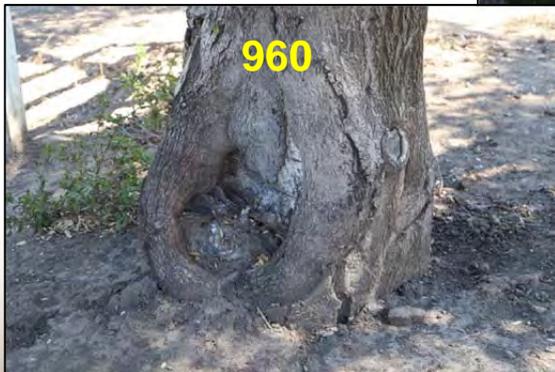
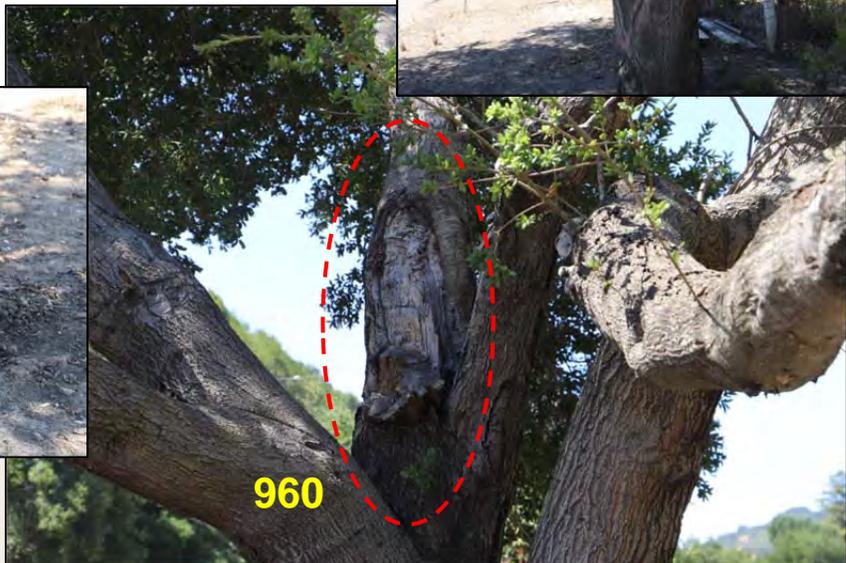
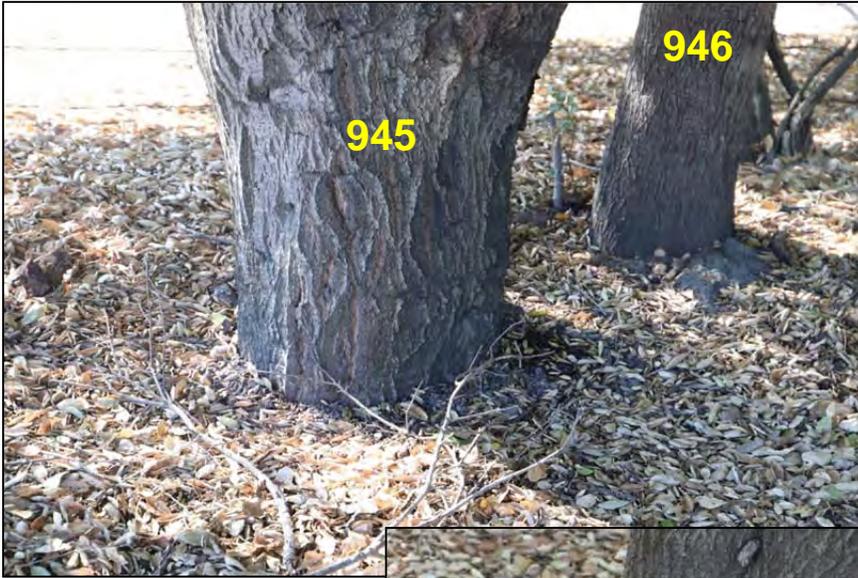
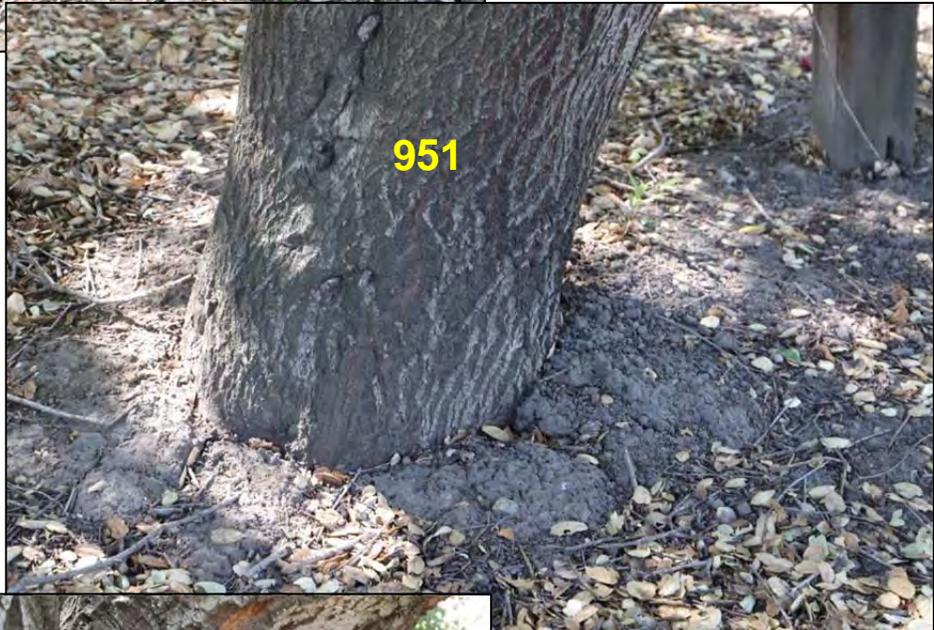
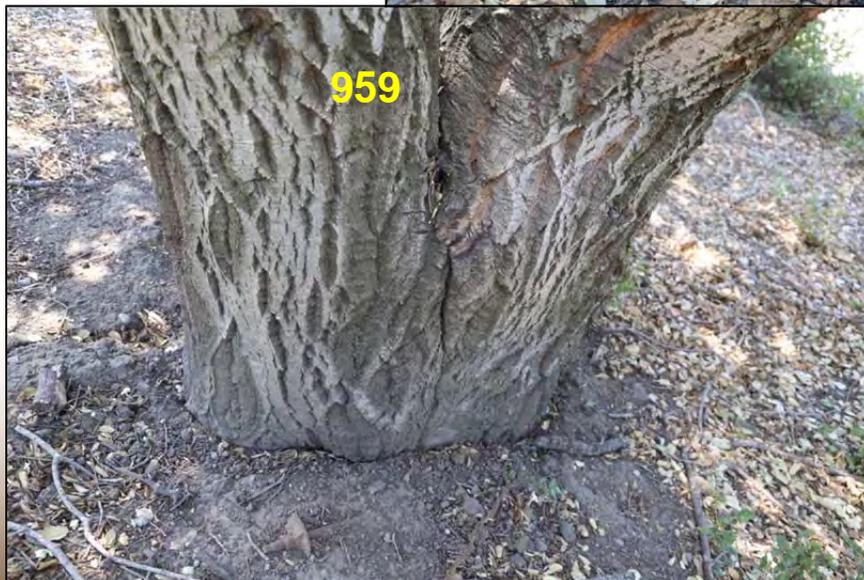
Typical examples of excess soil over root collars, exhibited by virtually every tree in this report.

**General comments:** Virtually all 28 trees within the construction zone have excess soil over the root collars. Any trees to be retained should have root collars excavated and inspected before deciding to preserve the tree. Doing so is not construction related but can be critical to discovering or preventing serious root decay disease.
