Project Name: RESURRECTION GREEK ORTHODOX CHURCH PLEASANTON
11/10/2020

In accordance with your authorization, we have performed an update geotechnical investigation for the subject project in Pleasanton, California. Our investigation was performed to observe the soil and geologic conditions that may impact site development for the project as presently planned. The accompanying report presents the results of our investigation and conclusions and recommendations pertaining to the geotechnical aspects of the proposed project. The findings of this study indicate the site is suitable for development as planned provided the recommendations of this report are implemented during design and construction.

This report presents the results of an update geotechnical investigation for the planned new Resurrection Greek Orthodox Church at 11300 Dublin Canyon Road in Pleasanton, California (see Vicinity Map, Figure 1). The purpose of this investigation was to evaluate the subsurface soil and geologic conditions in the area of planned development and provide conclusions and recommendations pertaining to the geotechnical aspects of project design and construction, based on the conditions encounter

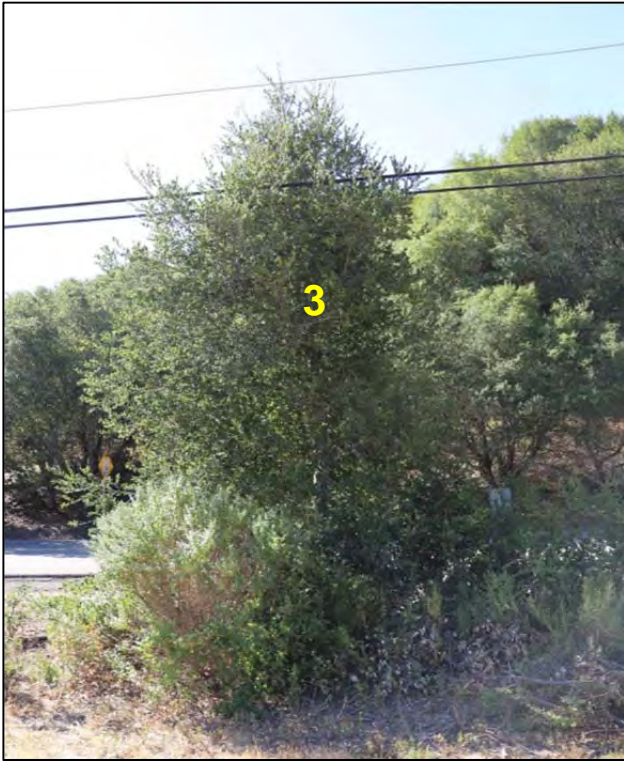
Tree no. 3: Code 5 (conflict with construction only). This small tree is a viable candidate for preservation, except that it is in conflict with the proposed pathway.

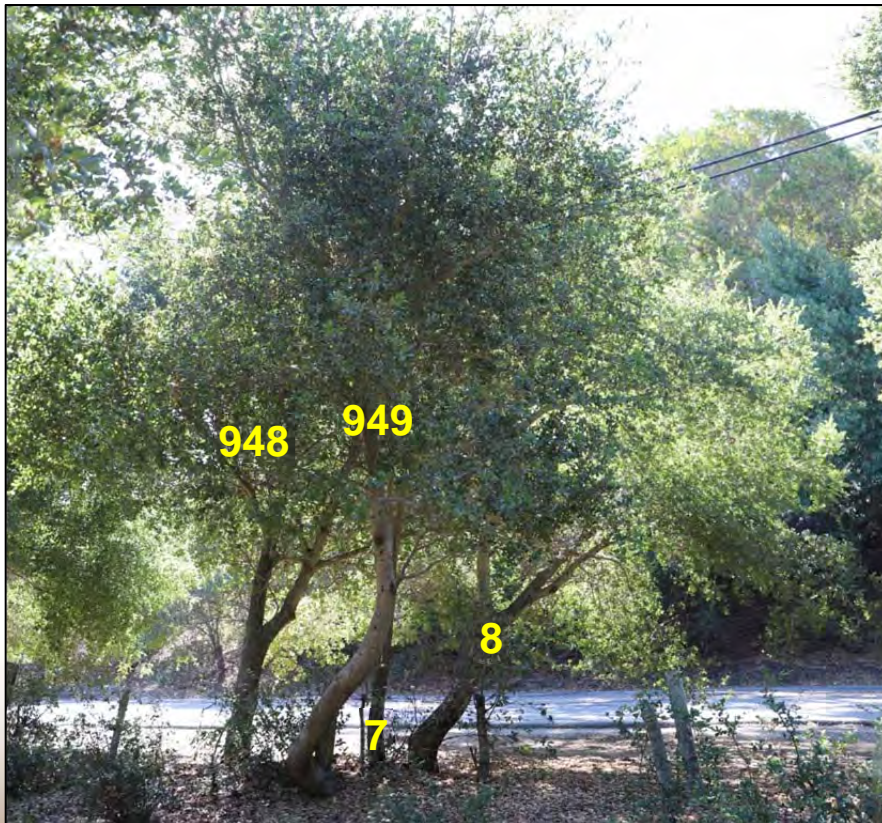
Trees nos. 948 & 949: Both are code 5 (conflict with construction).

Trees nos. 7 & 8: Both are code 2 (poor condition), but are also in conflict with the proposed pathway. These trees all exhibit poor architecture.

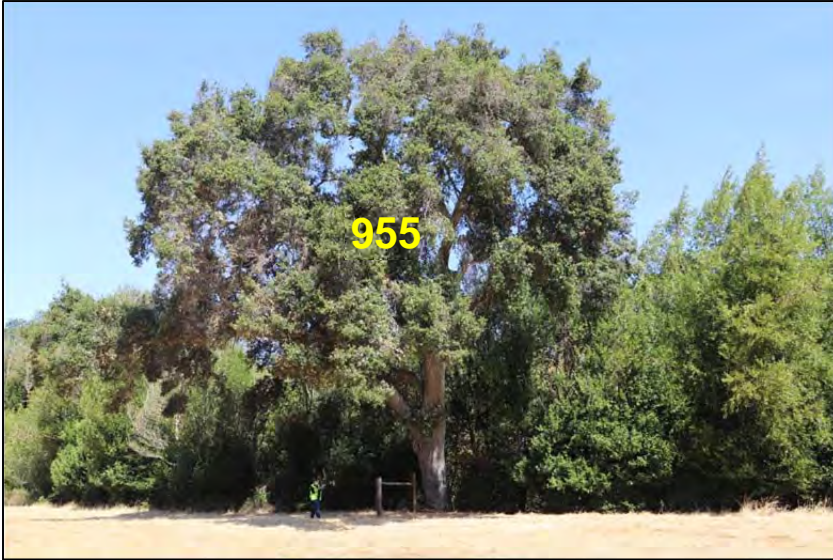
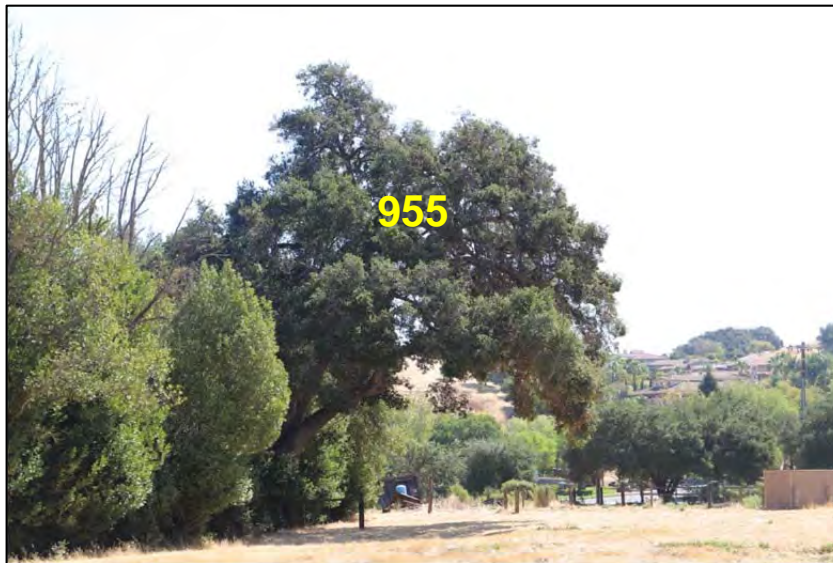
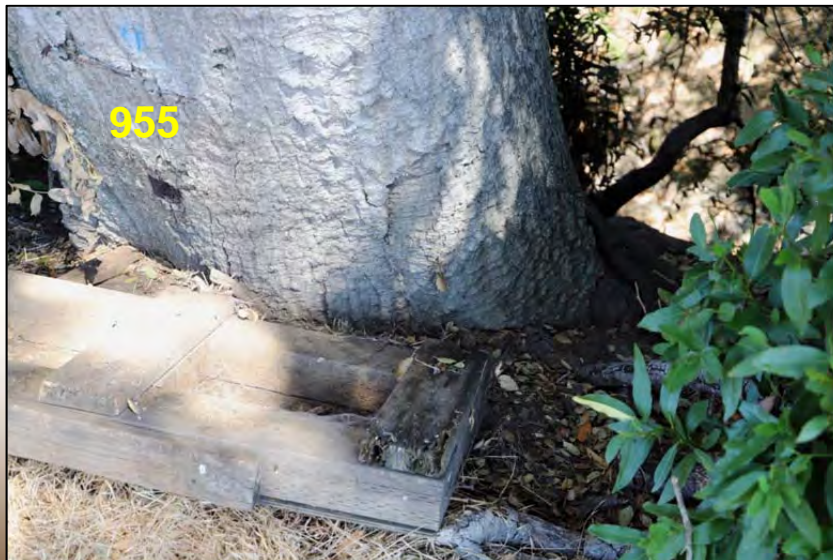
Tree no.955: Code 1 (Retain)
Although aesthetically desirable, this tree leans severely to the south (towards development) and is very stunted (stressed) with significant excess soil over the root collar. Excavation and inspection of the root collar is recommended to determine condition before deciding to retain. If sound, to deter root disease and decay.

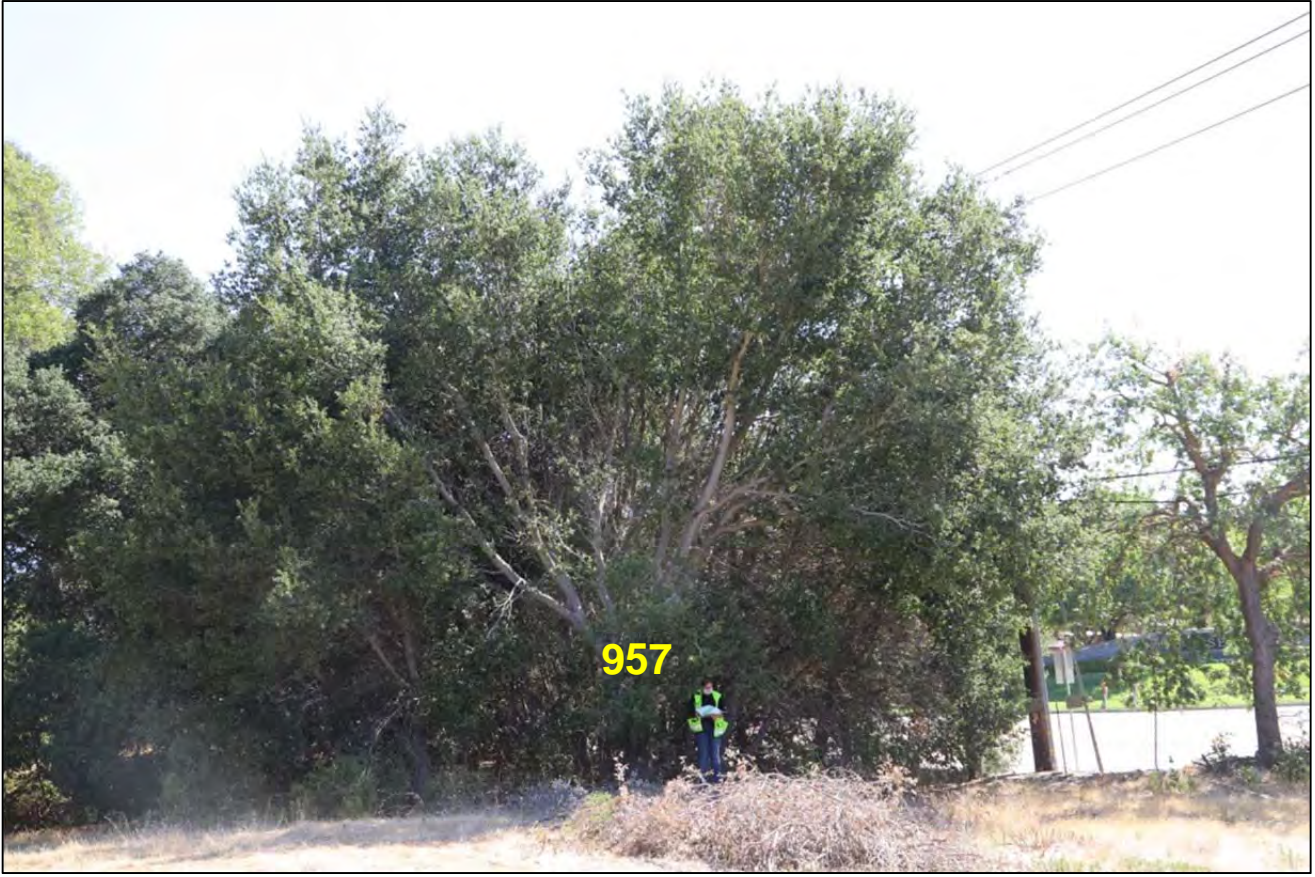
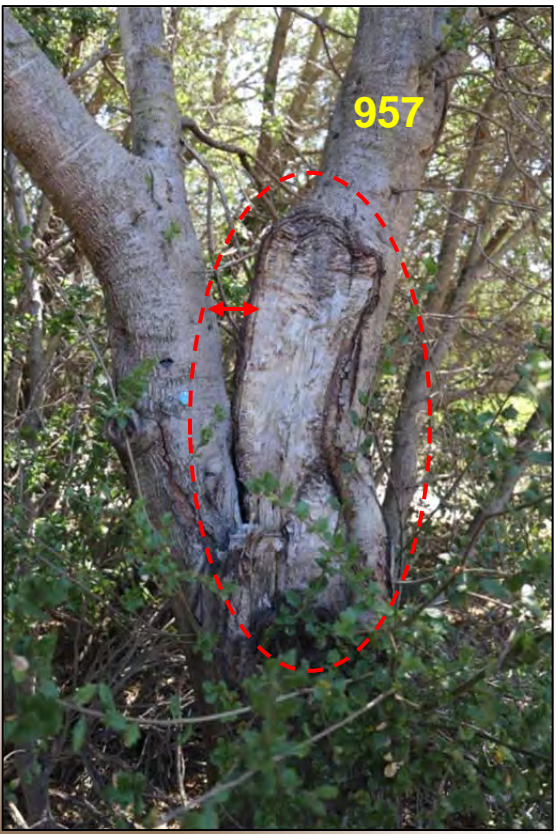
Tree no. 957: Code 4 (remove due to condition) – Major failure resulted in loss of ~40% of canopy. Codominant stems with weak attachment.

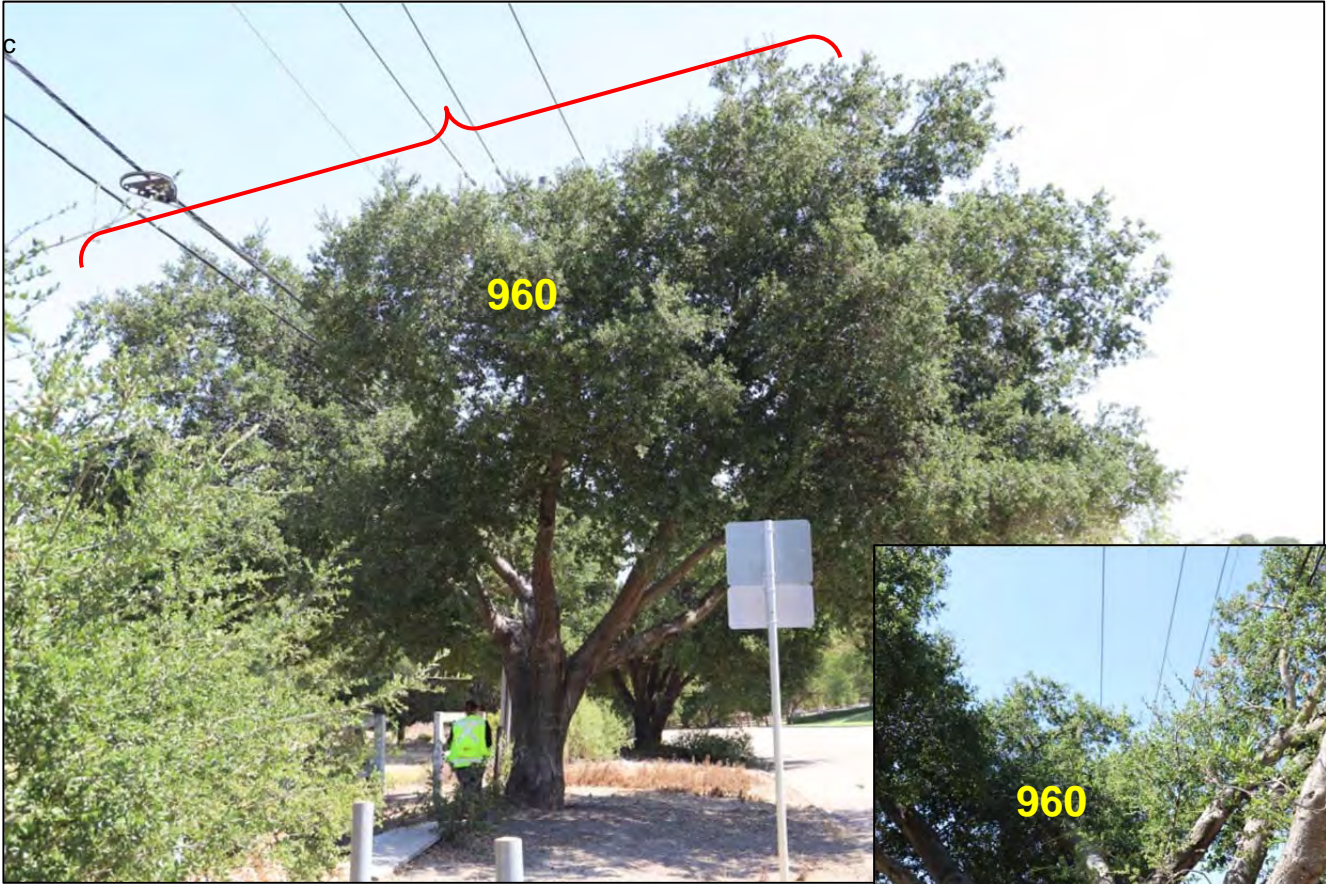
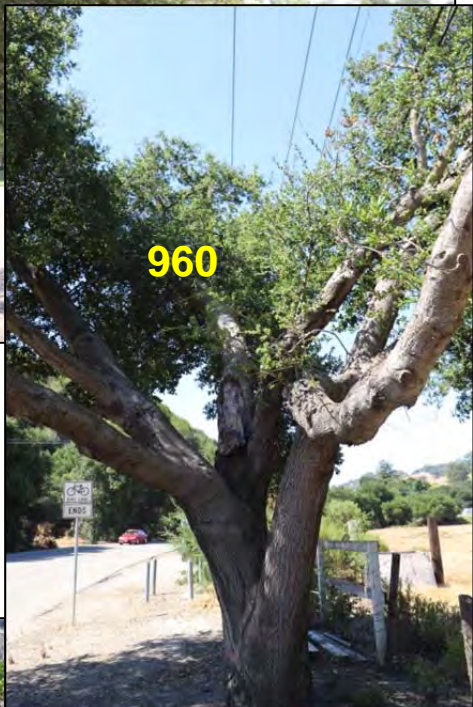
Tree no. 960: Code 2 (poor condition) – Major failure, repeated topping for utility lines, multiple stems with weak attachments, large basal wound, excess soil over root collar.

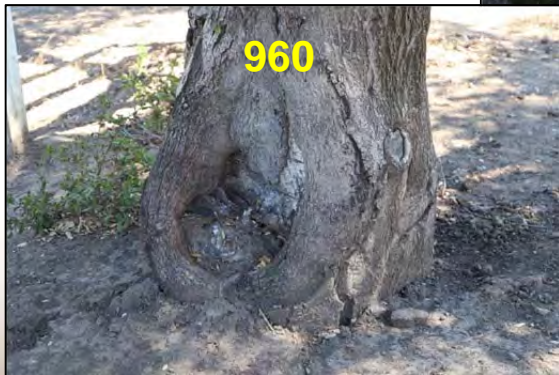
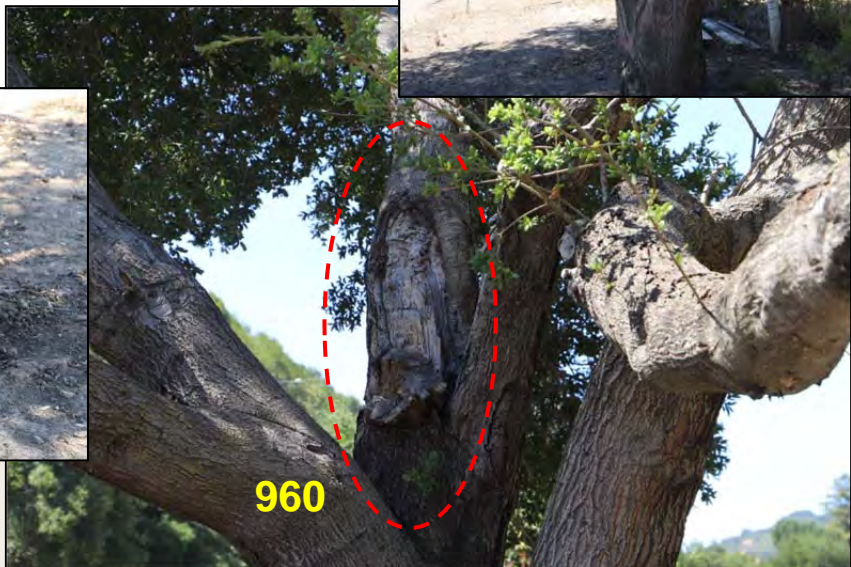
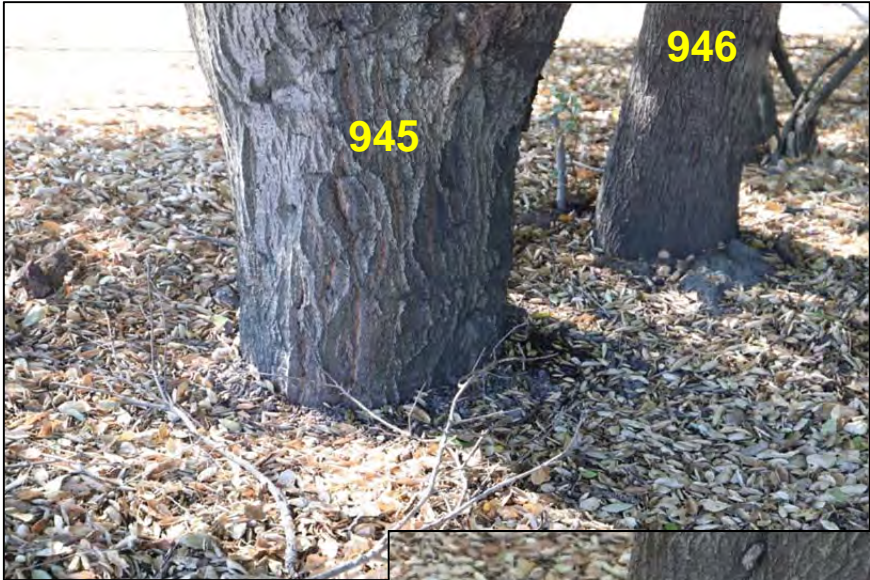
Typical examples of excess soil over root collars, exhibited by virtually every tree in this report.

General comments: Virtually all 28 trees within the construction zone have excess soil over the root collars. Any trees to be retained should have root collars excavated and inspected before deciding to preserve the tree. Doing so is not construction related but can be critical to discovering or preventing serious root decay disease.
