# ARBORIST REPORT

California Center  
Pleasanton, CA

**October 2012**

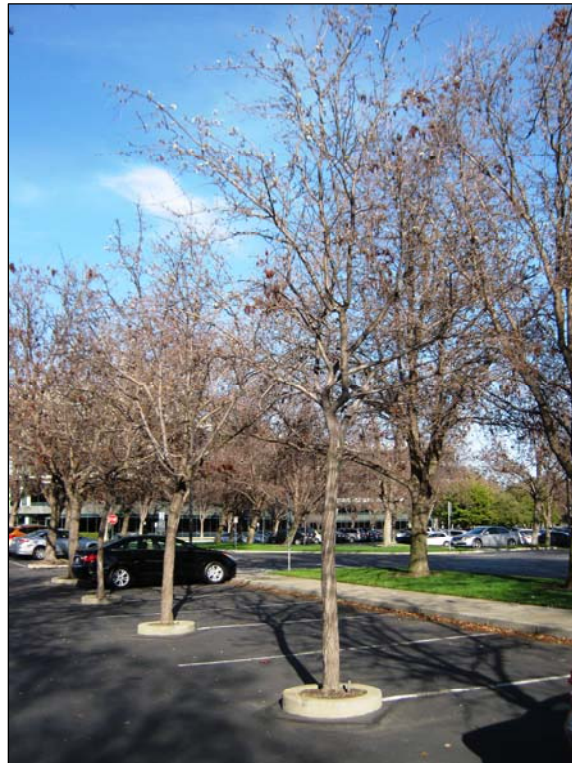
There were 12 species represented at the site. The most frequently occurring species was callery pear, with 166 trees or 36% of the population. One hundred fifteen (115) of the trees (69%) were in good condition, 49 were in fair (30%) and two (2) were in poor (1%). In general, the species had been planted in the larger end-cap islands or landscaped areas throughout the parking lots, where adequate soil volume and moisture were available. Where the tree had been planted in small islands, drought stress and stunted growth resulted (**Photo 1**).

**Photo 1:** In general, callery pears had been planted in larger end-cap islands or landscaped areas (background). Where the species had been planted in small parking lot islands (foreground), drought stress and stunted growth were common.

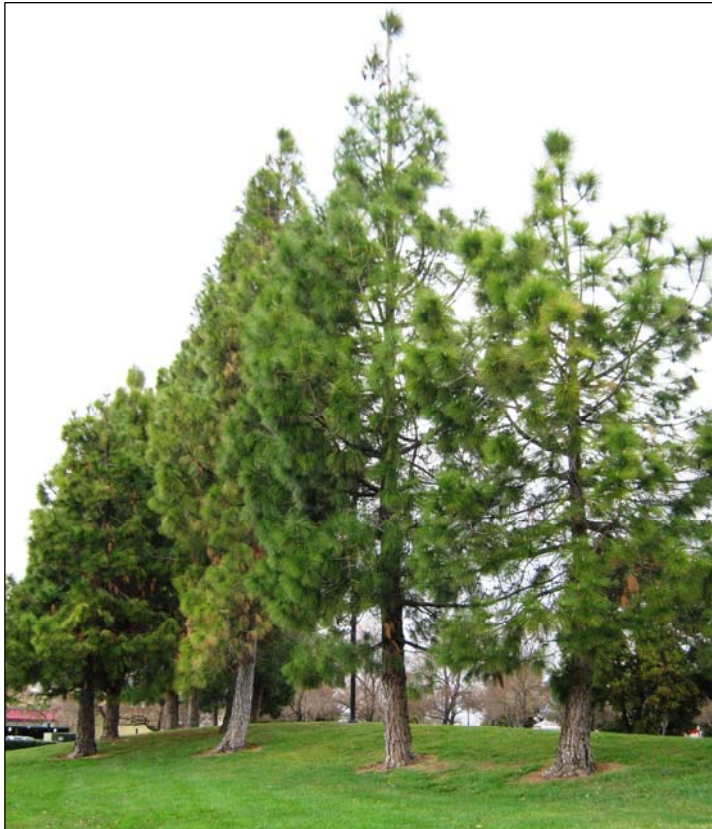
**Photo 2:** Canary Island pines, blackwood acacias and Chinese tallows had been planted in the southwest corner of the site. Canary Island pines and blackwood acacias were growing on the soil berm and Chinese tallows were planted in the Rosewood Dr. frontage landscape.
