Preliminary Arborist Report

1701 Springdale Ave.
Pleasanton, CA

January 2021

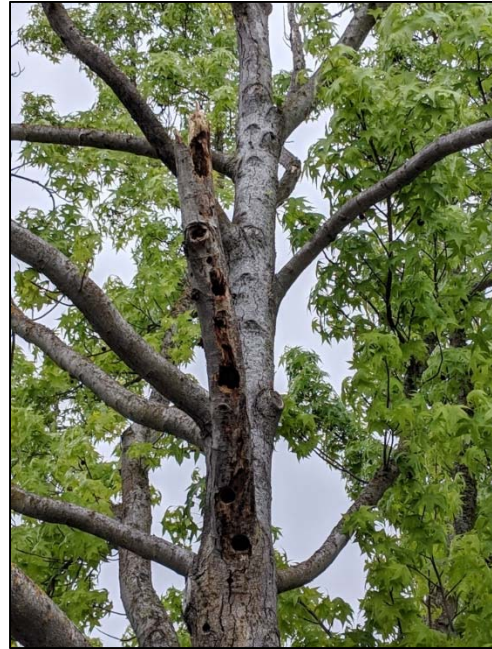
The most common species assessed was sweetgum (64 trees, 40% of population). The sweetgums were in fair condition (36 trees) with 20 trees in good condition and eight trees in poor condition. They ranged in trunk diameter from 8 to 28" with an average diameter of 17". Several of the sweetgums in the parking lot had large diameter dead branches and stems with multiple cavities. European starlings were nesting in the cavities (Photo 1).

Photo 1 – Sweetgum #70 had a dead branch with European starlings nesting in cavities.

69	Sweetgum	10	1	Low	No	Mostly dead.
70	Sweetgum	16	1	Low	No	Mostly dead; starling cavities.
71	Sweetgum	12	3	Low	No	Codominant trunks arise from 15 feet; chaotic form; replaced curb.
72	Sweetgum	12	2	Low	No	Multiple trunks arise from 15 feet; chaotic form; replaced curb; 4 inch branch dieback.
73	Sweetgum	12	3	Low	No	Multiple trunks arise from 15 feet; chaotic form; dense crown; replaced curb.
74	Sweetgum	8	3	Low	No	Multiple trunks arise from 10 feet; low vigor; dead branch.
75	Sweetgum	14	1	Low	No	Mostly dead; cavities with decay.

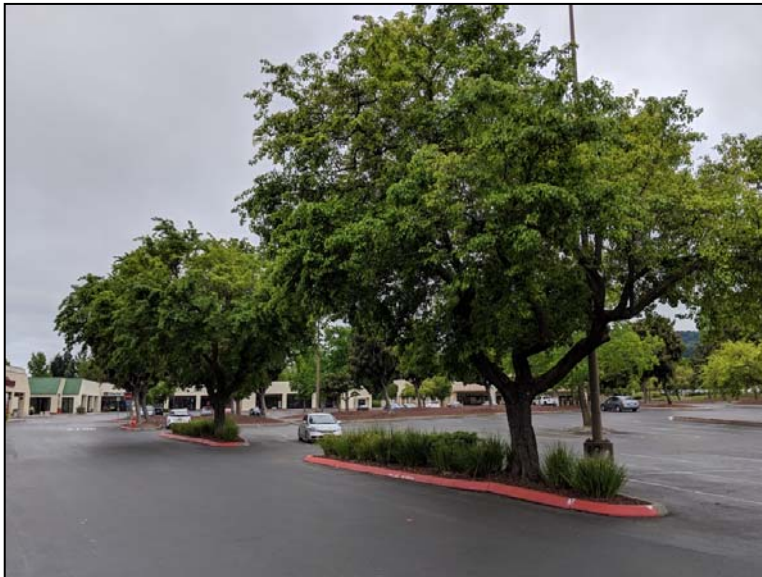
Photo 2 – Evergreen pears #45 and 46 were in good condition with dense, wide-spreading crowns.

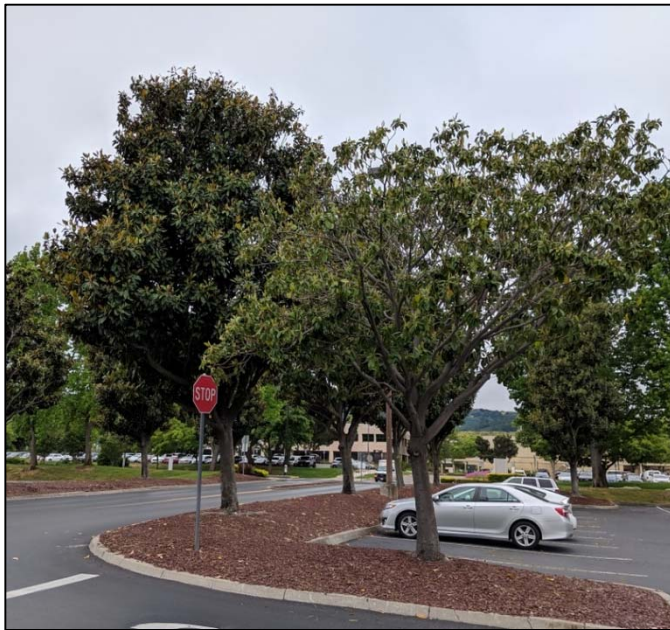
Photo 3 – Southern magnolias #36 and 37 appeared to be different varieties. The more upright variety was much healthier with dense, vigorous crowns.

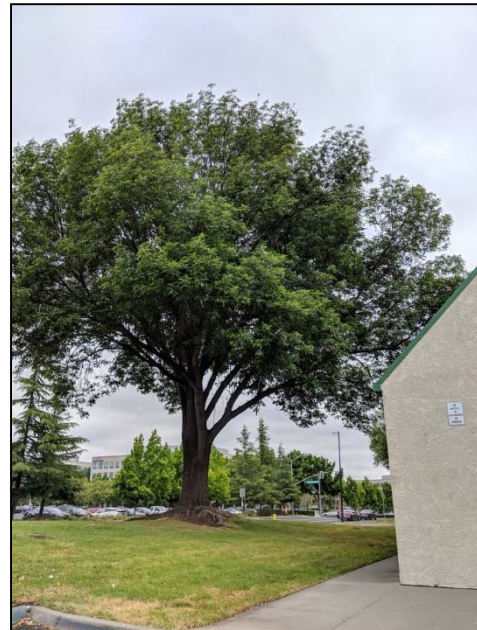
Photo 4 – Evergreen ash #1 was one of the largest trees assessed with a trunk diameter of 44”.

TREE No.	SPECIES	SIZE DIAMETER (in inches)	HERITAGE	CONDITION 1=POOR 5=EXCELLENT	SUITABILITY FOR PRESERVATION	COMMENTS
1	Evergreen ash	44	4	High	Heritage	Multiple trunks arise from 10 feet; dense wide spreading crown; minor dieback; large surface roots.
2	Camphor	25	2	Low	Heritage	Codominant trunks arise from 8 feet; leaning east; half dead.
3	Blackwood acacia	26	3	Moderate	Heritage	Multiple trunks arise from 16 feet; trunk sweeps east; 3 foot tear out wound; dense crown.
4	Southern magnolia	14	4	Moderate	No	Multiple trunks arise from 8 feet; narrow upright form.
5	Southern magnolia	14	4	Moderate	No	Multiple trunks arise from 8 feet; narrow upright form.
6	Southern magnolia	11	3	Moderate	No	Multiple trunks arise from 8 feet; narrow upright form; trunk sweeps east.
7	Southern magnolia	14	4	Moderate	No	Multiple trunks arise from 8 feet; narrow upright form.
8	Sweetgum	19	4	Moderate	Heritage	Multiple trunks arise from 10 feet; dense crown; narrow upright form; 12 inch surface roots pushing out curb.

Tree #	Species	Trunk Diameter (in.)	Heritage?	Recommendation	Estimate of Value
1	Evergreen ash	44	Heritage	Preserve , sidewalk 6' S and bioswale 18' S.	26850
2	Camphor	25	Heritage	Remove, poor health	9100
3	Blackwood acacia	26	Heritage	Remove, within sidewalk	7300
4	Southern magnolia	14	No	Preserve , drive isle 16' S., sidewalk 20' W.	4000
5	Southern magnolia	14	No	Remove, within parking lot reconfiguration	4000
6	Southern magnolia	11	No	Preserve , curb 14' S., sidewalk 12' N.	1800
7	Southern magnolia	14	No	Remove, impacted by sidewalk	4000
8	Sweetgum	19	Heritage	Preserve , sidewalk 9' S.	9250
9	Sweetgum	22	Heritage	Preserve , outside impacts	12350
10	Sweetgum	19	Heritage	Preserve , outside impacts	6600
11	Sweetgum	17	Heritage	Preserve , sidewalk 13' S.	5300
12	Sweetgum	22	Heritage	Preserve , outside impacts	12350
13	Sweetgum	22	Heritage	Preserve , sidewalk 15' SE.	8850
14	Sweetgum	15	No	Preserve , outside impacts	4150
