Lexus of Pleasanton

Preliminary Arborist Report

**4346 Rosewood Dr.
Pleasanton, CA**

March 6, 2014

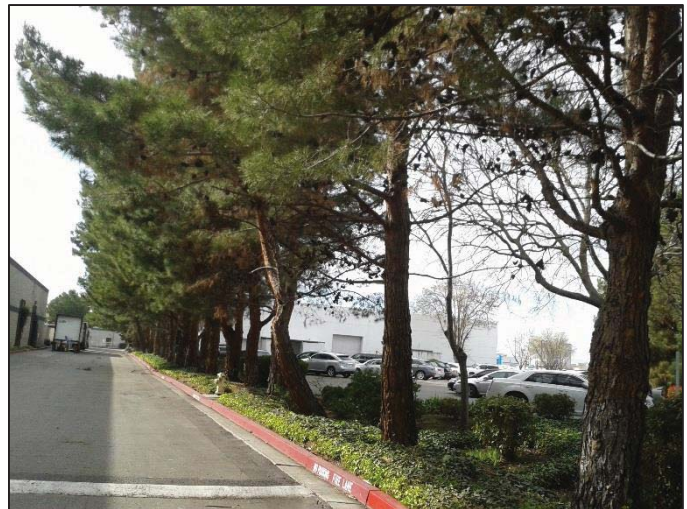
Photo 1: The row of off-site Aleppo pines on the southern boundary of the property (#78 on right).

These trees were primarily in fair condition (24 trees) with only one tree in good condition and six in poor. They tended to have narrow canopies due to crowded growing conditions and poor structure. The trunks had masses of pitch indicative of infestation with sequoia pitch moth.

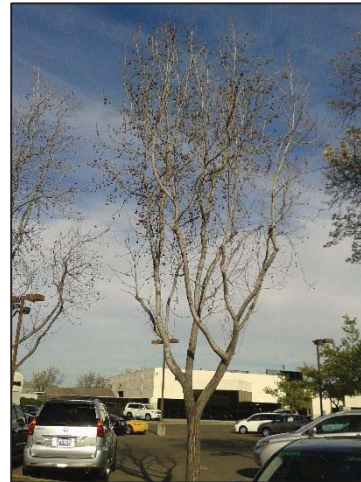
Two species had 19 trees each: sweetgum and Callery pear. Both species were spread throughout the parking lot in small islands limiting potential growth. The sweetgums were in good condition (9 trees) with 9 trees in fair condition and one in poor. They were young to semi-mature ranging from 6 to 15" in trunk diameter with an average of 10". The sweetgums tended to be narrow with an upright form (Photo 2).

Photo 2: Sweetgum #92 had a narrow upright form that was typical of the sweetgums at the site.

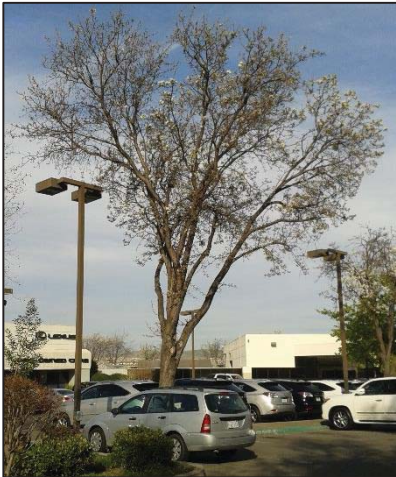
The Callery pears had three trees in good condition, 11 in fair condition and five in poor condition. They were young to semi-mature ranging in trunk diameter from 7 to 19" with an average of 13". They tended to have multiple attachments (Photo 3). Several trees were thin due to excessive pruning.

Photo 3 (left): Callery pear #7 was growing in a small parking lot island had multiple branch attachments arising at one location and a dense full canopy.

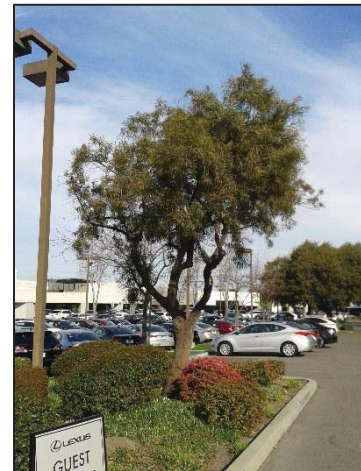
Six African sumacs were located in the south western corner of the property. They were in fair condition (4 trees) with one in good condition and one in poor condition. They tended to be semi-mature, ranging in trunk diameter from 10" to 22" with an average of 14". Some suffered from poor form, thin canopies, and sunburn (Photo 4).

Photo 4 (right): African sumac #1 was in fair condition with a thin canopy and sunburned trunk.

I estimate that seven additional trees can be preserved: African sumac #1, evergreen pear #75, raywood ash #76, sweetgums #77-79, and Canary Island pine street tree #84 with minimal impacts anticipated from the available plans. Seven trees (honey locust #2; sweetgums #14-15; glossy privet #50; hackberry #52 & 74 and Canary Island pine #83) can possibly be preserved depending on more specific plans.

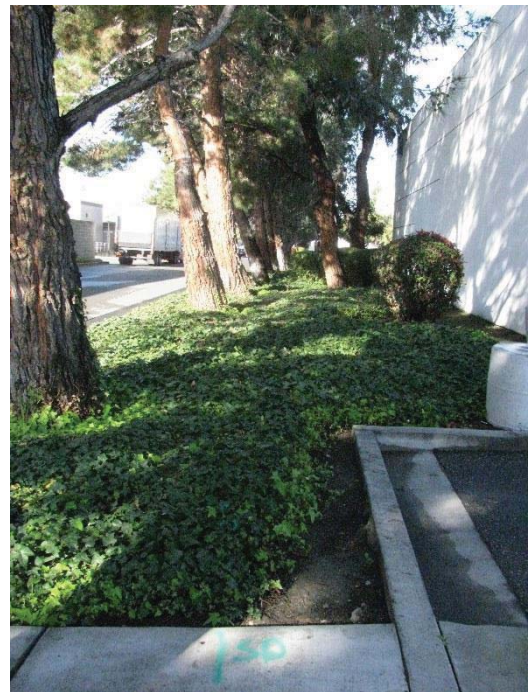
The Aleppo pines can be broken into three groups in terms of preservation. Aleppo pines #16-21, 41-49 & 53-54 may be able to be preserved depending on the specific plans for construction, drainage and utilities in this area. It appears that the existing curb will remain the same, but other work is planned in the landscape area. Aleppo pines #22-24, 27-28 & 30-32 currently have a large area for root development to the north which will be excavated and paved (Photo 5). This will destabilize these pines, necessitating their removal.

Photo 5: Aleppo pine (#32) and other trees in this photo will be impacted by pavement extending into current landscape area.

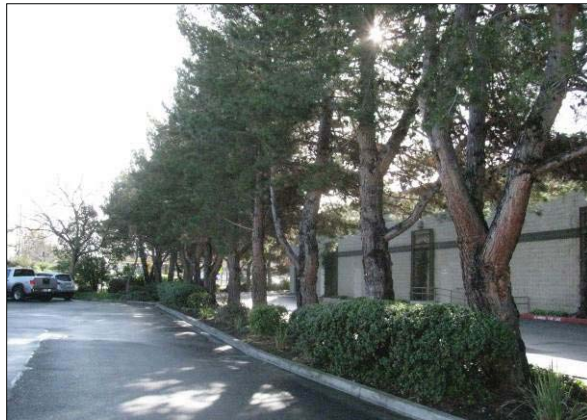
There is a row of Aleppo pines (#16-25, 27-28, 30-33, & 36-49) on the adjacent property to the south, 1-2 feet from the Lexus of Pleasanton property line. The trees are currently growing in a 5'-wide planting strip. They are large, leaning to the south, and roots have caused lifting of the adjacent pavement and damage to the existing curb and gutter.

Aleppo pines at the south property line. Viewed from the Lexus of Pleasanton's property towards the southeast corner of the property.
