Phan Residence

1131 Sleepy Head Lane Pleasanton, California

Site Plan

Subject: Updated Arborist Report 1131 Sleepy Head Lane – Parcel B, Pleasanton

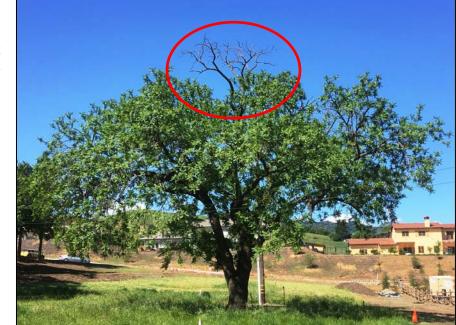
Calif. black walnut #76 was a mature tree at 36" in diameter. It was in fair condition, with good form but the central stem of the tree was dead, which represented a major portion of the upper crown (Photo 1).

Photo 1: Looking northwest at Calif. black walnut #76. This mature tree had good form but was in fair condition due to a dead central stem (red circle).
