### **P17-0356 & PUD-124 4664, 4676, and 4682 Augustine Street Work Session Topics**

**Re: Arborist Report for Augustine Street, Pleasanton**

**TREE PROTECTION PLAN**

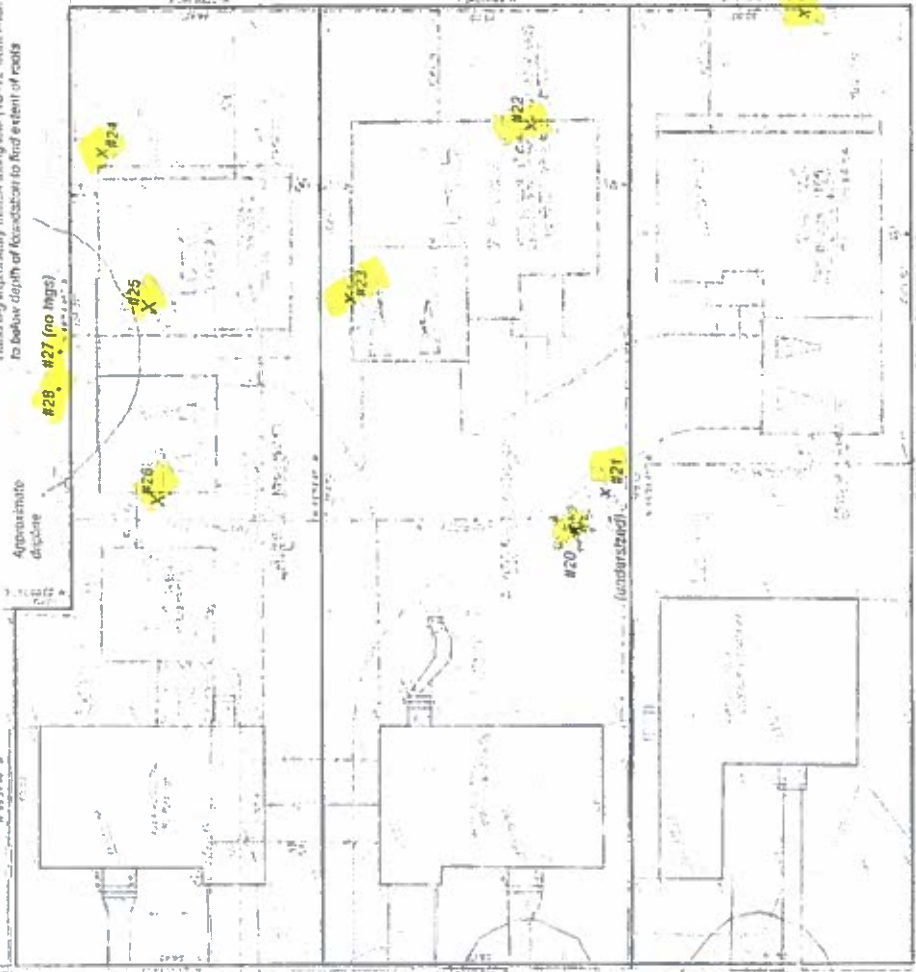
The garage and home proposed for Lot 6 is within 10' of the trunks of two redwoods on the adjacent property and may lead to significant root encroachment. Exploratory trenching will be needed to assess extent of potential damage. It is my opinion that a total of 8 of trees will need to be removed to accommodate the proposed homes and additions, and that the remaining 4 trees can be retained given that protection measures within this report are followed.

Hand dig exploratory trench along base (10'-12" from which (right))  
 to below depth of frost-table to find extent of roots

- Remove trees #19-26.
- Perform exploratory trenching on the redwoods (#27, 28), 10'-12' from the trunks in each direction for a total length of 30'. Trench shall be dug by hand along the proposed foundation to below the required depth of excavation. If large roots are encountered, design should be adjusted to accommodate roots or trees will need to be removed.
- Prior to construction or any grading, contractor shall construct a temporary 6' chain-link fence to set up a Tree Protection Zone (TPZ) around the redwoods (#27, 28) as directed by the project arborist (PA).
- TPZ fencing shall remain in an upright sturdy manner from the start of grading until the completion of construction. Fencing shall not be adjusted or removed without notifying the PA.
