Preliminary Arborist Report

**Valley Trails
Pleasanton CA**

Prepared by:
**HortScience, Inc.
325 Ray Street
Pleasanton, CA 94566**

June 2015

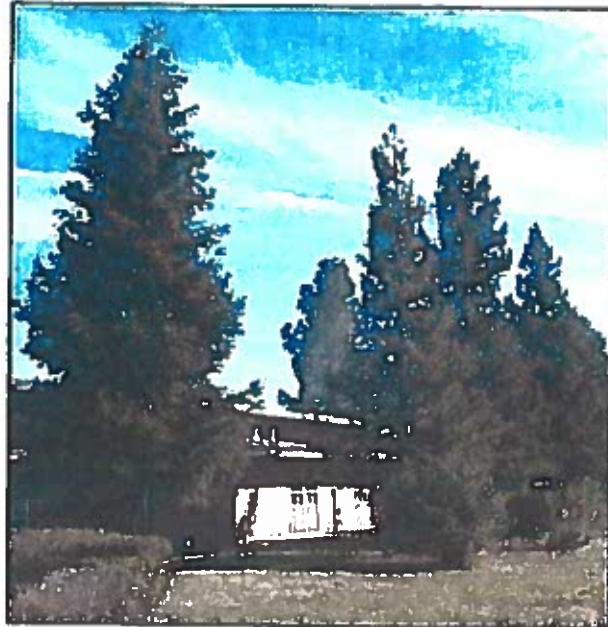
Photo 1: Looking south at coast redwoods #228 (L) and #229-231 (background R). There was a noticeable difference between the canopy density of tree #228 and the other redwoods assessed at the site. I attributed the difference to increased soil moisture associated with a leaking pipe next to tree #228.
