Annual Collision Analysis 2019

Summary

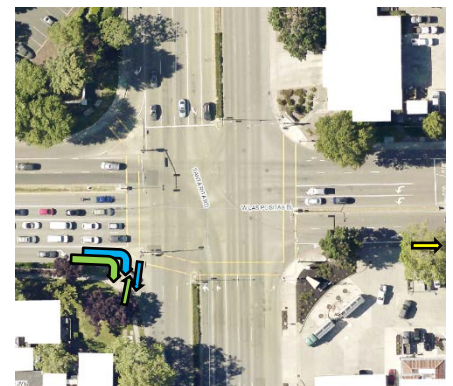
Three collisions occurred at this intersection and all three involved a bicyclist under the age of 18. Two of the collisions occurred in the same crosswalk. Both of the collisions in the southwest corner of the intersection were located between the curb and the pedestrian island. Both found a right turning vehicle at fault. One of the two collisions occurred during the school peak travel period. The third collision was a bicyclist who fell off his bike, and was noted in the collision report as an inexperienced rider.

These collisions will be considered in the West Las Positas Corridor plan currently in design.

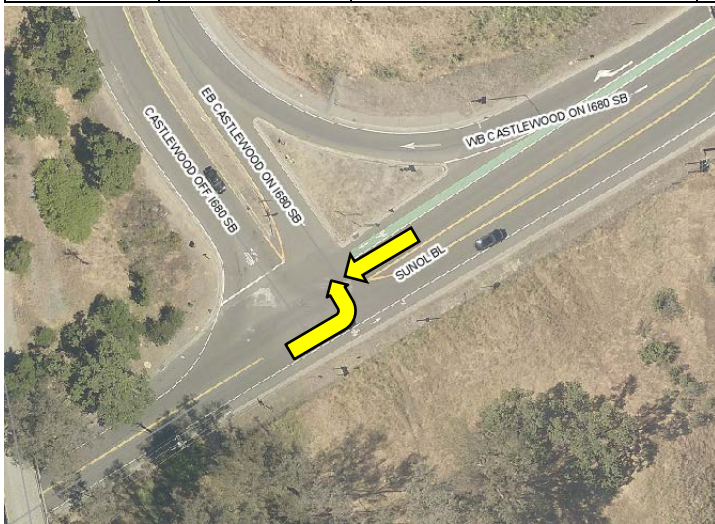
Analysis: Seven of the eight collisions involved an eastbound left turning vehicle and a westbound through vehicle with the left turning vehicle found at fault. The most common reason given for the collision was that the left turning vehicle did not see the approaching westbound vehicle. Collisions occurred mainly in the morning but not many in the commute hour. This intersection will be signalized as part of the Sunol Boulevard I680 ramp capital improvement project (we are currently in the design phase with Caltrans).

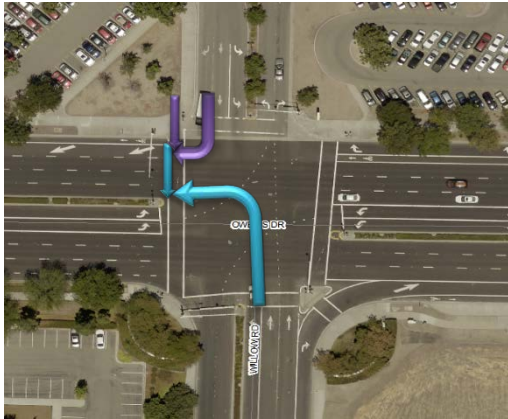
Analysis: Both collisions occurred in the west crosswalk and both found the driver to be at fault. One collision was a northbound vehicle striking a pedestrian and the other involved a southbound right turning vehicle striking a pedestrian. The right turning driver admitted he was "not watching where he was going". The northbound left turn collision should no longer occur, as the left turn movement no longer operates at the same time as the pedestrian movement. The intersection was modified on 4/6/2017 to provide protected left turns. No further pedestrian collisions have occurred at this intersection since the signal modification.

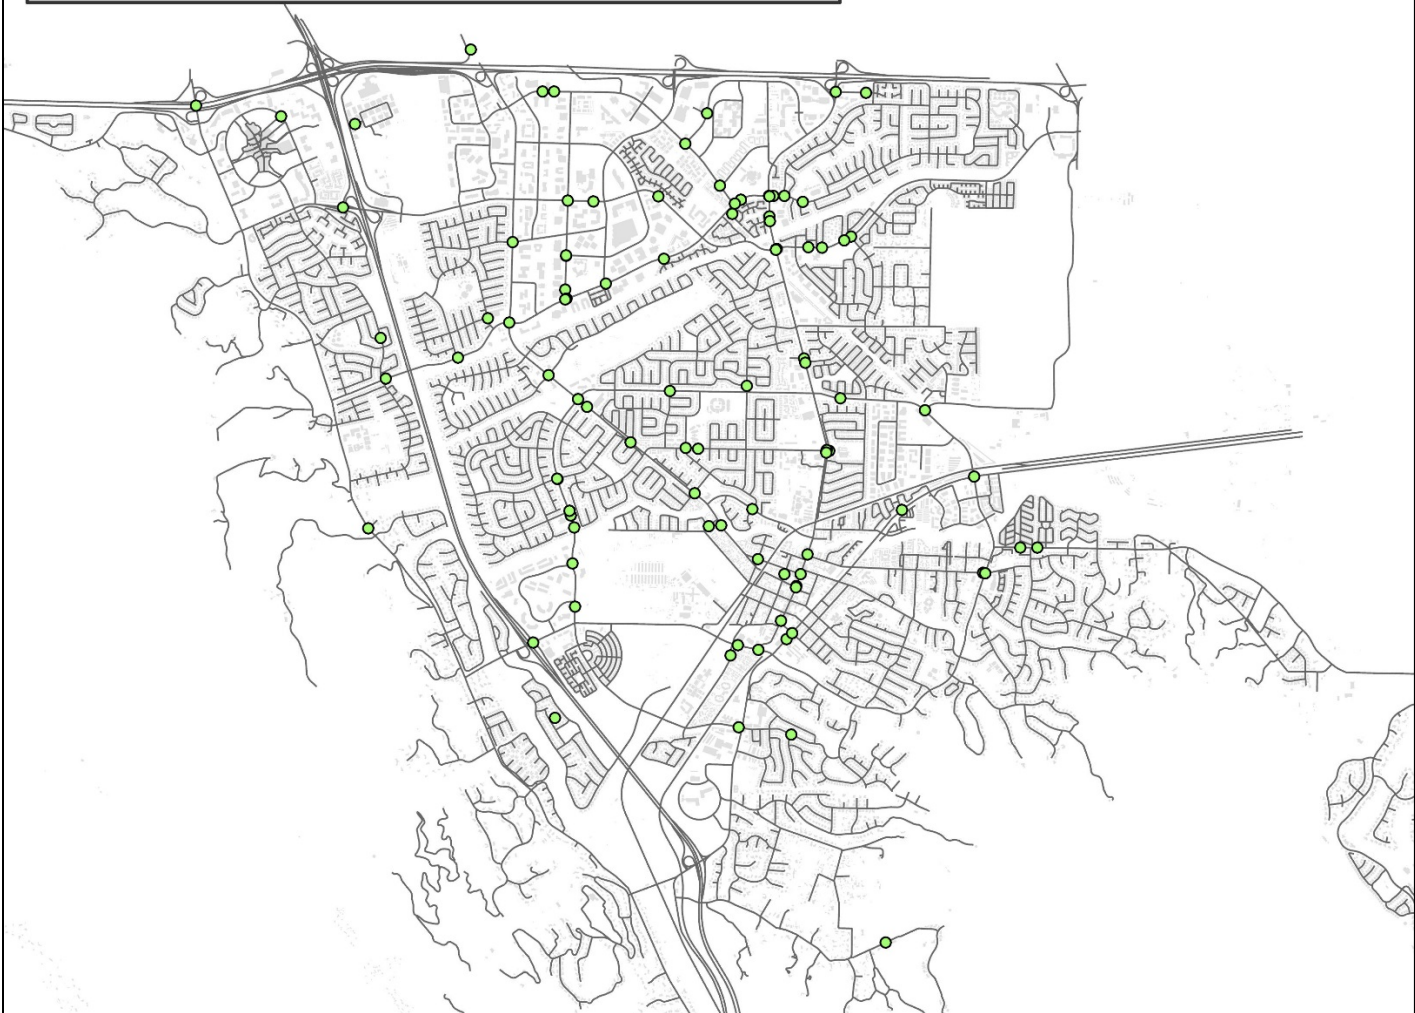
Bicycle Collisions 12/01/2015 to 11/30/2018

Summary		
	12/01/2015-11/30/2018	12/01/2014-11/30/2017
Vehicle/Bicycle	87 (85%)	83 (79%)
Bicycle only (solo)	15 (15%)	16 (16%)
Total	102	99
Bicycle in Crosswalk		
	40/102 (40%)	35/99 (35%)
Bicycle on Sidewalk		
	18/102 (18%)	17/99 (17%)
Bicycle in Street (other than bike lane)		
	27/102 (27%)	35/99 (35%)
Bicycle in Bike Lane		
	17/102 (17%)	12/99 (12%)
Bicyclist under 18 years old		
	40/102 (39%)	33/99 (33%)
Fault (Vehicle/Bicycle Collisions)		
Bicycle at Fault		
	31/87 (36%)	30/83 (36%)
Vehicle at Fault		
	54/87 (62%)	51/83 (61%)
Unknown/Other		
	2/87 (2%)	2/83 (2%)
