Re: Neighborhood Improvement
Valero Station
Santa Rita & Las Positas

Exhibit B
P13-0336
3192 Santa Rita Road
Dated "Received July 26, 2013"

Project Location:
3192 Santa Rita Rd.
@ Las Positas Blvd.
Pleasanton, CA 94588
 7-Eleven No. 1028068 - Tenant Improvement of 3,403 SQ. FT.

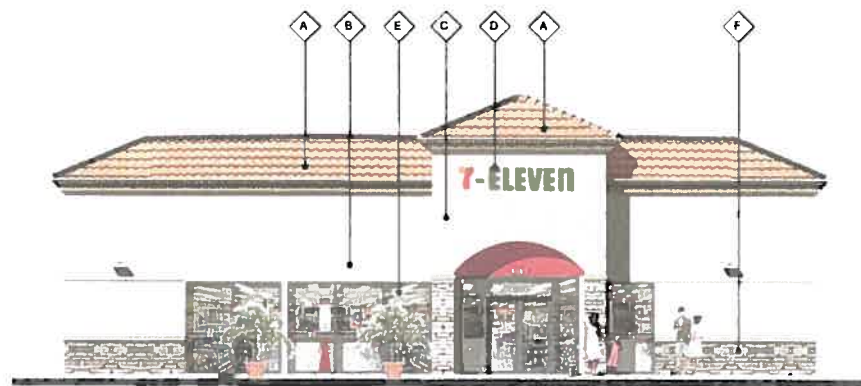
3 PROPOSED WEST ELEVATION
Scale: 1/8" = 1'-0"

Elevation Keyed Notes	
◇	TILE ROOF
◇	STUCCO FINISH OVER CEMENT PLASTER - LIGHT CREAM COLOR
◇	STUCCO FINISH OVER CEMENT PLASTER - LIGHT BROWN COLOR
◇	SIGN BY OTHER
◇	FIX WINDOW
◇	CULTURAL STONE - NATURAL COLOR
◇	HVAC UNIT
◇	ROOF ACCESS HATCH
