A MODIFICATION OF CONDITIONAL USE PERMIT

PCUP-109

for
U-Haul of Pleasanton

**5555 Sunol Blvd.
Pleasanton, CA**

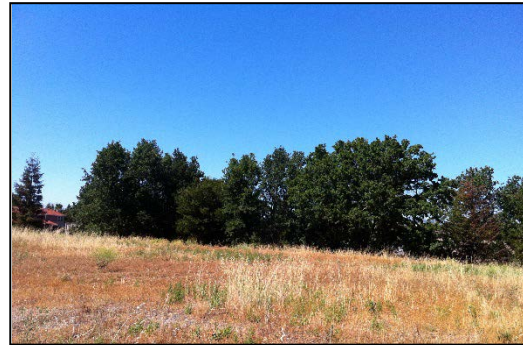
Valley oak was the most common species present, with 22 trees (28% of the population). All were in good or fair condition except for #55 which had failed in the past. Trees were generally small (average 11 inches in trunk diameter) and densely spaced in the northwestern section of the property. There were five Heritage valley oaks: #32, 44, 47, 48 and 78. The other California native species (redwoods, coast live oaks, black walnut, and Monterey pine) were mixed with the valley oaks in the northwestern section of the property (Photo 1).

Photo 1: Looking northwest from open field (Parcel 2), native oaks were mixed with several species including redwoods, and black walnut.

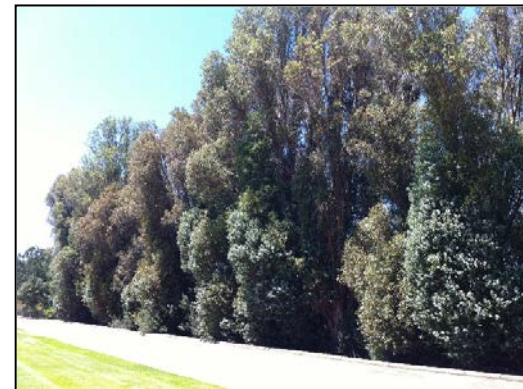
Dwarf blue gum eucalyptus was the second most common species with 20 trees (26% of the population). All but one was a Heritage tree. As is characteristic of the species, they tended to have many attachments at three feet and were sprouting at the base. All eucalyptus were growing on the northern property boundary and appeared to be under water stress (Photo 2). The eucalyptus were mostly in fair to good condition, except for #8 and #15 which had large amounts of dead branches.

Photo 2: Dwarf and non-dwarf blue gum eucalyptus growing along the eastern property boundary.

Accurate tree trunk locations were not available at the time of our review, so our assessment of impacts to trees is preliminary. It appears that regarding along the northern portion of the site will require removal of 32 trees, eight of which are Heritage trees (Table 3). Six trees appear to be near the limits of grading and it may be possible to retain them, depending on their exact trunk location. It appears that 40 trees can be preserved, including 33 Heritage trees, although we recommend removing two of the dwarf blue gum trees (#8, 15) due to poor condition.

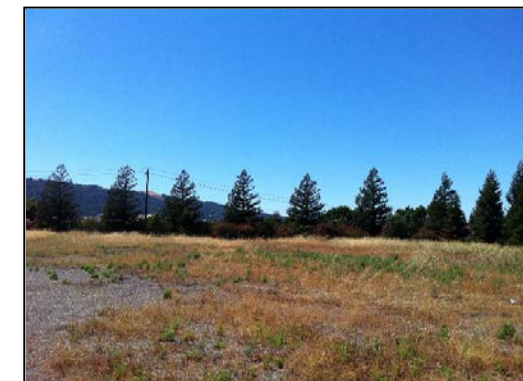
Coast redwood was another species present in large numbers with 19 trees (24% of the population), 11 of which were Heritage trees. The redwoods were located along the western property boundary (Photo 3) and mixed with the oaks in the northwestern section. Redwoods tended to be semi-mature with an average diameter of 15 inches. The redwoods were in very good condition with good form; only one tree was declining (#42).

Photo 3: Coast redwoods lining the western boundary of the property from Parcel 2 on the east.
