Annual Collision Analysis 2020

Summary

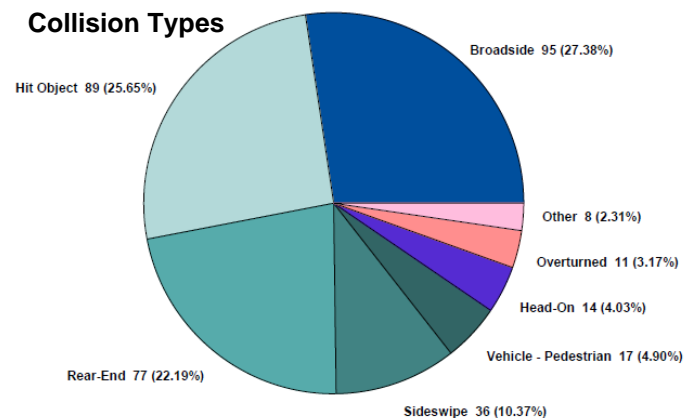
Collision Types

Collision types (by percentage) remained the same as last year except for small decreases in broadside and head-on collisions, and an increase in collisions where vehicles hit objects.

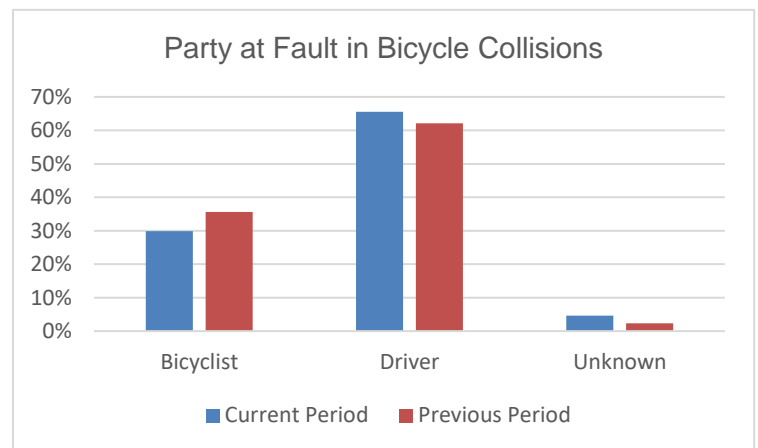
Party at fault (bicyclist, driver or unknown) is shown on the bar graph to the right. Similar to the 34% of pedestrians found at fault, 30% of bicyclists were found at fault (excluding the solo bicycle crashes) with the driver of the vehicle at fault 66% of the time, and the remaining percentage did not have a party at fault identified. When comparing to the last period there was a slight increase in drivers found at fault and a corresponding decrease in the bicyclists found at fault. The number of collisions where fault could not be determined increased slightly (it went from two collision to four collisions)

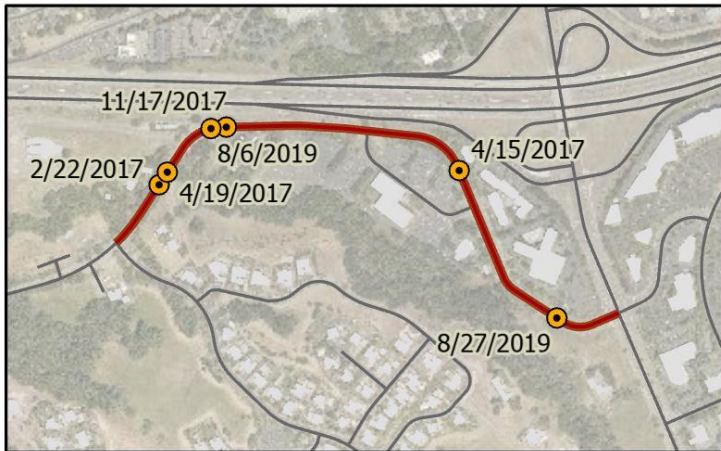
Analysis: Predominately single vehicle collisions, but not clustered at one location. In past years there pattern has been more collision at the westernmost curve. Additional and larger signs were installed on this curve in 2016. No further patterns were identified and no changes are recommended at this time.

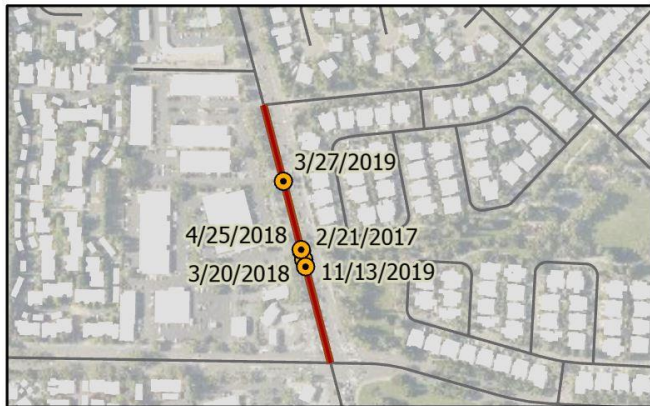
Analysis: Three out of the five collisions were southbound rear-end collisions. The southbound direction has some congestion, so an increase in rear-end collisions is not unexpected.

There were also two bicycle collisions along this segment. Both bicycle collisions involved a northbound bicyclist traveling on the west sidewalk and striking an EBR vehicle exiting a driveway. In the northernmost collision the driver claimed had stopped and was waiting for a gap in traffic when the bicyclist struck him, the bicyclist claimed the vehicle struck him (fault was unable to be determined). In the second collision the bicyclist was in a "hurry to math class" and was found at fault.

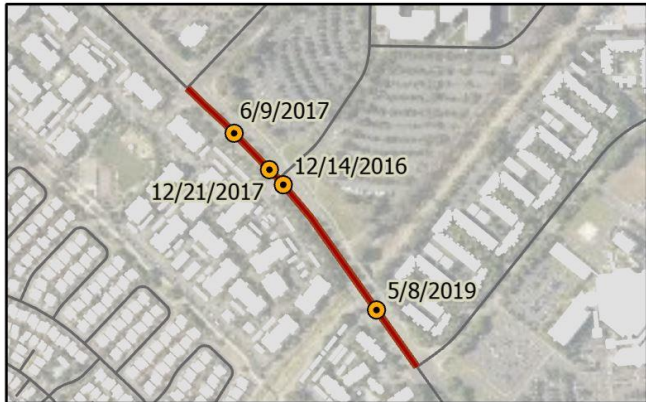
#8 OWENS DR from ANDREWS DR to ROSEWOOD DR

Analysis: No patterns are identified and no changes are recommended to this segment at this time.

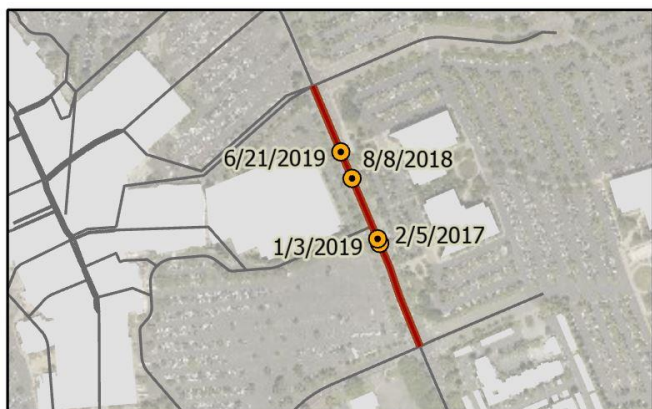
#10 STONERIDGE MALL RD from WORKDAY WY to EMBARCADERO CT

Analysis: No patterns are identified and no changes are recommended to this segment at this time.

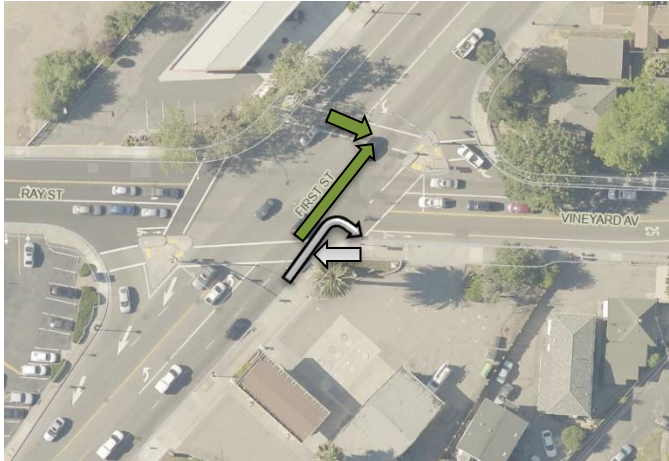
Analysis: In the first collision a northbound right turning vehicle struck a westbound pedestrian in the south crosswalk. The driver was looking at a computer instead of where he was headed. In the second collision a northbound through vehicle struck an eastbound pedestrian in the north crosswalk on a green pedestrian signal (no independent witness could confirm northbound vehicle ran red light, but that is likely the case).

No roadway/signage changes are recommended at this time.

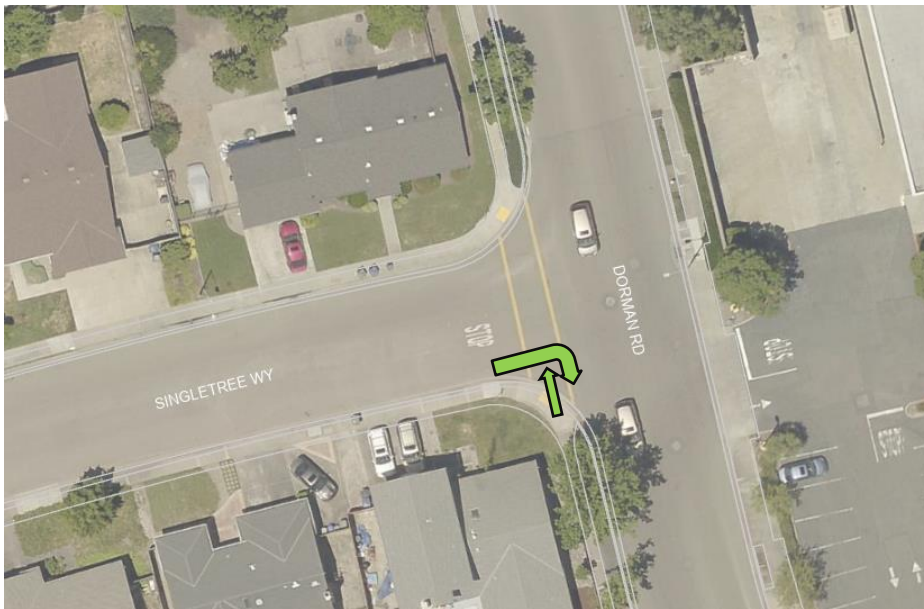
Analysis: Both collisions occurred in the west crosswalk and involved a northbound bicyclist and an eastbound right turning vehicle. Both bicyclists were under 18 and traveling to nearby Donlon Elementary School.

In the first collision the bicyclist saw the stopped vehicle and believed the driver saw him. The driver did not see the bicyclist and luckily had only just let her foot off the brake when the collision occurred. The driver was found at fault.
