**EXHIBIT A
DISCUSSION POINTS**

**PUD-125
2350 Santa Rita Road, Carpenter's Training Facility
July 26, 2017**

**SITE PLAN - NEW CARPENTERS TRAINING CENTER
2350 SANTA RITA ROAD**

PUD-125, 2350 Santa Rita Road, Carpenter's Training Center

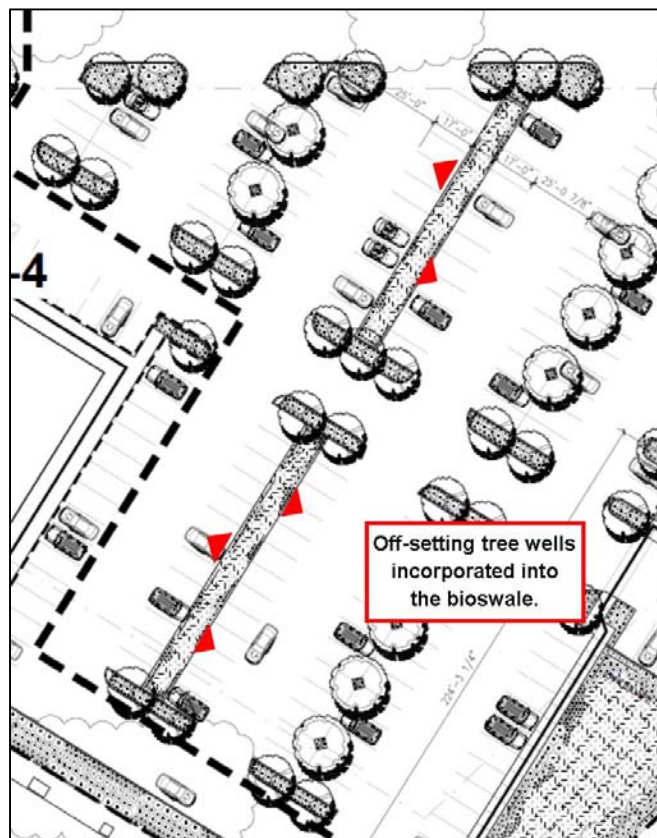
6. Please revise irrigation note #8 to reflect Pleasanton Municipal Code requirements and not South County Regional Water Reuses Authority.
7. Please add an additional narrow landscape planter along the south side of the proposed Training Facility trash enclosure. In addition please extend the landscaping along the north and east side of the enclosure all the way up to the enclosure wall.
8. Please add off-setting tree wells adjacent to the central parking lot bioswale similar to the diagram below.

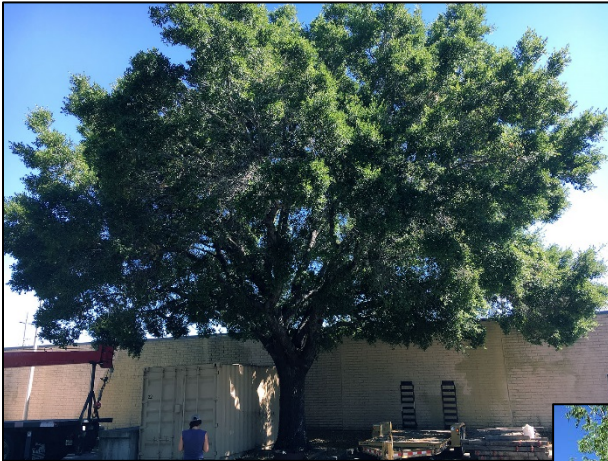
Photo 1 (left): Coast live oak #15 is a Heritage tree, 21" in diameter, and in good condition. It is surrounded by pavement.

Coast live oak is the most frequently occurring species, with 37% of the tree population. The largest tree is 34" in trunk diameter, with an average of trunk diameter of 23". The canopies are broad and rounded as is typical of the species (photo 1).

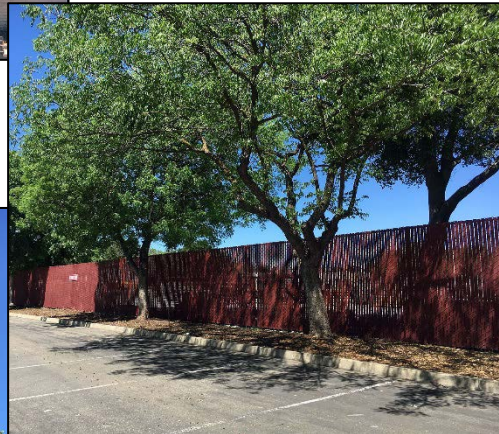
Photo 2 (below): Chinese pistache #63-65 are in fair condition.

The second most frequently occurring species is Chinese pistache (28% of population), followed by Chinese hackberry (15%) (photos 2 and 3). Half of the Chinese pistache are in good condition, and half in fair condition. For the Chinese hackberry, one-third are in good condition and two-thirds are in fair condition. None of the two species are in poor condition.

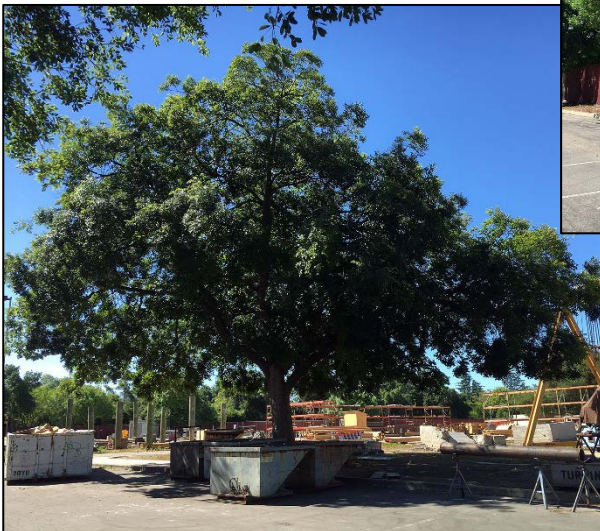
Photo 3 (left). Chinese hackberry #10 is a Heritage tree, 23" in diameter, and in excellent condition. It is surrounded by pavement.

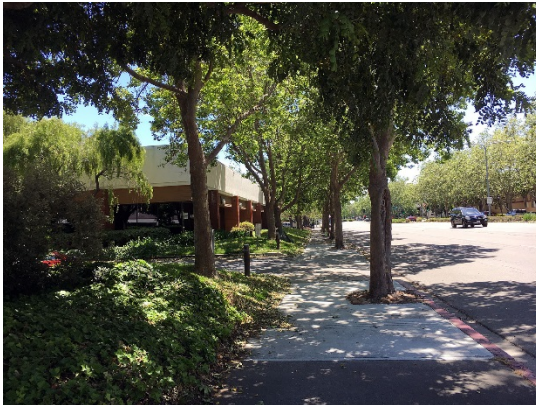
Photo 4 (above left): London plane street trees #101-113 line Santa Rita Road.

Off-site trees include 14 London plane street trees located along Santa Rita Rd. (#101-114, photo 4). They are generally in good condition, and range in trunk diameter from 9 inches to 17 inches in diameter.

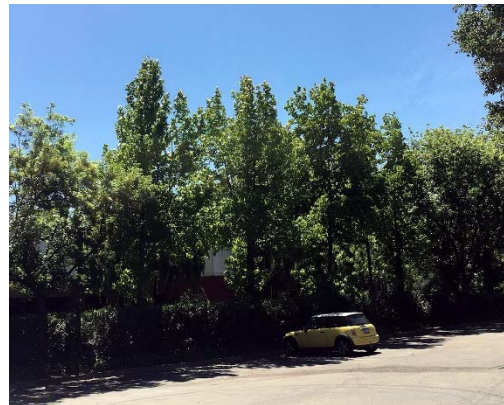
Photo 5 (above right). Sweetgum trees #114-121 are along the property line with Parcel 3.

Seventeen sweetgum trees are along the property lines with Parcel 3 (#115 – 121, 124-133). These trees are 6 inches to 10 inches in diameter, and are in fair condition (photo 5).

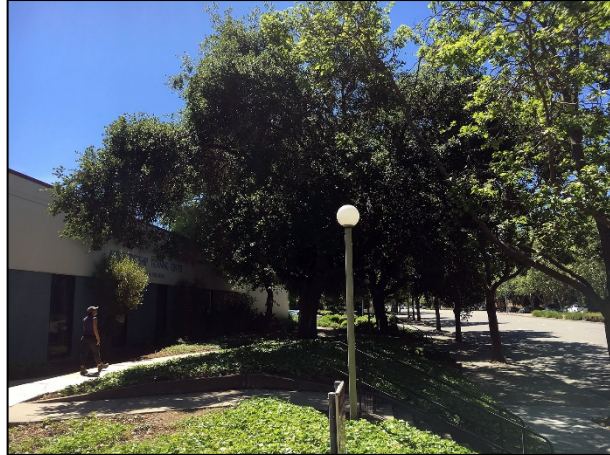
Photo 7: Heritage coast live oak #43 can be preserved if the bio-retention area planned east of the tree is redesigned to maintain 10 feet tree protection zone.

- Adjust the location of the bio-retention area to remain at least 10 feet from Heritage trees #42, 43, 44, and 75 (photo 7).
- Adjust the location of the wall adjacent to coast live oaks #75 and 76 to avoid excavation within 15' of trunk and pruning branches greater than 4 inches in diameter to provide clearance for construction.

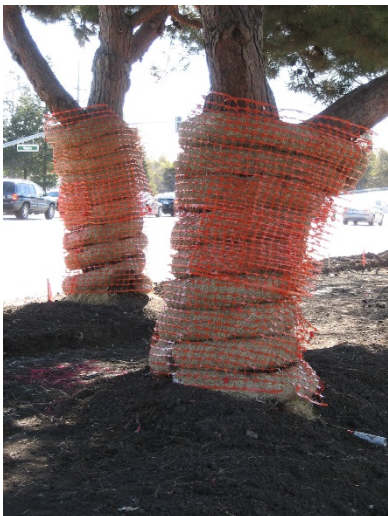
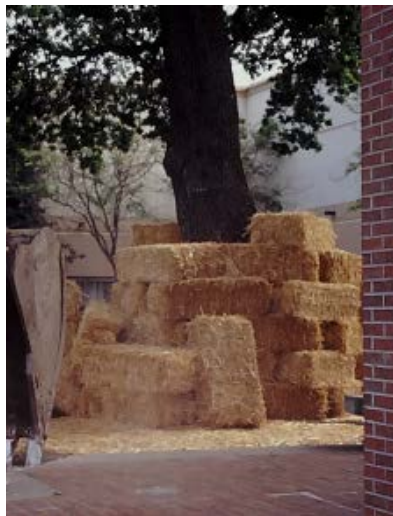
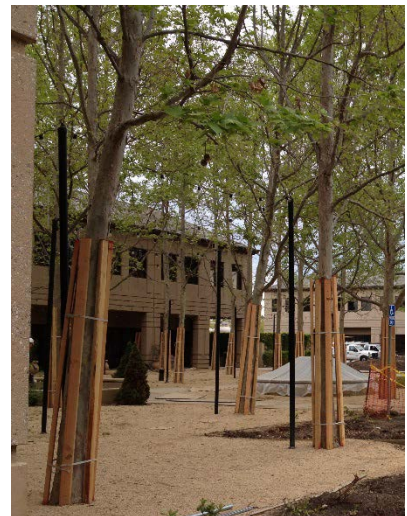
5. Where demolition must occur close to trees, such as removing curb and pavement, install temporary trunk protection devices such as winding silt sock wattle or wood planks around trunks or stacking hay bales around tree trunks to

- a height of approximately 5'. Any low branches that are within the work zone should also be protected. Remove trunk protection after demolition is completed and install protective fence at the limits of the tree protection zone. Do not retain wattling around tree trunks for more than 2-3 weeks to avoid damaging trunks from excess moisture.

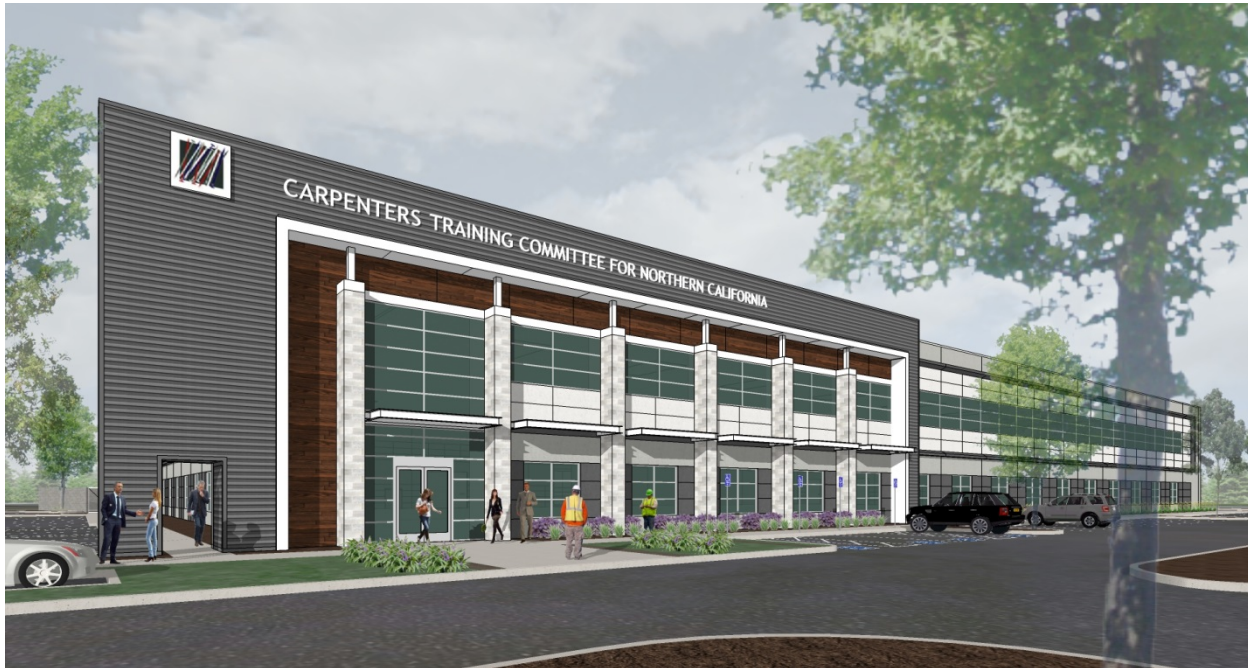
The Carpenters Training Committee of Northern California (CTCNC) would like to inform you of a project that we are embarking on at our 2350 Santa Rita Road location. We are proposing to expand and upgrade our present facility by building a new 87,000 square foot building which will replace the existing 67,000 square foot Carpenters Training Center building. The new building will be located adjacent to the existing building on the 2350 Santa Rita Road site. The existing Training center will remain in operation while the new building is constructed. Once the new building is completed, the existing building will be demolished and replaced by new parking and a future small office building.

The lush, tree lined and landscaped character of the Carpenter's site will be maintained in the project. All of the street trees and most of the Heritage trees along Santa Rita Road will remain. Trees that surround the perimeter of the site and provide a buffer between our neighbors will also be preserved. A few trees have been identified as being in poor health or unsuitable for preservation and will be removed. For those trees removed, we plan on planting new trees in the same numbers. New parking areas will be planted with trees, and the site will receive new landscaping and storm water planters to address storm water drainage requirements. Existing driveway locations are utilized to access the New Training Center, future office building, and new parking areas.

The new Training Center, roughly 280' x 190', will consist of 17 classrooms, 9 shops, administrative offices, and an exterior teaching yard behind the Training Center enclosed by a decorative 8 foot high wall. The Center will be
