# PLANNED UNIT DEVELOPMENT PLEASANT VIEW CHURCH SITE CITY OF PLEASANTON, ALAMEDA COUNTY, CALIFORNIA

**PUD-114**

**EXHIBIT B**

DATE: JUNE 2016 JOB NO. 141084 SHEET 1 OF 5

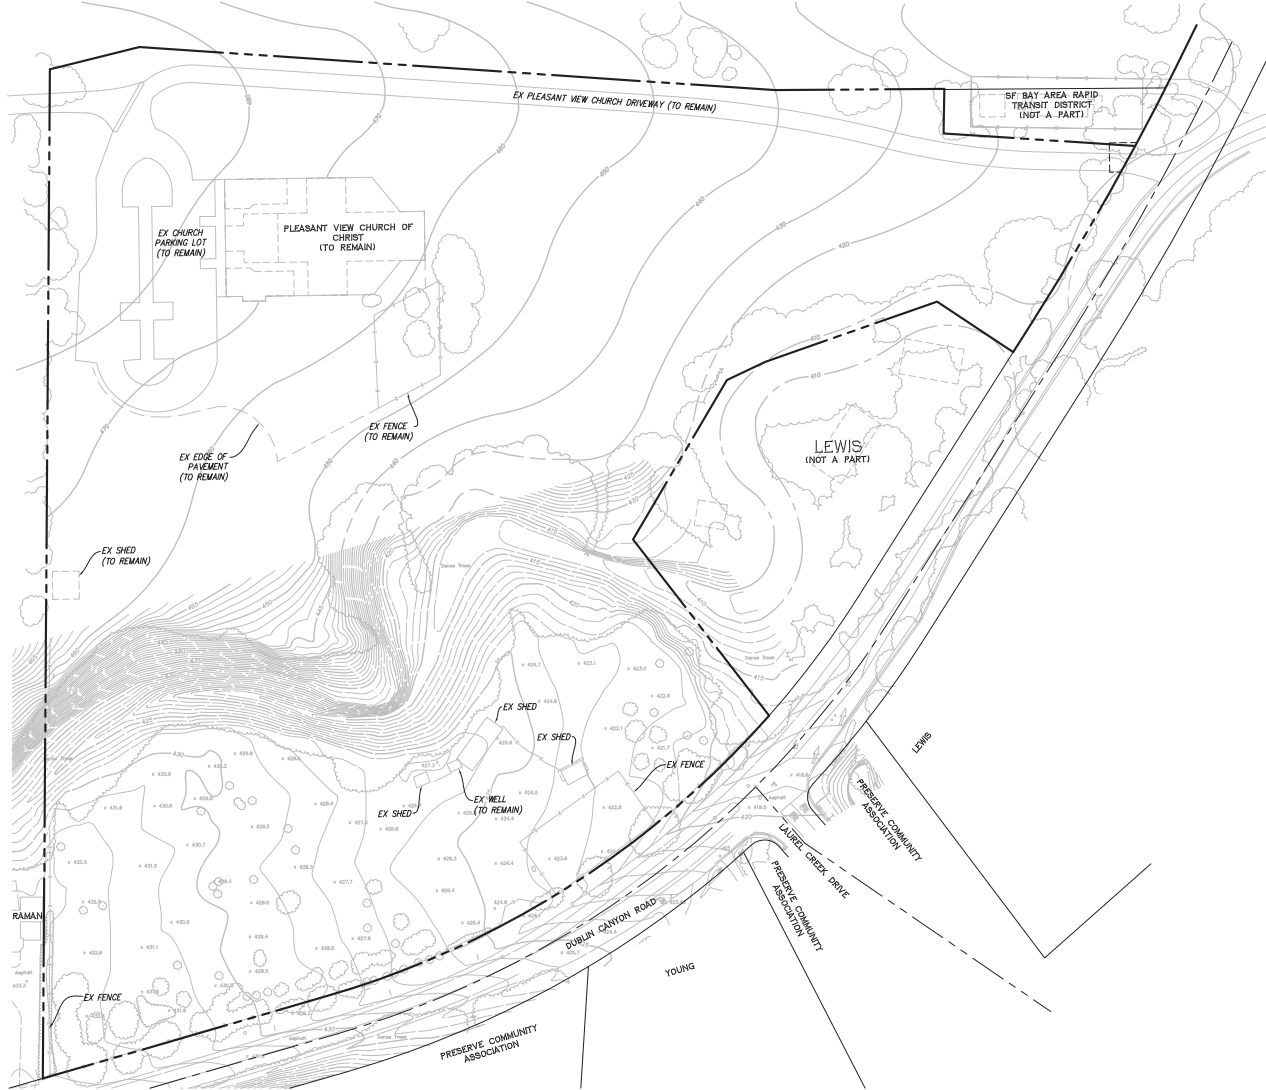
**EXISTING CONDITIONS  
PLEASANT VIEW CHURCH**

1. BUILDINGS AND ACCESSORY STRUCTURES TO BE REMOVED, UNLESS OTHERWISE NOTED.

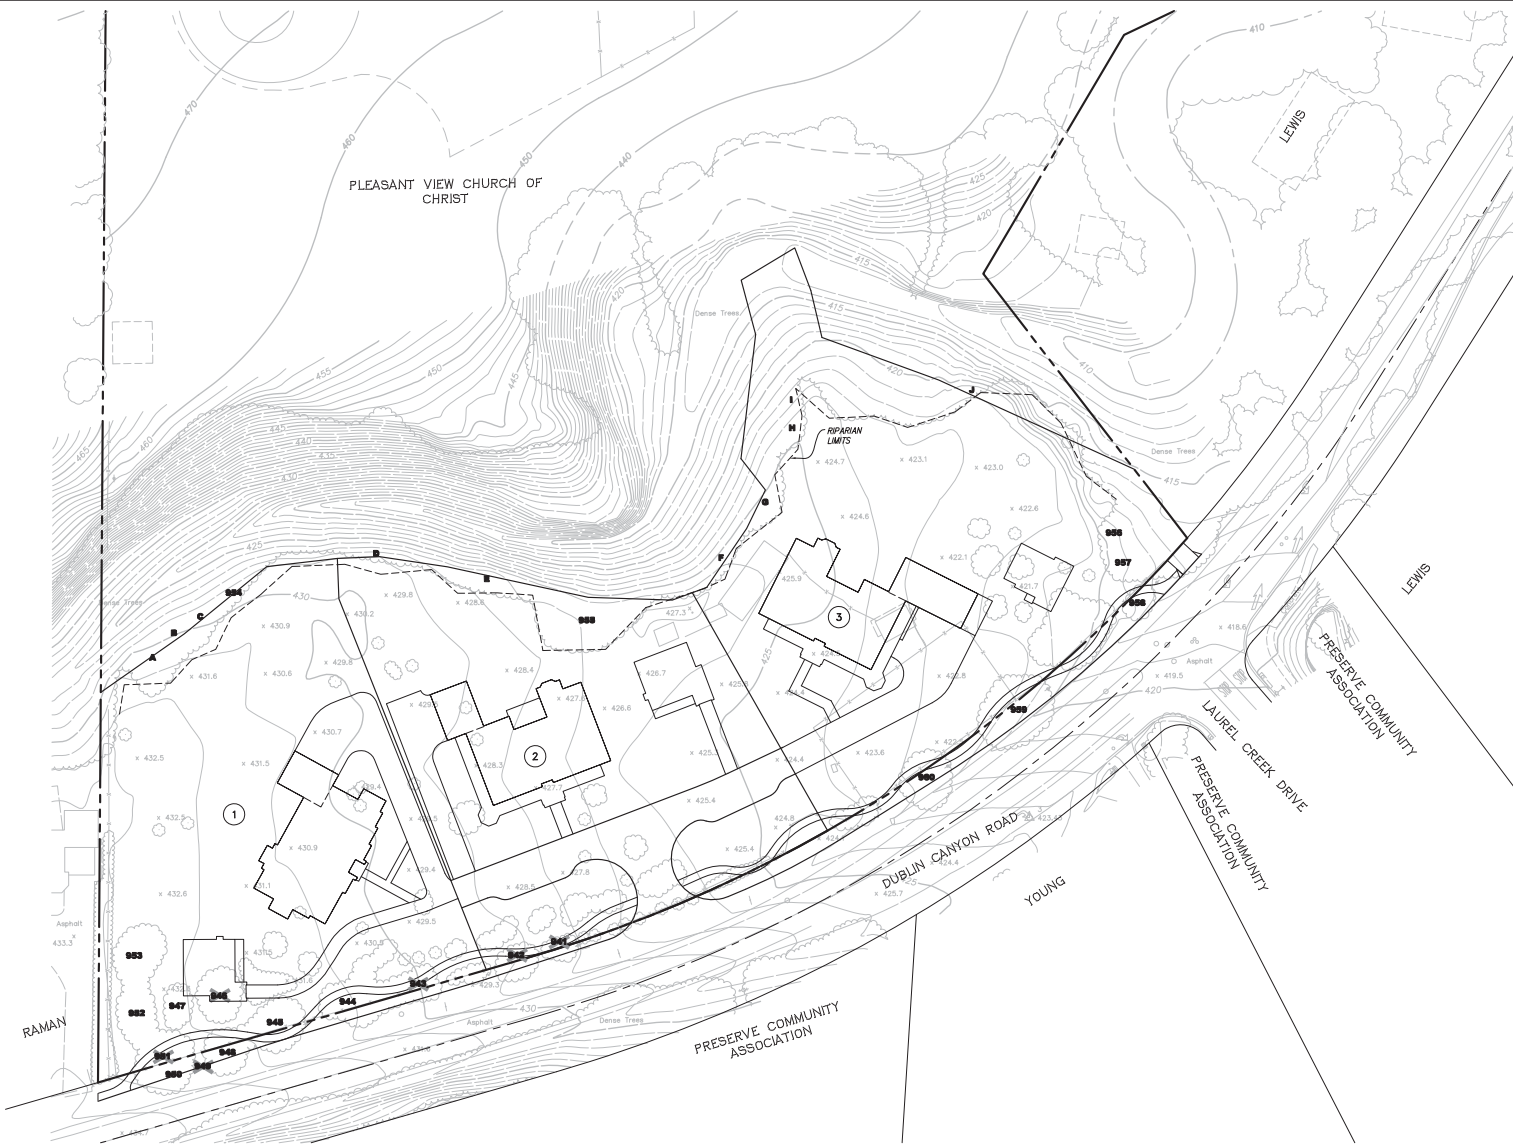
- LEGEND**
- A-J** TREES IN RIPARIAN CORRIDOR TO BE SAVED
  - 955** TREE TO BE SAVED
  - 943** TREE TO BE REMOVED

FOR TREE ASSESSMENT, SEE THE TREE REPORT PREPARED FOR PLEASANT VIEW CHURCH SITE BY DRYAD LLC, JUNE 24, 2016.

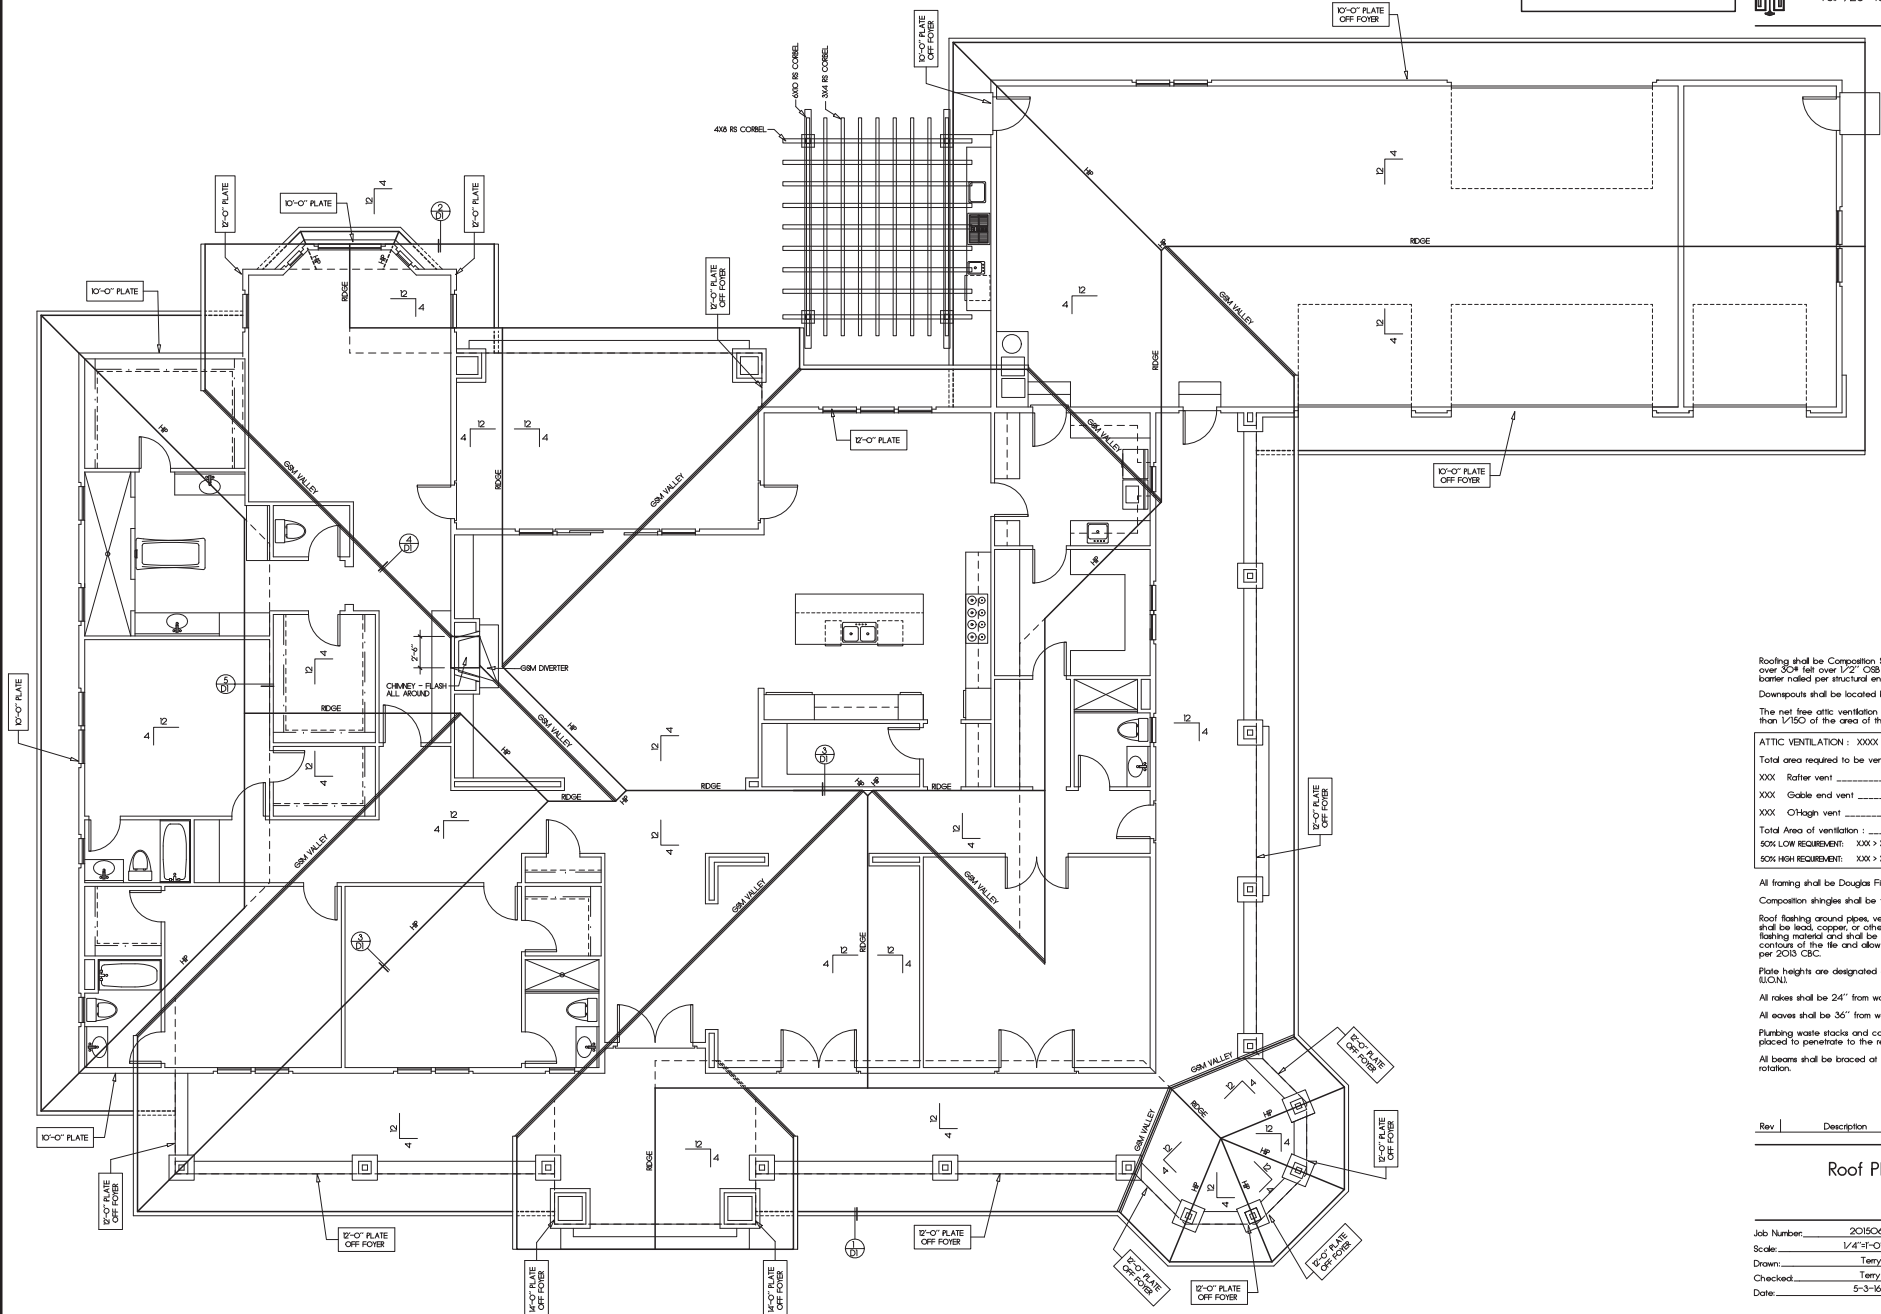
Roofing shall be Composition Shingle over 5/8" felt over 1/2" OSB sheathing w/ radant barrier nailed per structural engineer's specifications. Downspouts shall be located by others.

The net free attic ventilation area shall be not less than 1/150 of the area of the space ventilated.

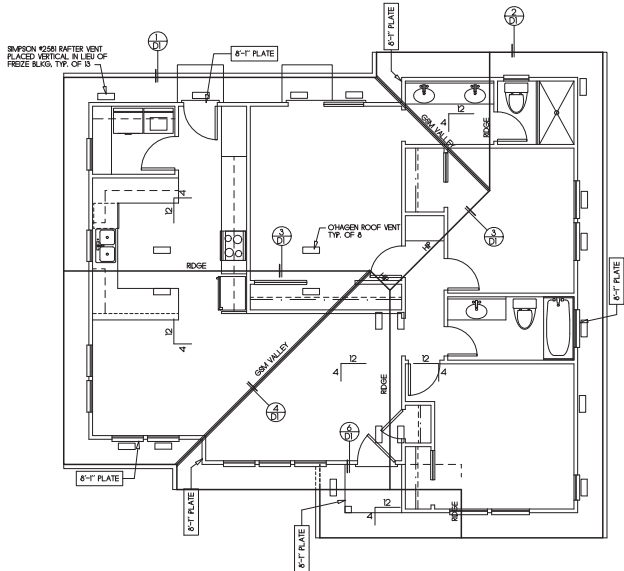
**Roof Plan**

Roofing shall be Composition Shingle over 3/4" felt over 1/2" OSB sheathing w/ radiant barrier noted per structural engineer's specifications. Downspouts shall be located by others.

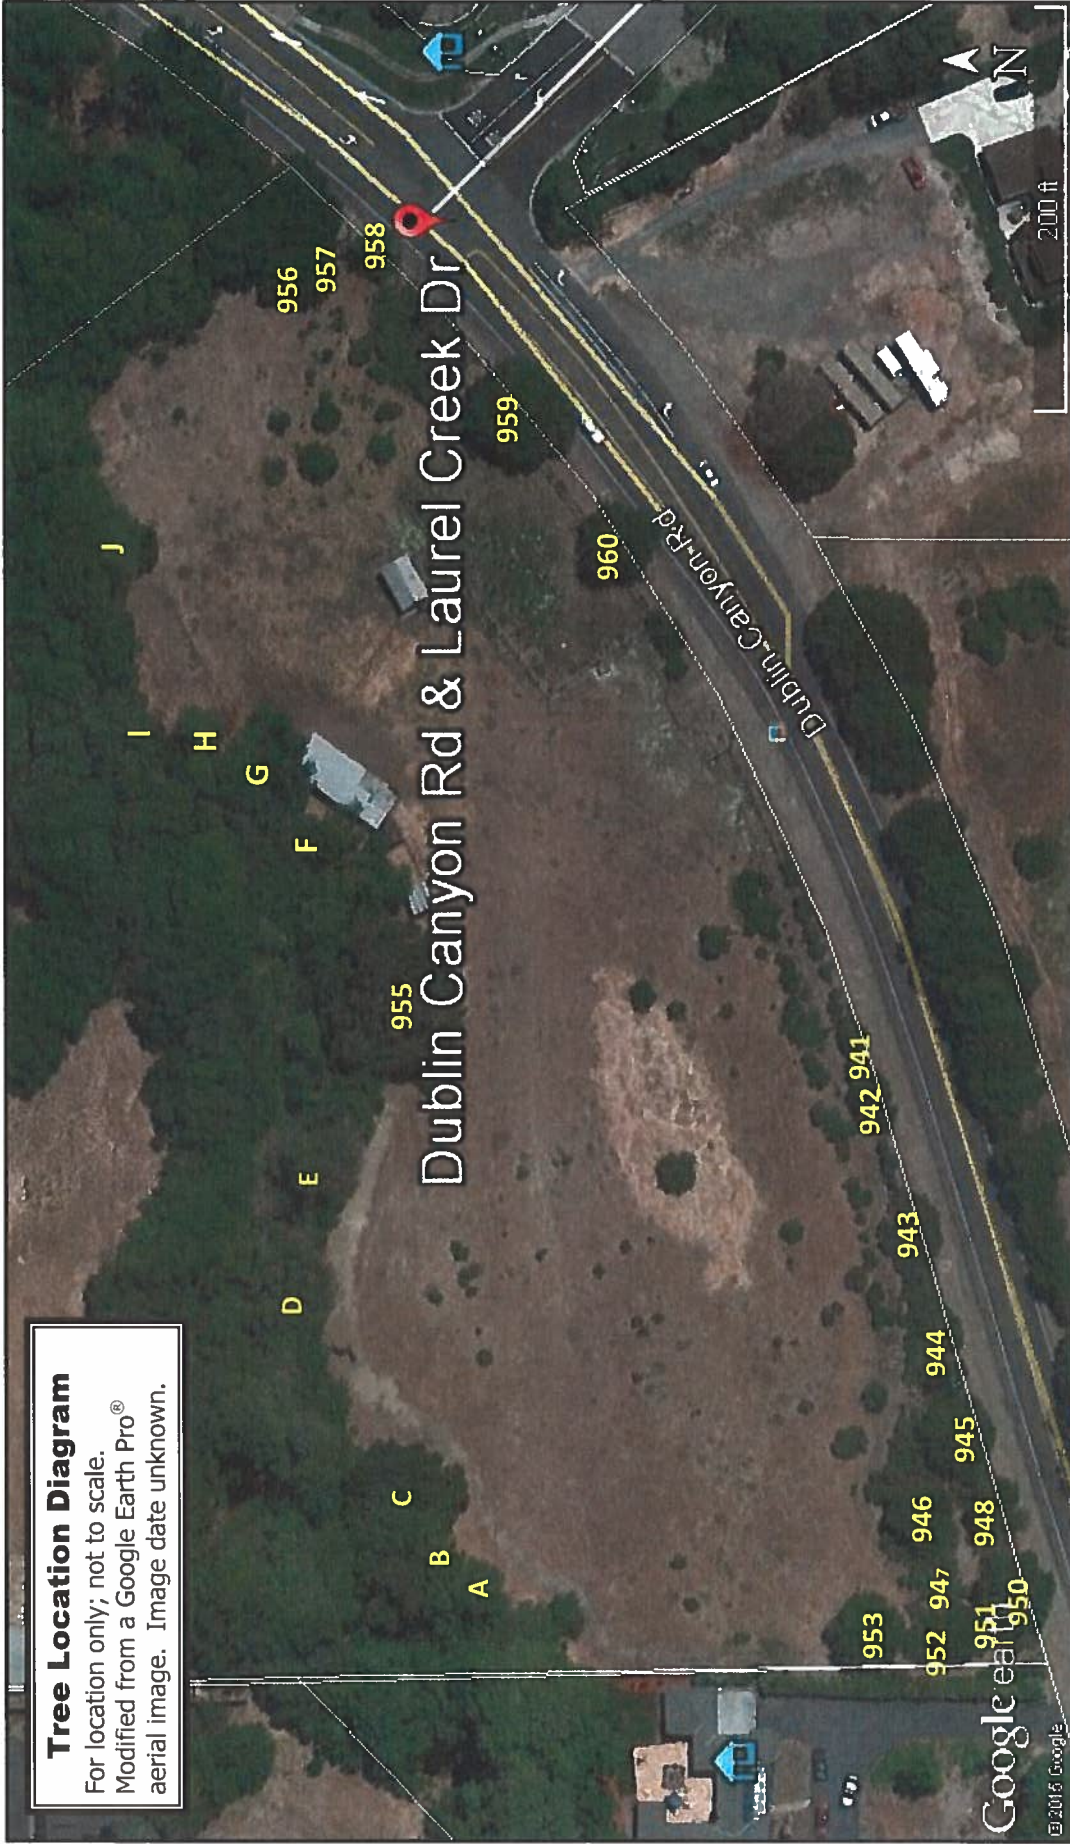
**Tree Location Diagram**

For location only; not to scale.  
 Modified from a client-provided site plan  
 entitled *Conceptual Site plan for Pleasant  
 View Church Property*, Ruggeri-Jensen-Agar,  
 01/29/2015.

Although of condition that warrants removal, I recommended 7 additional trees (nos. A-E, F, J) to be considered for preservation in view of their value for wildlife habitat and creek bank erosion mitigation. These 7 trees are not tagged and were not appraised<sup>5</sup>, but are marked on the enclosed Tree Location Diagrams (pages 6 & 7).

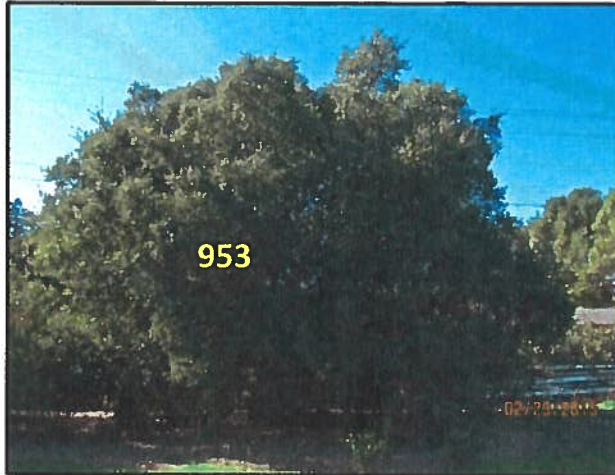
Above: two well-developed trees with no utility line conflicts.

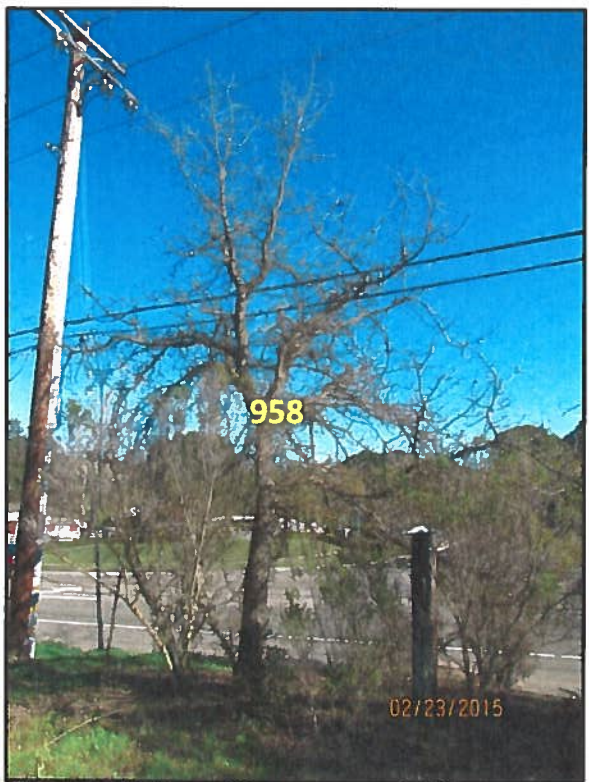
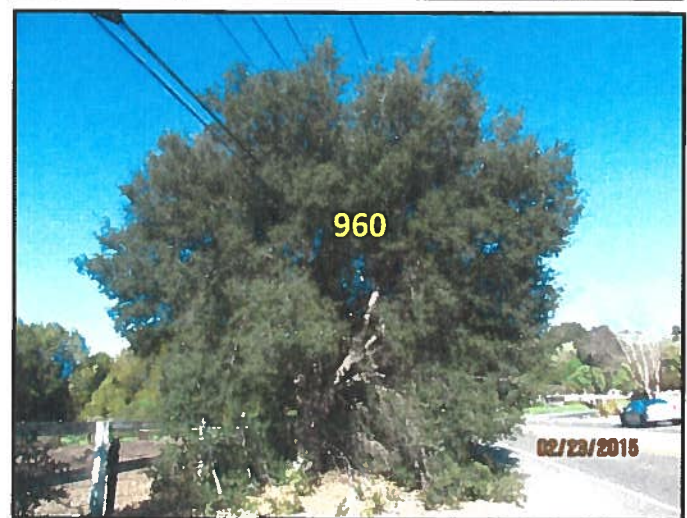
Below & right: trees with overhead utility line conflicts.

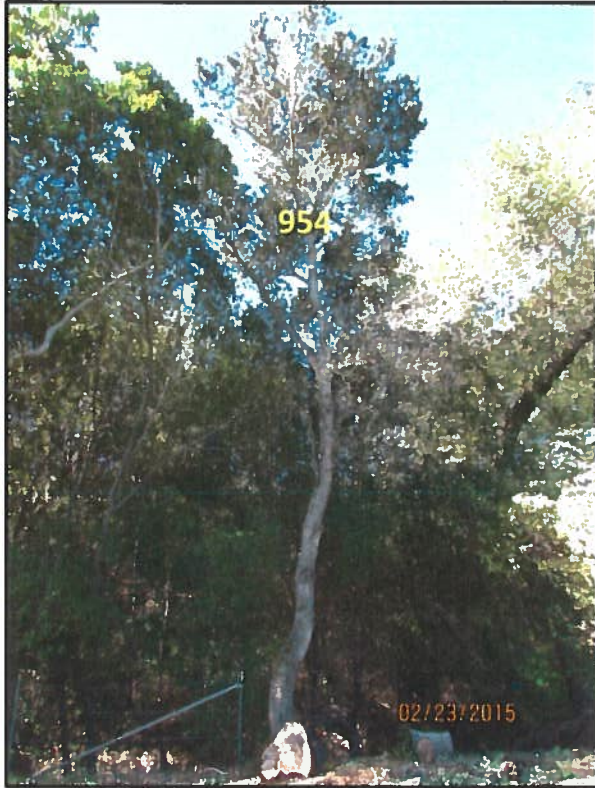
Tree no. 954: partially uprooted with major trunk removed; poor architecture & structure.

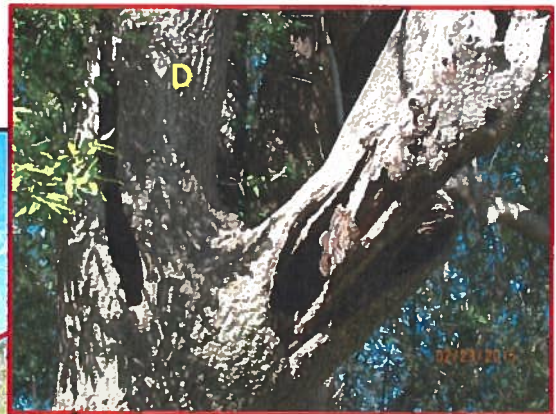
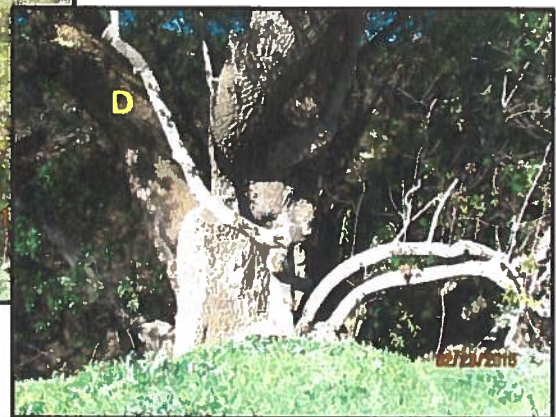
Tree no. 955: CA live oak.  
The most prominent tree on  
site. Images illustrate heavy  
defoliation, root crown  
condition and the severe lean.

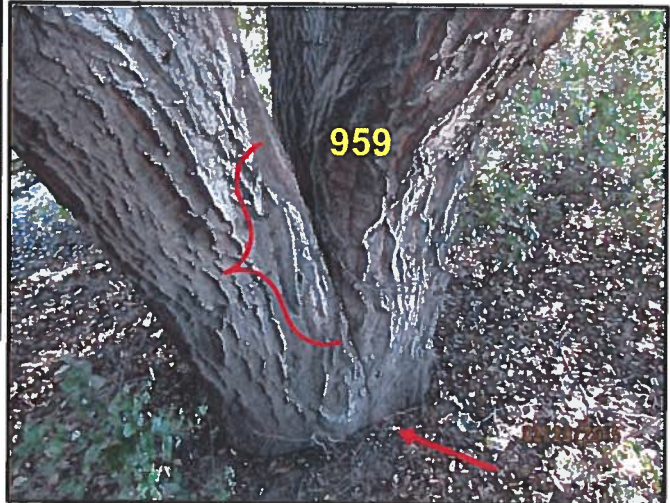
Tree no. 959: illustrating topping for power line clearance (above), the primary acute-angle attachment<sup>A</sup> with included bark and excess soil over the root crown/collar. (below).

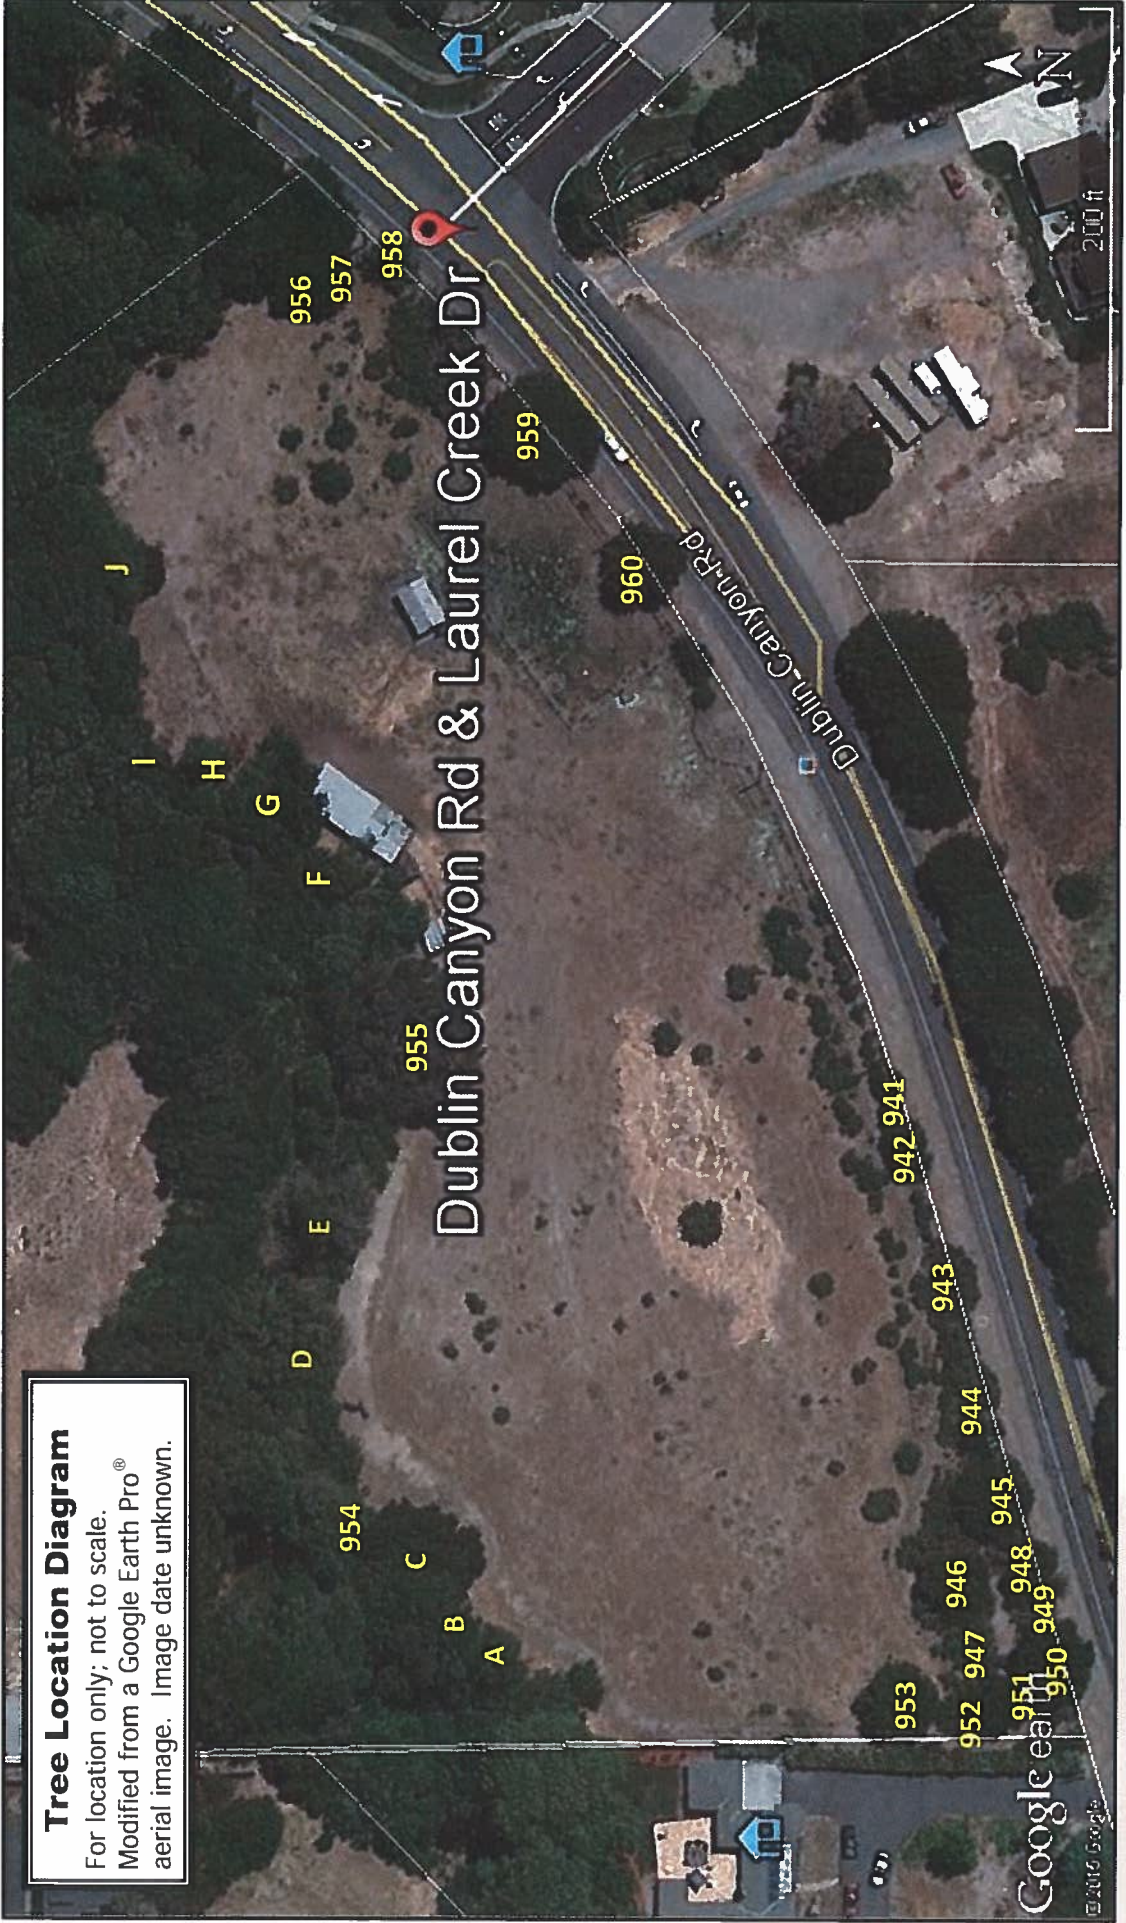
### Tree Location Diagram

For location only; not to scale. Modified from a client-provided site plan entitled *Existing Tree Plan, Pleasant View Church Property*, Ruggeri-Jensen-Agar, June, 2016.

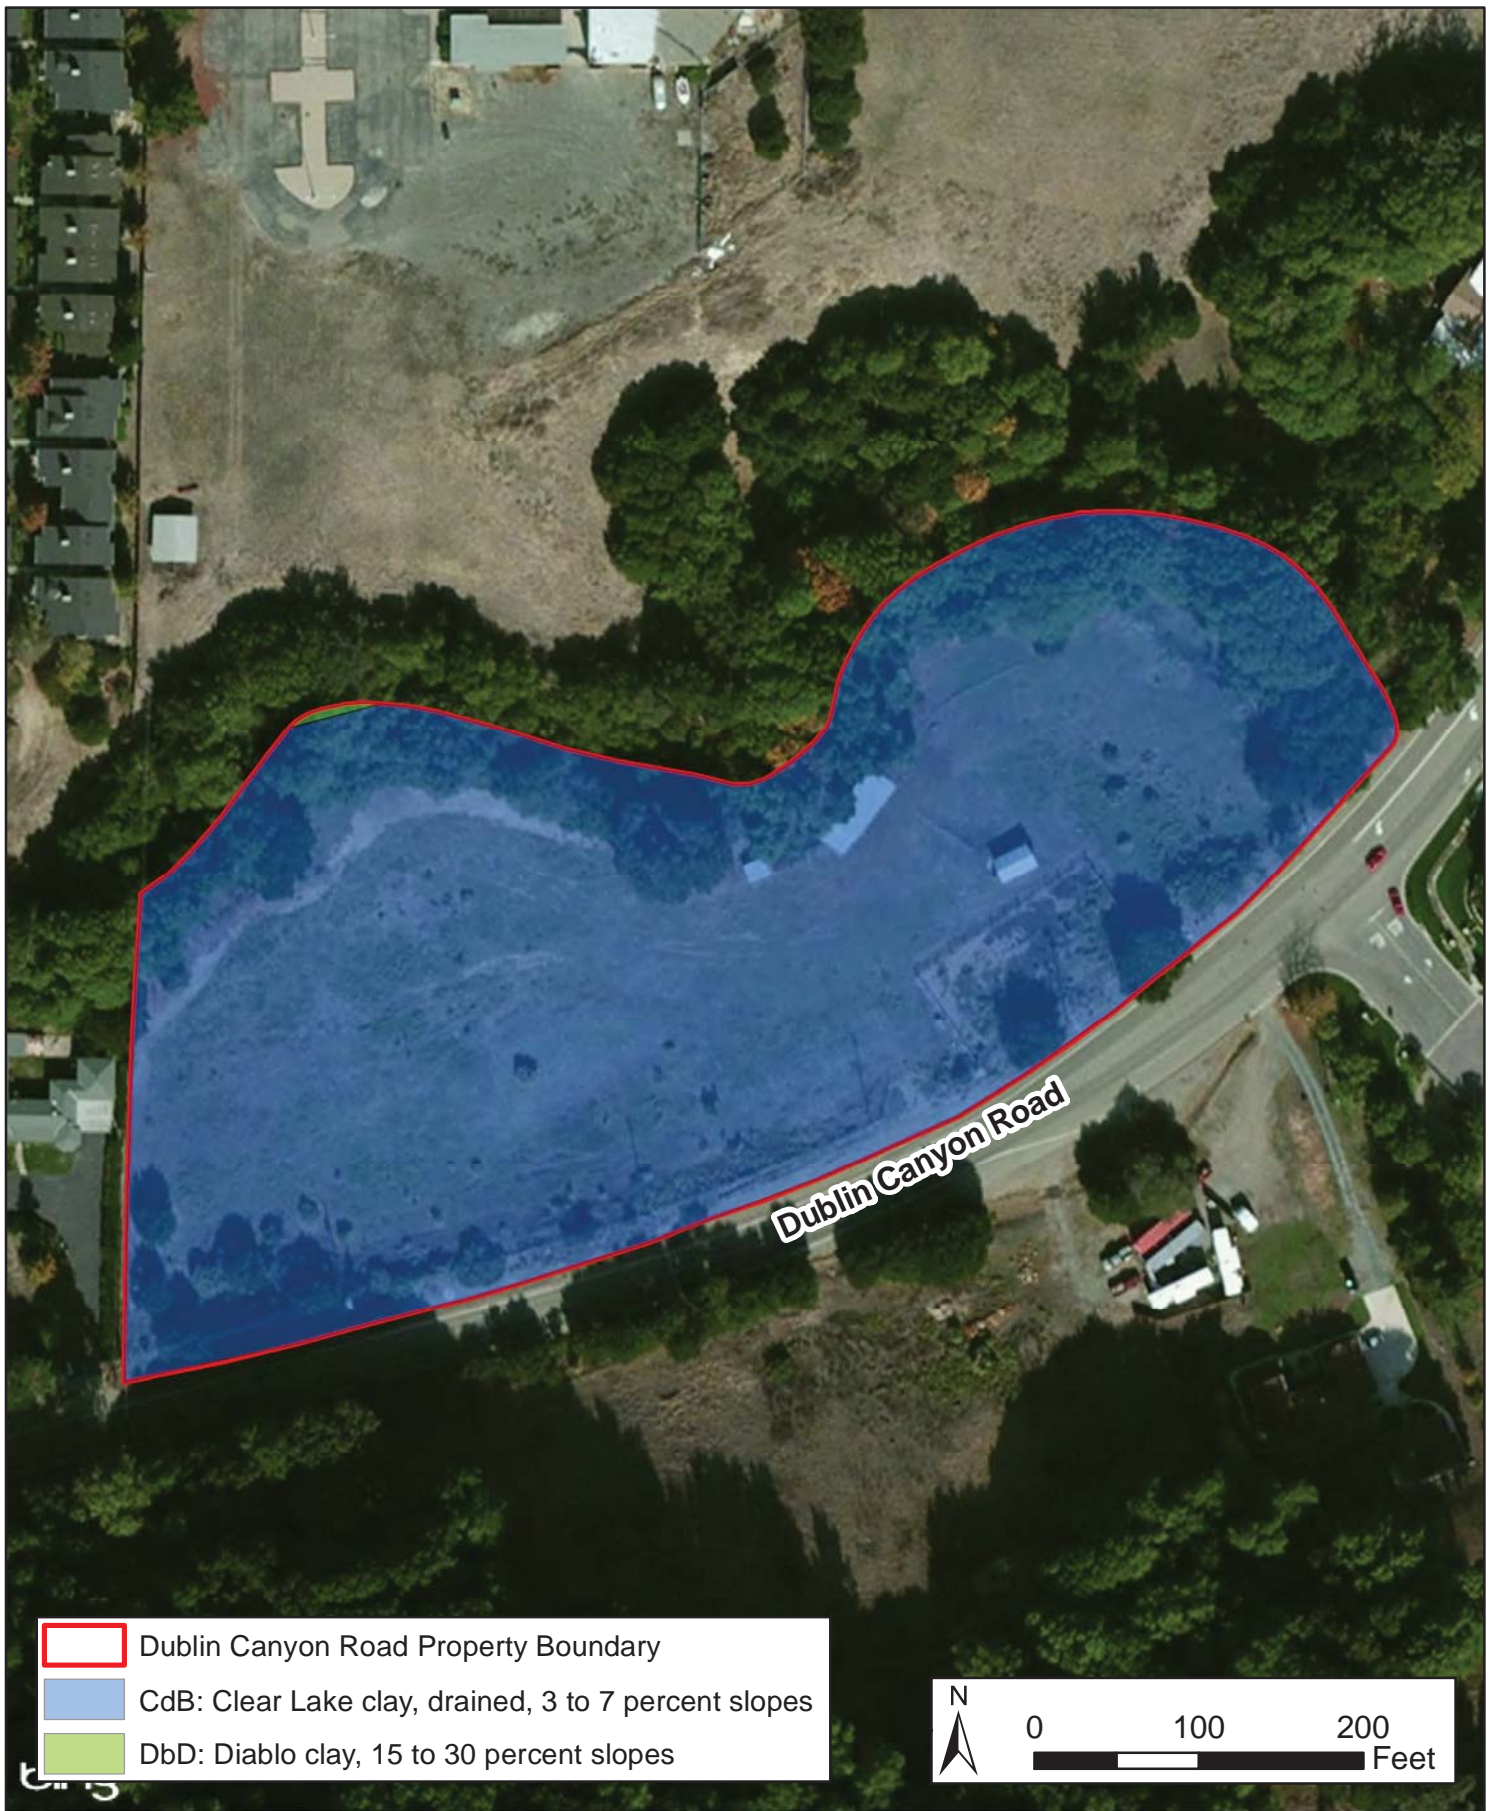
**Figure 8**  
**Soils Map**

**Figure 8: Soils Map  
 Dublin Canyon Road Property  
 Pleasanton, California**

The NRCS (2014) reports two soil types within the Property. A detailed map of these soil types can be found in Attachment 1, Figure 8. The soils mapped include the following types:

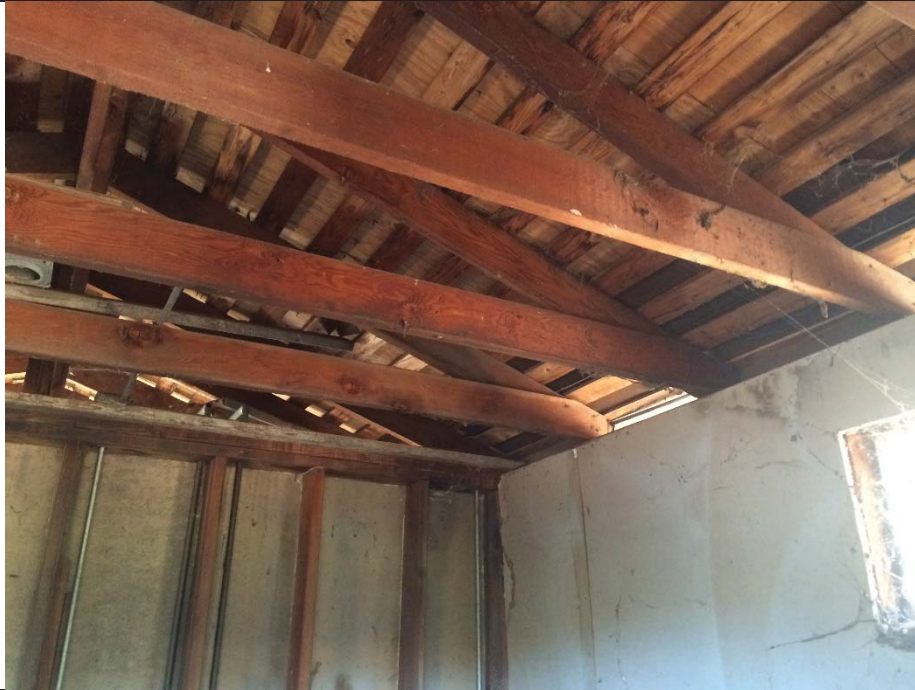
Photo 5: Photo taken within abandoned structure on site, a possible place for roosting bats. No bats were present at the time of the September survey.

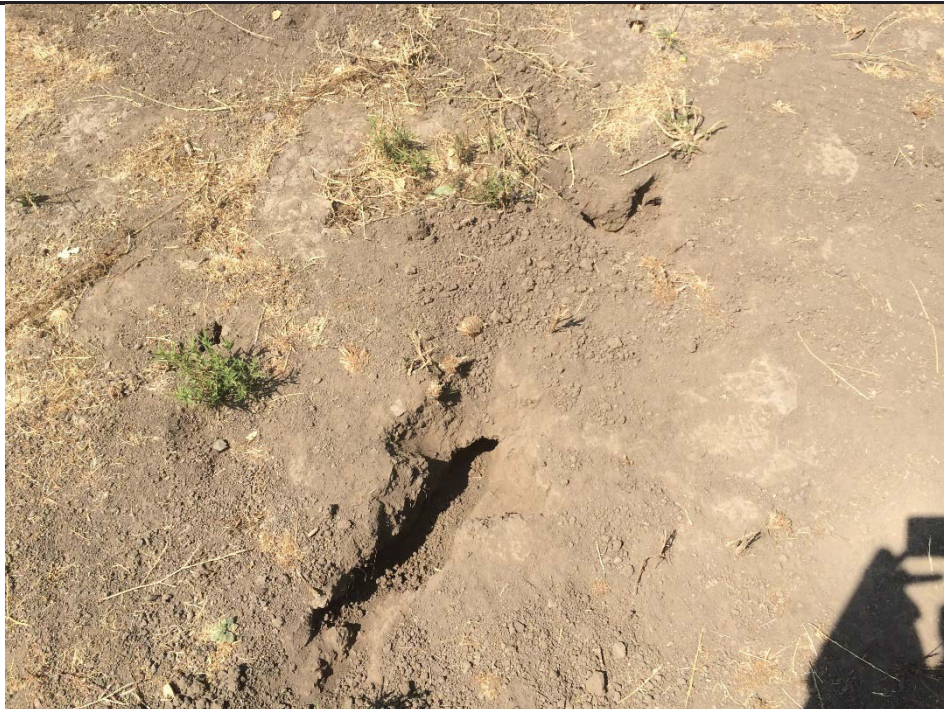
Photo 10: Photo shows one of many California ground squirrel burrows located on the property. Each burrow was observed to check if burrowing owl sign was present. No owls or owl sign were observed during the September survey.

Potential CRLF habitat on the Property is limited to upland refuge sites located in ground squirrel burrows. However the intermittent creek adjacent to the northern border of the Property could provide suitable habitat for CRLF especially since there was water in the creek during the September survey thus slightly increasing the potential of CRLF to be onsite. Lastly, critical habitat for the CRLF (refer to Attachment 1, Figure 7) (critical habitat unit number ALA-1A/1B) is located roughly 0.84 miles west of the Property. Given the information above, there is a chance that the CRLF could occur on the site though it is unlikely to occur. Nevertheless, the use

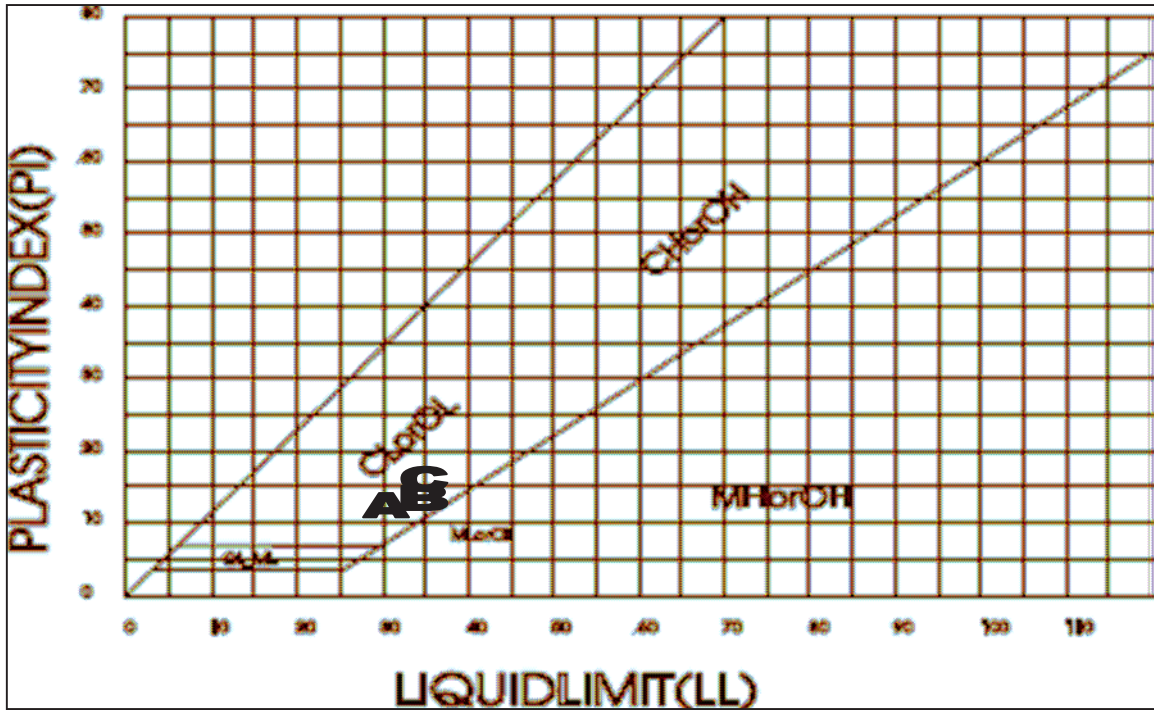
NICHOLAS ENGINEERING CONSULTANTS  
FIGURE 16-PLASTICITY INDEX

Sample No.	Liquid Limit (%)	Plastic Limit (%)	Plasticity Index	Classification
1-1 (A)	31%	20%	11	Non-plastic-CL
2-1 (B)	34%	21%	13	Non-plastic-CL
5-1 (C)	35%	20%	15	Non-plastic-CL

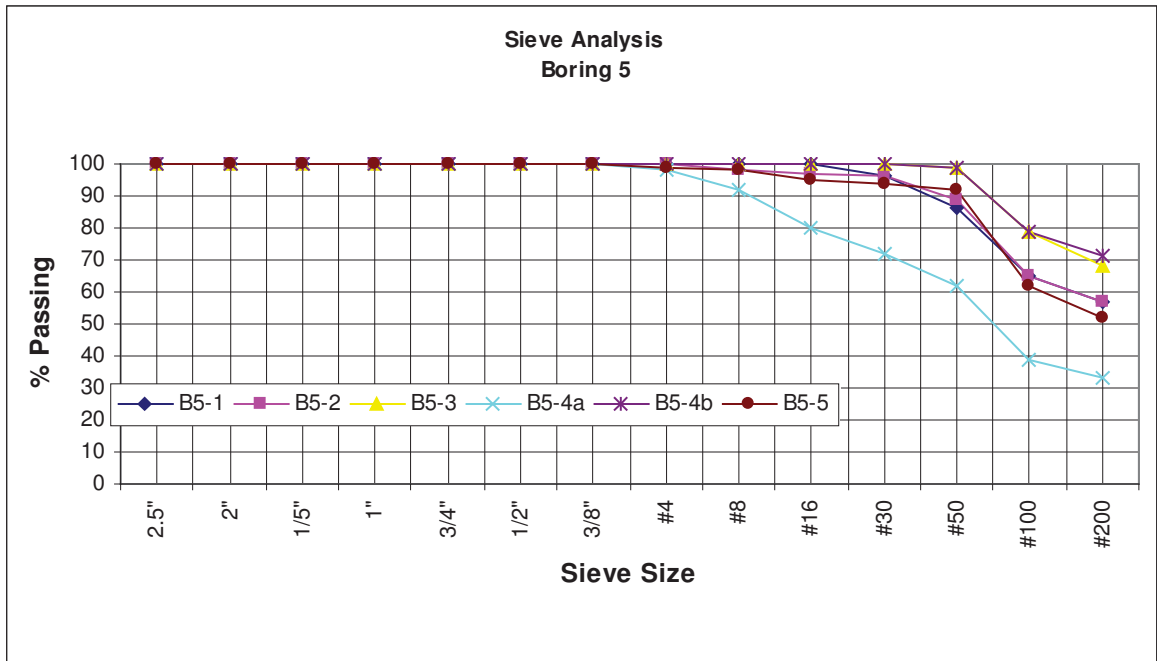
**NICHOLAS ENGINEERING CONSULTANTS**  
**FIGURE 20-SIEVE ANALYSIS**

B5-1	B5-2	B5-3	B5-4a	B5-4b	B5-5
2.5"	100	100	100	100	100	100
2"	100	100	100	100	100	100
1/5"	100	100	100	100	100	100
1"	100	100	100	100	100	100
3/4"	100	100	100	100	100	100
1/2"	100	100	100	100	100	100
3/8"	100	100	100	100	100	100
#4	100	100	100	98	100	99
#8	100	98	100	92	100	98
#16	100	97	100	80	100	95
#30	96	96	100	72	100	94
#50	86	89	99	62	99	92
#100	65	65	79	39	79	62
#200	57	57	68	33	71	52

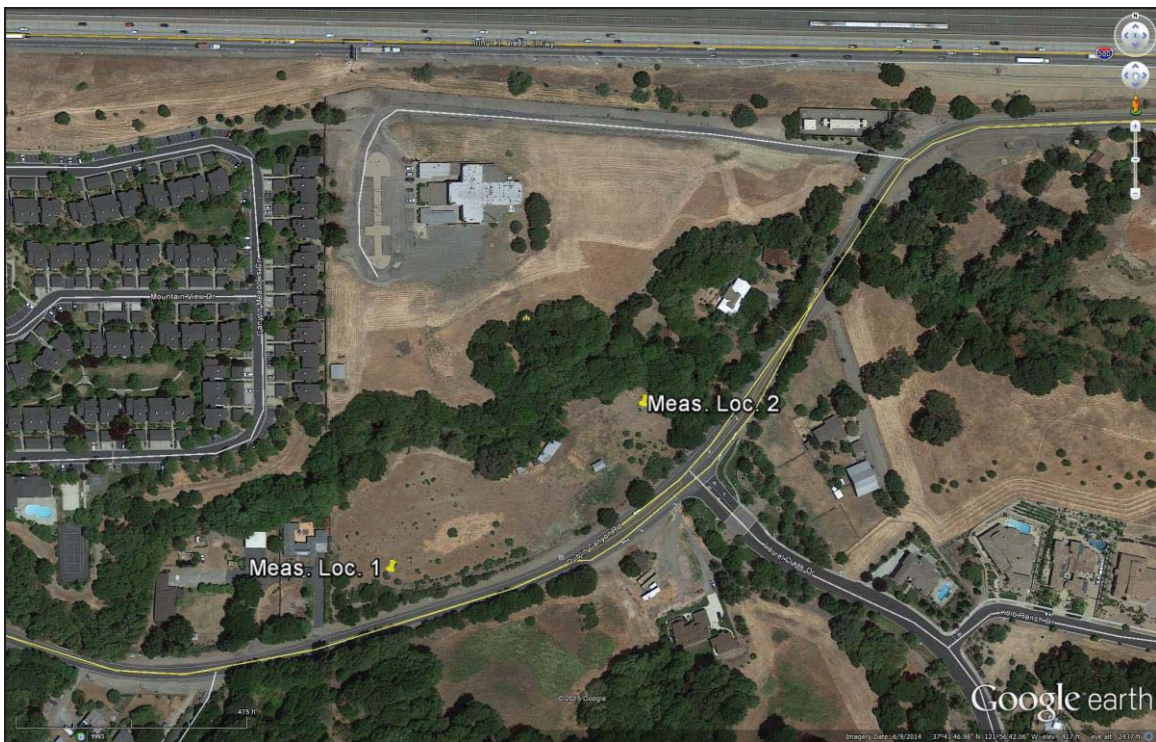
**FIGURE 2 – Noise Measurement Locations**

To determine the existing noise environment at the site, continuous recordings of the sound levels were made at two locations. Location 1 was 100 ft. from the centerline of Dublin Canyon Road and 1,120 ft. from the centerline of I-580, corresponding to the planned minimum setback of the home on Lot 1 from Dublin Canyon Road. Location 2 was 158 ft. from the centerline of Dublin Canyon Road and 785 ft. from the centerline of I-580, corresponding to the most impacted building setback of Lot 5 from I-580. The measurement locations are shown on Figure 2, below.
