Preliminary Tree Report

**Kottinger Senior Housing Project
Pleasanton, CA**

Prepared for:
**MidPen Housing Corp.
303 Vintage Park Dr. Suite 250
Foster City, CA 94404**

July 3, 2013

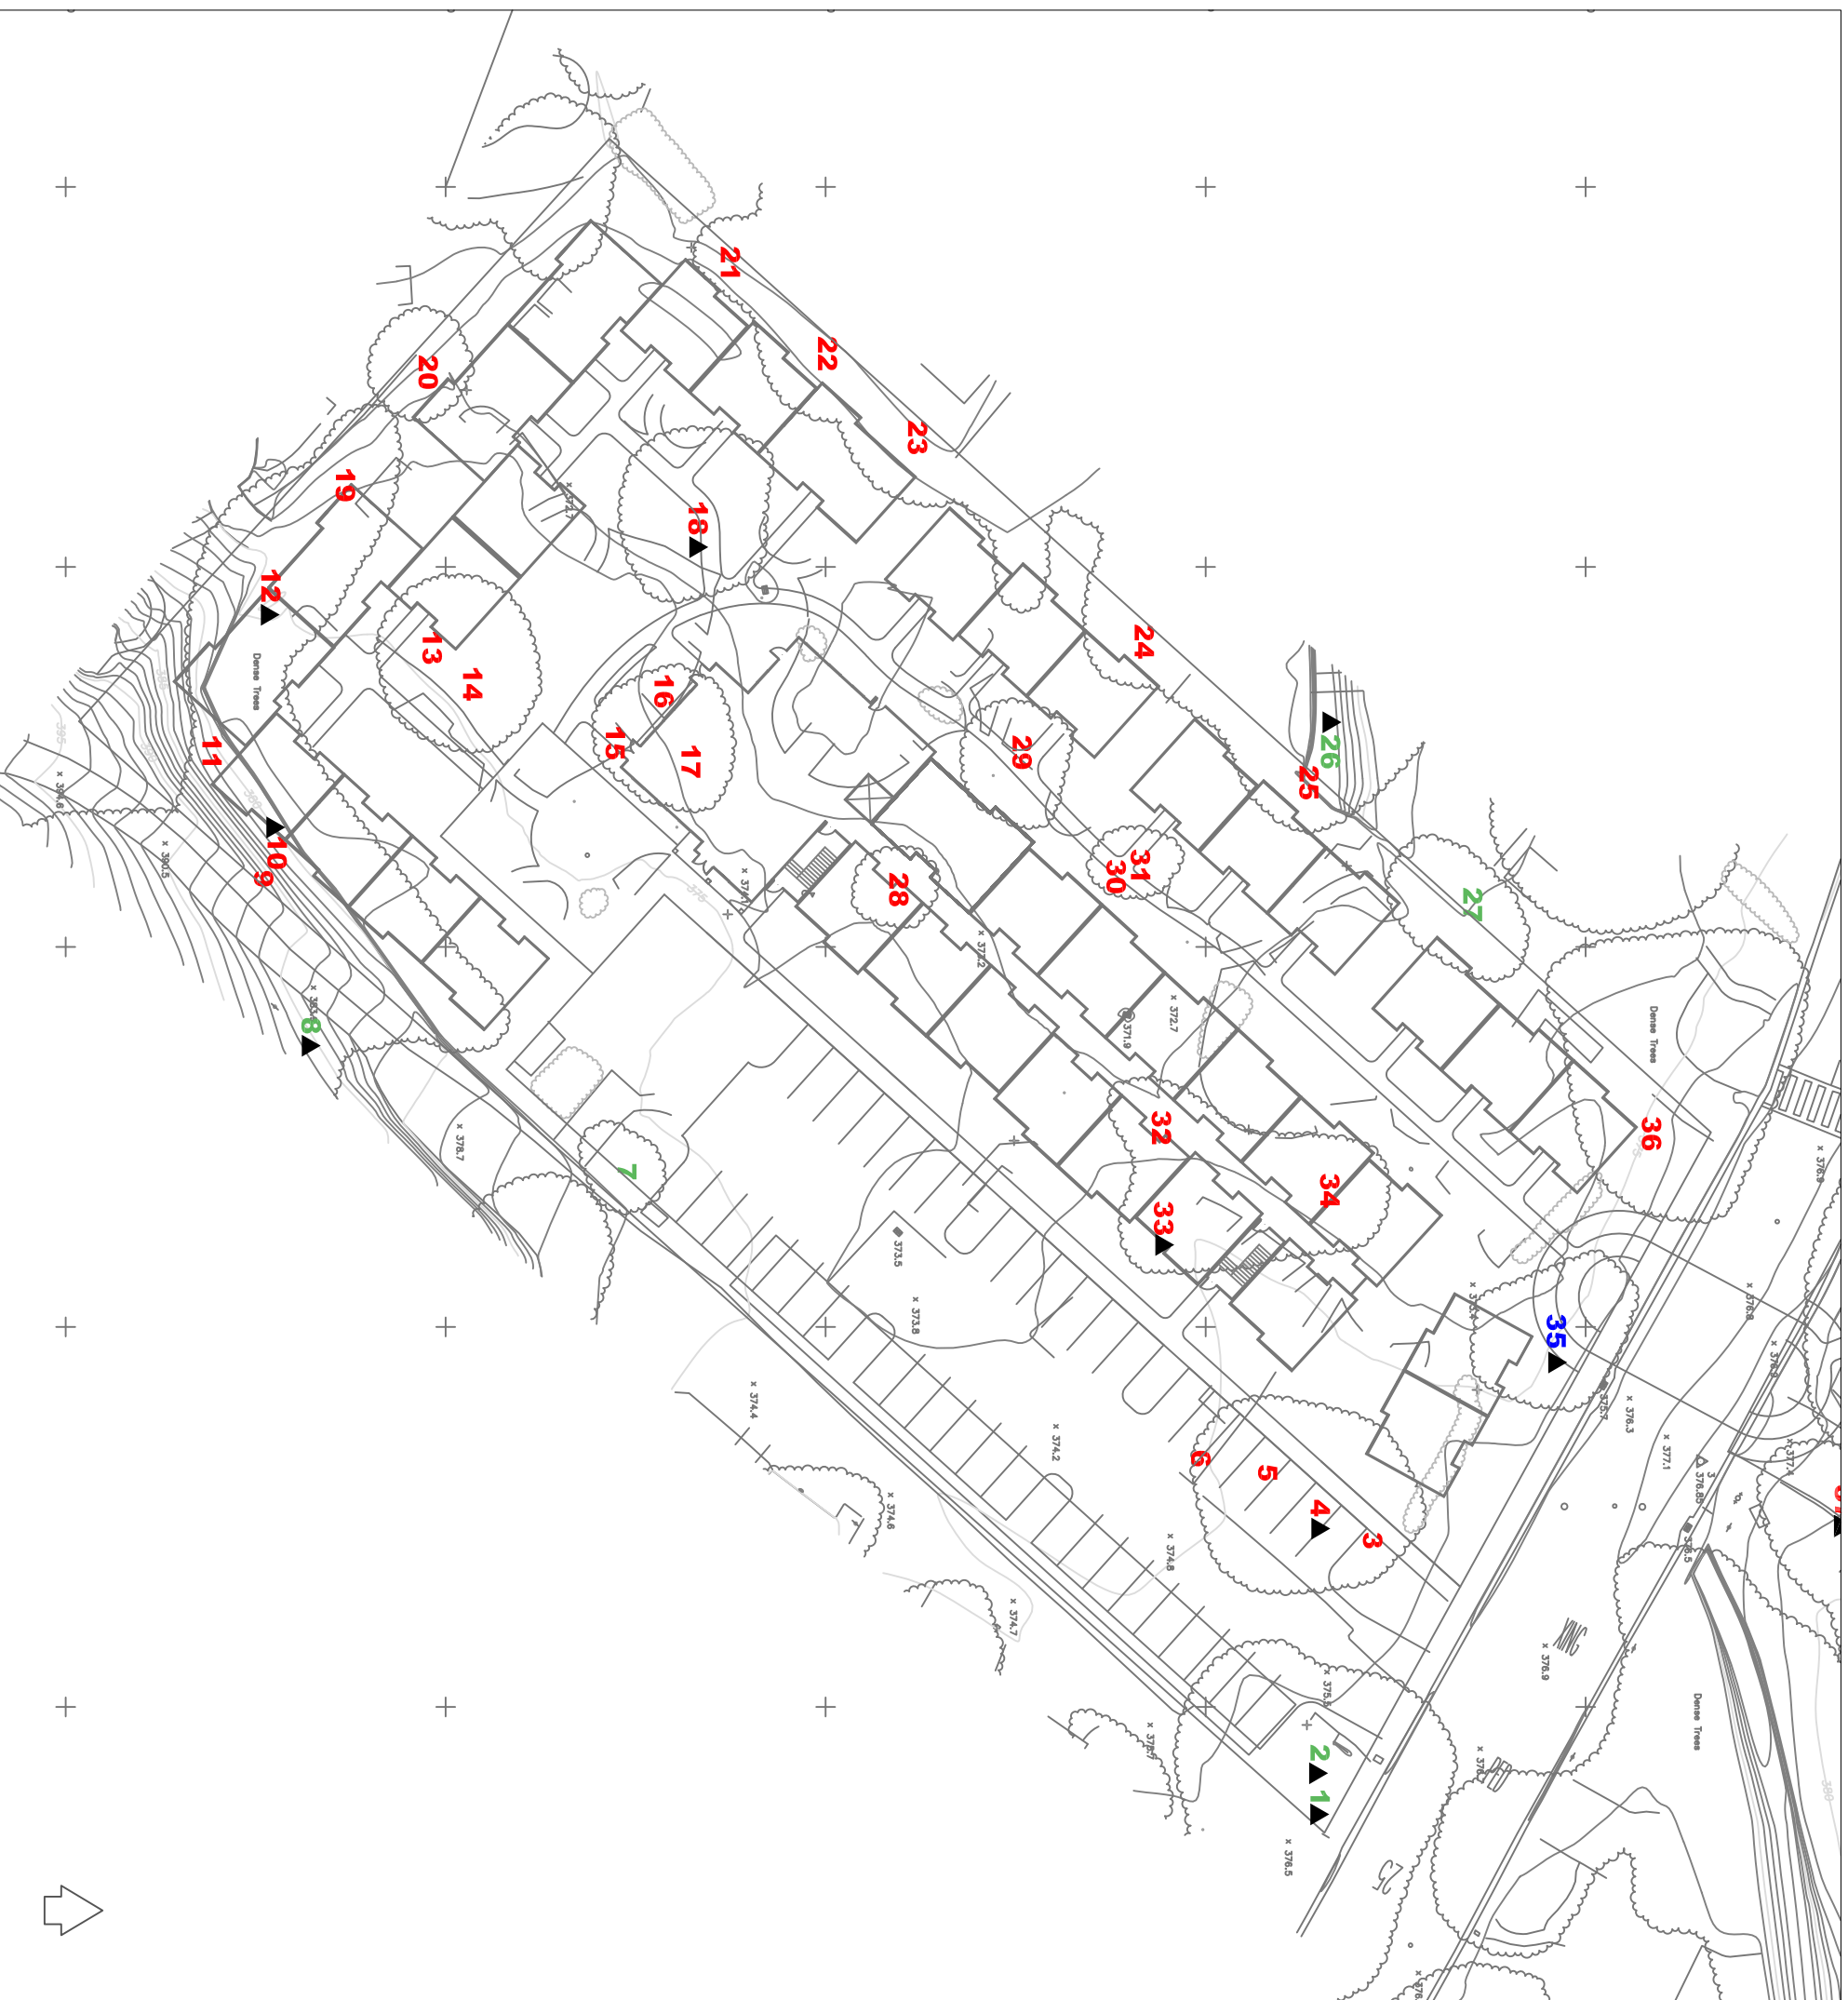
Tree Disposition Plan

Kottinger Senior
Housing Project
Northern Section
Pleasanton, CA

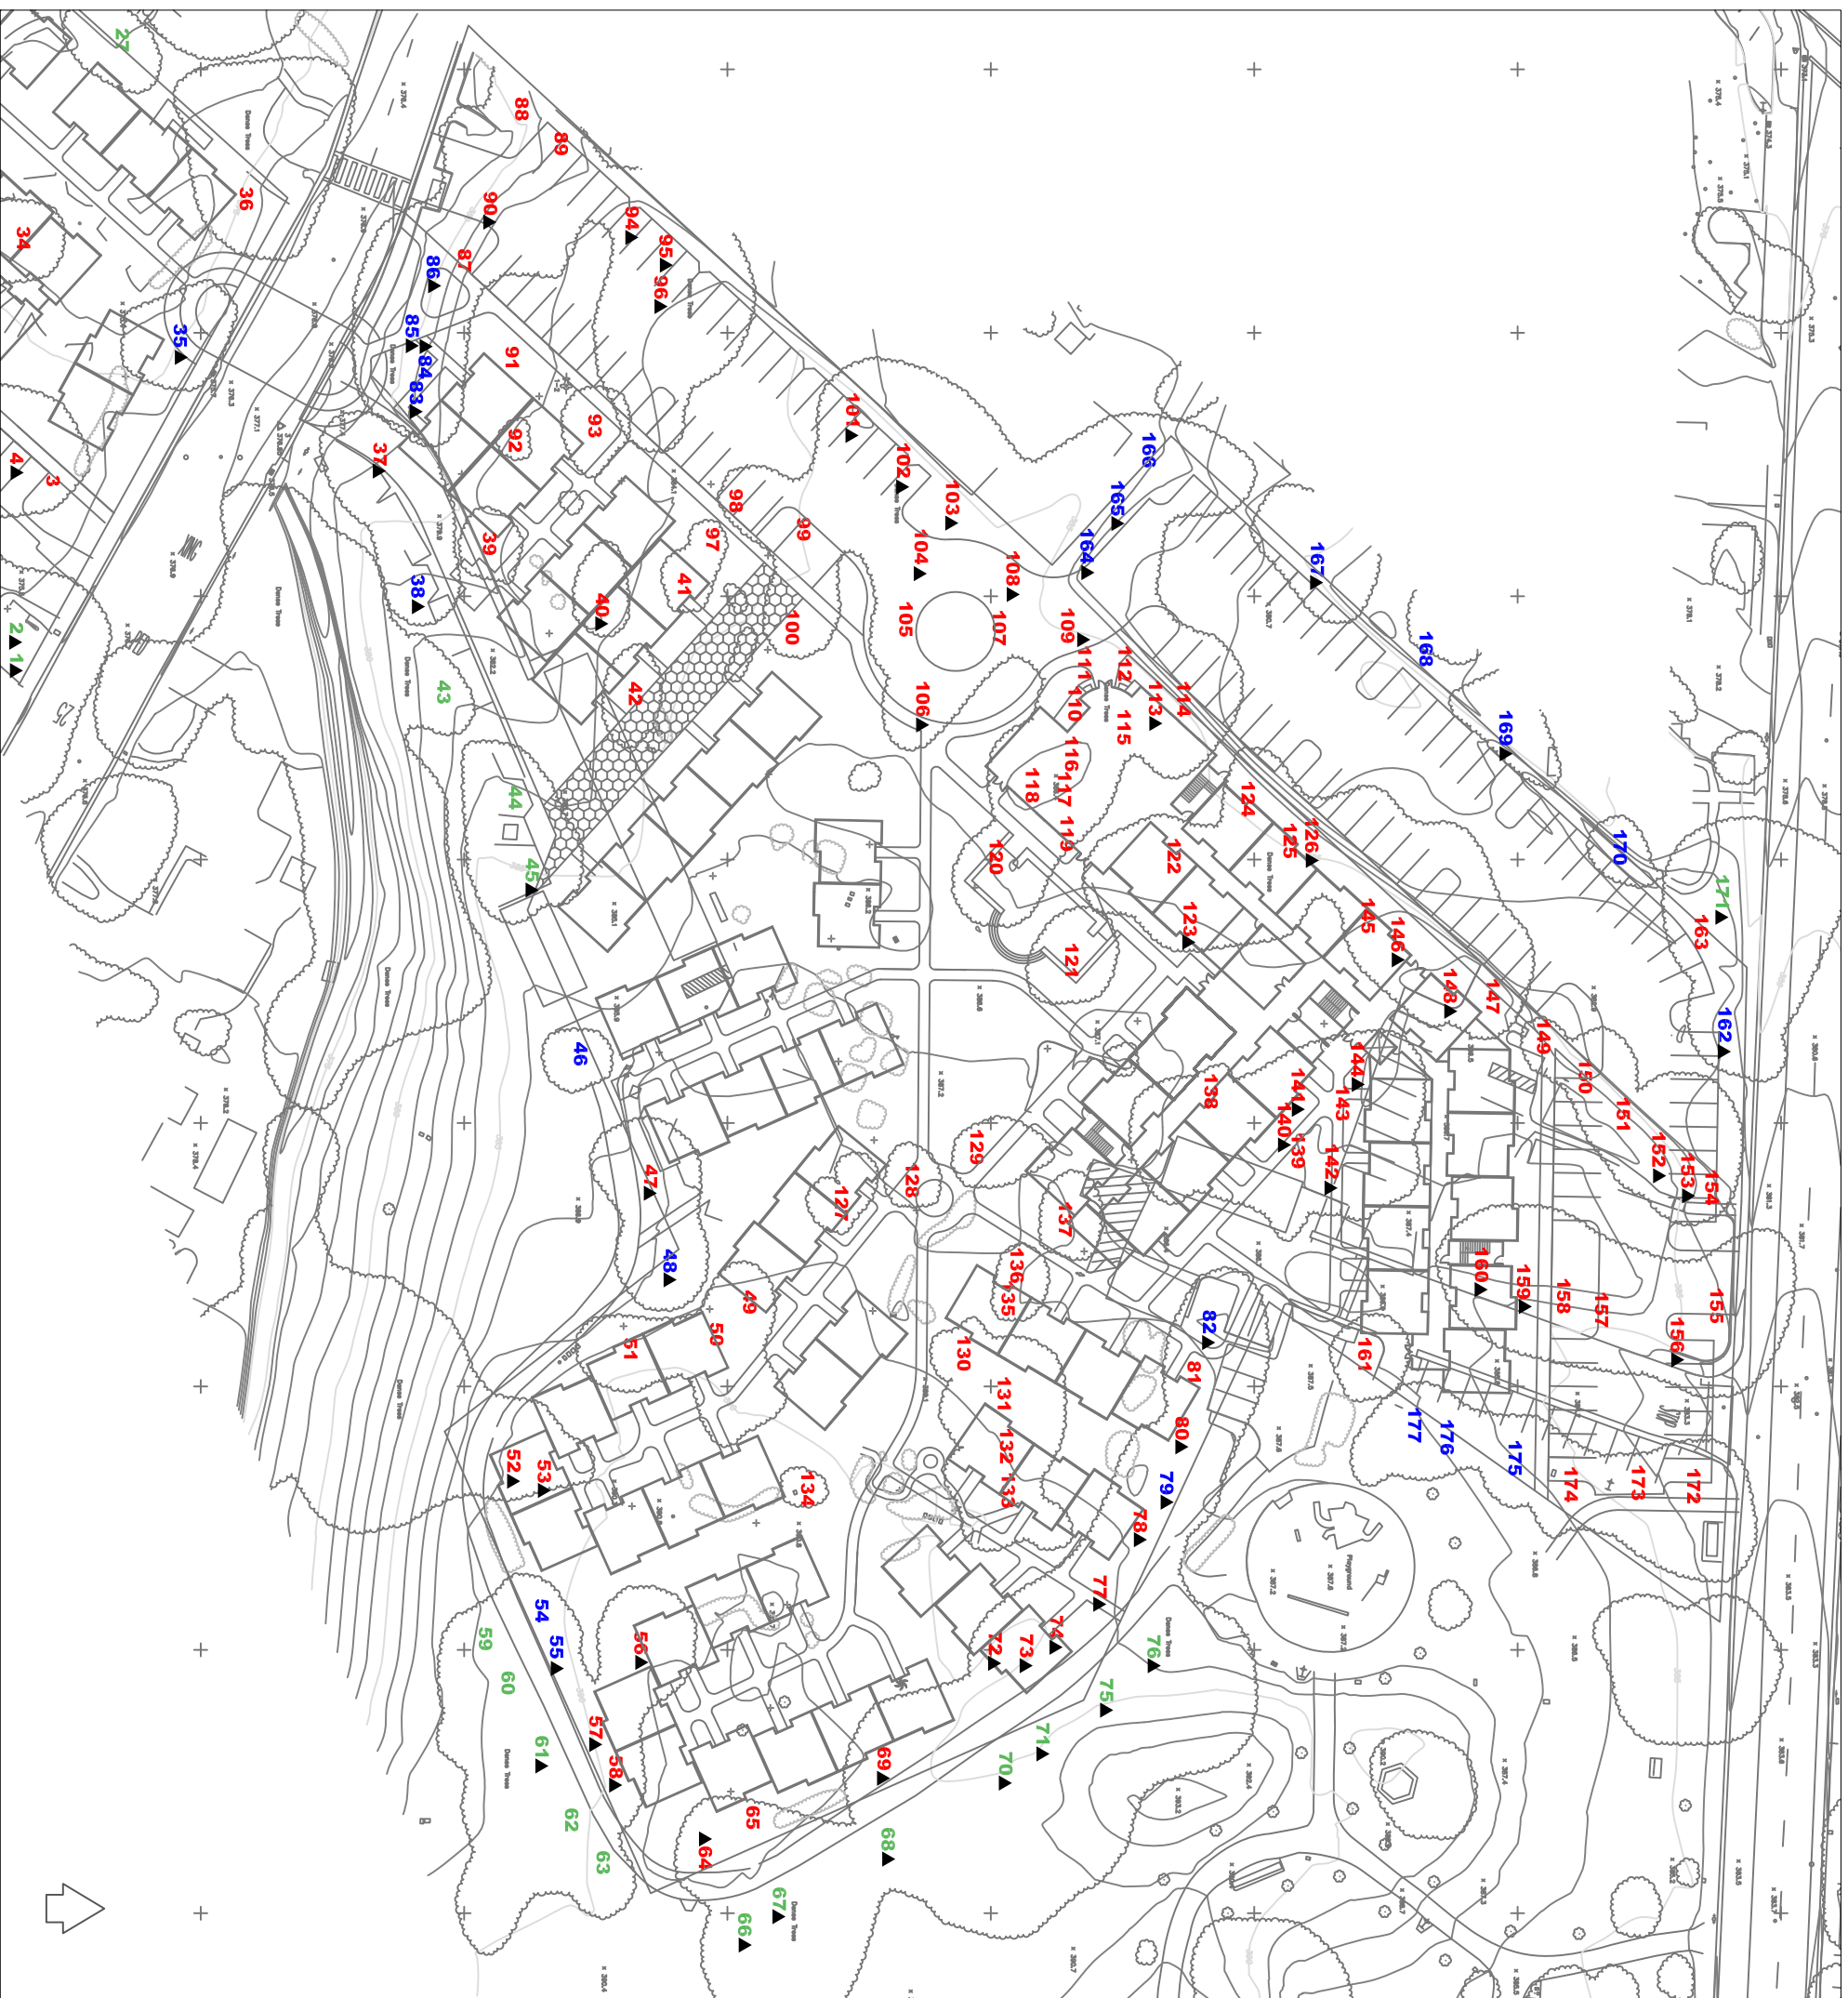
Tree Assessment

TREE No.	SPECIES	TRUNK DIAMETER (inches)	HERITAGE TREE?	CONDITION 1=Poor 5=Excellent	SUITABILITY FOR PRESERVATIO	COMMENTS
1	Valley oak	20	Yes	4	High	One-sided to N.; multiple attachments at 20'; fill and paving stones over root collar.
2	Valley oak	20	Yes	4	High	Multiple attachments at 10'; crown to S.; fill and paving stone over root collar; codominant form with #1.
3	Sweetgum	19	Yes	3	Moderate	Codominant at 8'; topped; very large surface roots.
4	Sweetgum	20	Yes	3	Moderate	Multiple attachments at 10'; topped; small cavity on W.
5	Sweetgum	17	No	3	Moderate	Topped; mounded at base; large surface roots.
6	Peach	6	No	4	Moderate	Multiple attachments at 5'.
7	Ginkgo	7	No	4	High	Good young tree.
8	Valley oak	18	Yes	4	High	Off-site; no tag; base engulfed in ivy; full crown.
9	Arizona cypress	9	No	3	Moderate	Very high narrow crown.
10	Coast redwood	25	Yes	4	High	Crown lifted to 25'.
11	Incense cedar	11	No	3	Moderate	Crown lifted to 12'; thin crown.

12	Coast redwood	25	Yes	4	High	Crown lifted to 12'; a bit thin; minor tip burn.
13	Callery pear	13	No	4	Moderate	Multiple attachments at 8' with narrow attachment; full crown.
14	Callery pear	11	No	4	Moderate	Multiple attachments at 8';
15	Sweetgum	14	No	3	Low	Codominant at 8' with very narrow attachment.
16	Sweetgum	14	No	3	Low	Codominant at 5' with very narrow attachment and included bark.
17	Cherry	10,7,5	No	3	Moderate	Multiple attachments at 3'; trunk decay.
18	Southern	19	Yes	4	High	Codominant at 6'; nice full crown.
19	Callery pear	14	No	4	Moderate	Multiple attachments at 10' with narrow attachment.

TREE No.	SPECIES	TRUNK DIAMETER (inches)	HERITAGE TREE?	CONDITION 1=Poor 5=Excellent	SUITABILITY FOR PRESERVATIO	COMMENTS
20	Desert willow	10	No	3	Low	Extensive cracks in trunk and branches; good form.
21	Callery pear	10	No	2	Low	Extensive dieback.
22	Callery pear	15	No	3	Low	Leaning to E.; multiple attachments at 6'; bark checking at base.
23	Callery pear	15	No	3	Moderate	Multiple attachments at 6'; topped; full crown.
24	Monterey pine	8,8	No	1	Low	Little live foliage.
25	Glossy privet	6,5,3	No	2	Low	Multiple attachments at 1'; poor form.
26	English walnut	14,11	Yes	3	Moderate	Off-site; no tag; codominant at 5'; full crown.
27	Glossy privet	multi-stem	No	3	Low	Off-site; no tag; hedge of 30 stems 6" and smaller at fence line.
28	Colorado spruce	13	No	5	High	Nice tree; good form.
29	Crape myrtle	8,6,6,5,5	No	5	High	Multiple attachments at base; full crown; excellent health.
30	European white birch	6	No	1	Low	Topped; extensive dieback.

31	European white birch	7	No	2	Low	Topped; dieback.
32	Purple-leafed plum	6,5,4,4,3	No	2	Low	Multiple attachments at 4'; extensive trunk decay.
33	Southern	18	Yes	4	High	Full crown; small cavity on S.
34	Chinese tallow	12	No	4	Moderate	Codominant at 7'; interior deadwood; surface roots.
35	Coast redwood	39	Yes	5	High	Excellent health and structure.
36	Hackberry	11	No	4	High	Good form; minor dieback.
37	Modesto ash	21	Yes	3	Moderate	Codominant at 5'; stem to N. is starting to separate; thinning crown.
38	Modesto ash	21	Yes	3	Moderate	Multiple attachments at 5'; branch tore out on E.; thinning crown with dieback.

TREE No.	SPECIES	TRUNK DIAMETER (inches)	HERITAGE TREE?	CONDITION 1=Poor 5=Excellent	SUITABILITY FOR PRESERVATIO	COMMENTS
39	Strawberry tree	7,5,5,5,5,4	No	4	High	Multiple attachments at base; full crown.
40	Canary Island pine	18	Yes	4	High	Tall narrow form.
41	Blackwood acacia	9,7,7,4	No	3	Low	At edge of building; multiple attachments at 2'; branches twist around each other.
42	Canary Island pine	17	No	4	High	Tall narrow form.
43	Raywood ash	14	No	3	Low	Poorly pruned; one upright stem remains.
44	Modesto ash	14	No	3	Low	Codominant at 6'; extensive dieback; trunk leans S.
45	Modesto ash	21	Yes	3	Low	Multiple attachments at 6'; extensive dieback.
46	Idaho locust	11	No	3	Low	Very thin; enlarged basal flare.
47	Modesto ash	20	Yes	2	Low	Trunk decay from base into upright stems; full crown.
48	Coast redwood	35	Yes	5	High	Excellent health and structure.
49	Pyracantha	8,6,5	No	3	Low	Poor form; dieback.
50	Scots pine	10	No	2	Low	Tall narrow form; leans N.

51	Zelkova	15	No	3	Moderate	Multiple attachments at 6'; nice full crown; girdling root.
52	Catalpa	15,10,8,6	Yes	3	Moderate	Multiple attachments at base; root pruned?
53	Catalpa	18	Yes	4	Moderate	Good upright form; decay in roots; root pruned?
54	Canary Island pine	15	No	4	High	Good upright form; a bit thin.
55	Canary Island pine	18	Yes	4	Moderate	Good upright form; a bit thin; one-sided to E.
56	Cork oak	18	Yes	4	High	Good form and structure.
57	Canary Island pine	18	Yes	4	High	Good upright form; a bit thin.
58	Canary Island pine	18	Yes	4	High	Good upright form; a bit thin.

TREE No.	SPECIES	TRUNK DIAMETER (inches)	HERITAGE TREE?	CONDITION 1=Poor 5=Excellent	SUITABILITY FOR PRESERVATIO	COMMENTS
59	Idaho locust	11	No	3	Low	Off-site; edge of existing path; multiple attachments at 4' with decay in point of attachment.
60	Aleppo	8	No	2	Low	Off-site; edge of existing path; failing at base.
61	Aleppo	29	Yes	3	Low	Off-site; edge of existing path; codominant at 15'; heavy low lateral limb.
62	Coast redwood	16	No	5	High	Off-site; edge of existing path; excellent health and structure.
63	Coast redwood	16	No	5	High	Off-site; edge of existing path; excellent health and structure.
64	Siberian elm	18	Yes	3	Low	Codominant at 6'; twig dieback.
65	Siberian elm	10	No	3	Moderate	Codominant at 7'; base at edge of building.
66	Coast redwood	34	Yes	5	High	Off-site; edge of existing path; excellent health and structure.
67	Coast redwood	34	Yes	5	High	Off-site; edge of existing path; excellent health and structure.

68	Coast redwood	43	Yes	4	High	Off-site; edge of existing path; excellent health; codominant high in crown.
69	Siberian elm	22	Yes	3	Low	Multiple attachments at 12'; full heavy crown; extensive surface roots with decay.
70	Coast redwood	35	Yes	3	Moderate	Off-site; edge of existing path; extensive wound from codominant failure.
71	Coast redwood	39	Yes	4	Moderate	Off-site; edge of existing path; codominant at 18'; otherwise good.
72	Canary Island pine	18	Yes	4	High	Good form; thin crown.
73	Canary Island pine	21	Yes	3	Moderate	Codominant high in crown.
