Project Name: RESURRECTION GREEK ORTHODOX CHURCH PLEASANTON
11/10/2020

In accordance with your authorization, we have performed an update geotechnical investigation for the subject project in Pleasanton, California. Our investigation was performed to observe the soil and geologic conditions that may impact site development for the project as presently planned. The accompanying report presents the results of our investigation and conclusions and recommendations pertaining to the geotechnical aspects of the proposed project. The findings of this study indicate the site is suitable for development as planned provided the recommendations of this report are implemented during design and construction.

This report presents the results of an update geotechnical investigation for the planned new Resurrection Greek Orthodox Church at 11300 Dublin Canyon Road in Pleasanton, California (see Vicinity Map, Figure 1). The purpose of this investigation was to evaluate the subsurface soil and geologic conditions in the area of planned development and provide conclusions and recommendations pertaining to the geotechnical aspects of project design and construction, based on the conditions encounter

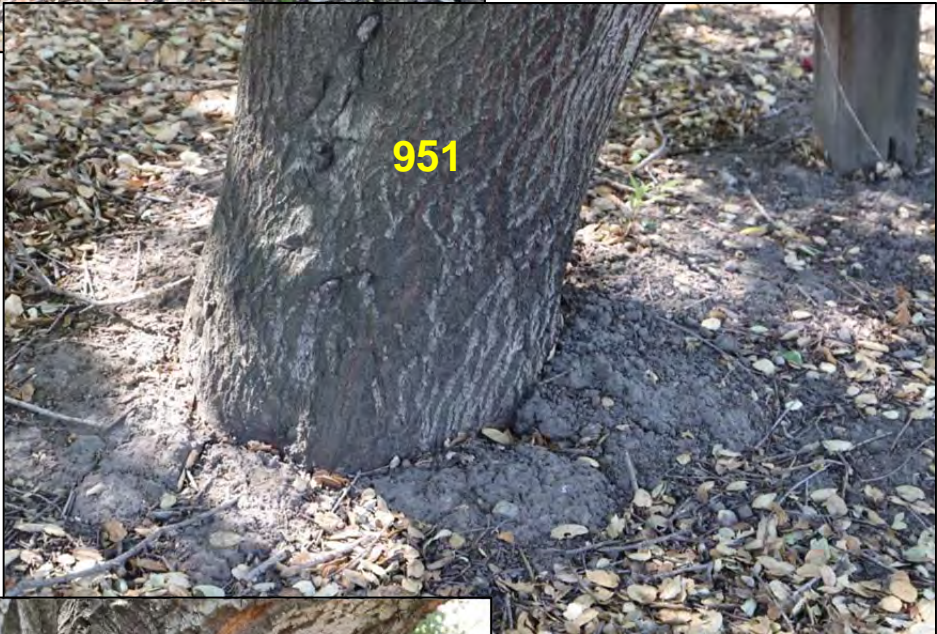
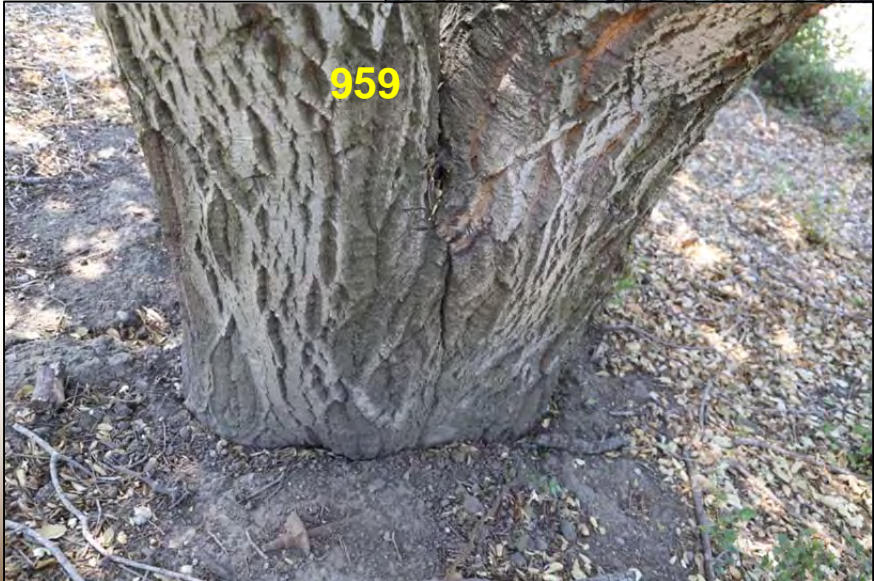
Typical examples of excess soil over root collars, exhibited by virtually every tree in this report.

General comments: Virtually all 28 trees within the construction zone have excess soil over the root collars. Any trees to be retained should have root collars excavated and inspected before deciding to preserve the tree. Doing so is not construction related but can be critical to discovering or preventing serious root decay disease.
