Lexus of Pleasanton

Preliminary Arborist Report

**4346 Rosewood Dr.
Pleasanton, CA**

March 6, 2014

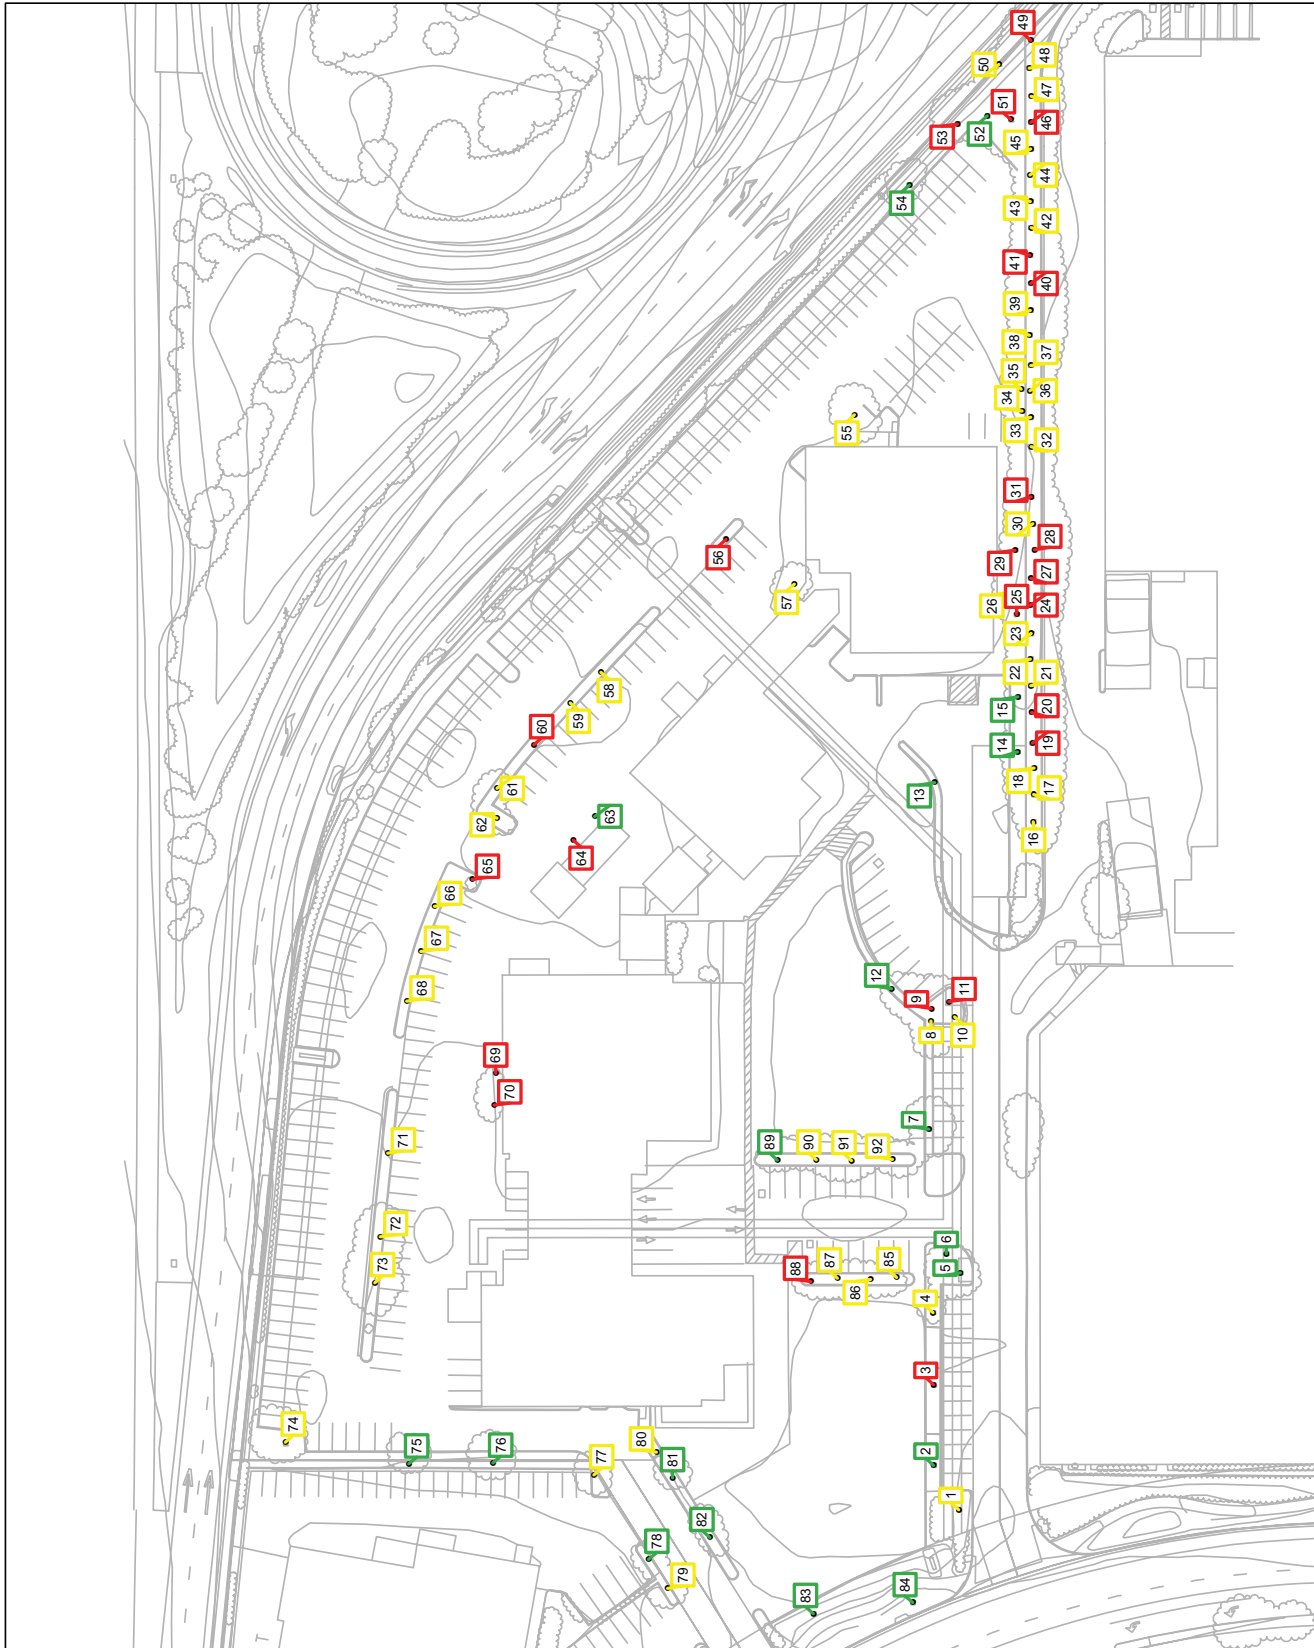
Tree Assessment

Tree No.	Species	Trunk Diameter (in.)	Condition 1=poor 5=excellent	Suitability for Preservation	Heritage Tree?	Comments
1	African sumac	13	3	Moderate	No	Codominant at 5 feet; sunburn; thin canopy.
2	Honey locust	7	4	High	No	Good young tree; remove staking.
3	Honey locust	6	3	Low	No	Peeling bark; fungus; remove staking.
4	Honey locust	6	3	Moderate	No	Trunk wound; fungus; remove staking.
5	African sumac	22	4	High	Yes	Good form and structure; Awkward branch angles.
6	African sumac	13	3	High	No	Poor form and structure; many shoots from branches.
7	Callery pear	18	3	High	Yes	Pruning wounds; multiple attachment at 10 feet.
8	Callery pear	14	3	Moderate	Yes	Asymmetrical; poor form; multiple attachment at 10 feet.
9	African sumac	10	2	Low	No	Extremely poor form.
10	African sumac	13	3	Moderate	No	Asymmetrical; multiple attachment at 10 feet.
11	African sumac	15	3	Low	No	Included bark; trunk wounds; codominant at 6 feet.
