Cover Sheet  
 Conceptual Landscape Planting Plan  
 Site Plan  
 Grading and Drainage Plan  
 Utility Plan  
 Hydrology Management Plan  
 Details  
 Building Plan  
 Unit Plan  
 Elevations  
 Color Materials

**PLEASANTON MEMORY CARE FACILITY**

Pleasanton CA

**PLEASANTON  
MEMORY CARE  
PROJECT**

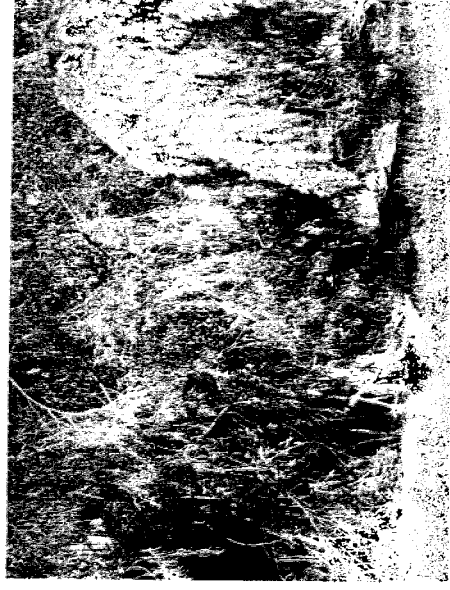
**Site Photos: Eucalyptus Pruning**

Eucalyptus pruning: Crown reduce elongated branches that will hang out over parking lot. To be coordinated with consulting arborist.

Clean crowns of large (>3") dead and broken branches, and fallen debris under trees for health and fire protection.
