ROSELYN ESTATES II

(7 New Home Development)
PLEASANTON, CALIFORNIA
PUD-94

ROSELYN ESTATES PHASE II
RESIDENTIAL HOME PROJECT
 (PUD 94 - TR 0000)

ROSELYN ESTATES PHASE II PROJECT
P.U.D. #94 - TRACT 0000
CITY OF PLEASANTON, ALAMEDA COUNTY, CALIFORNIA

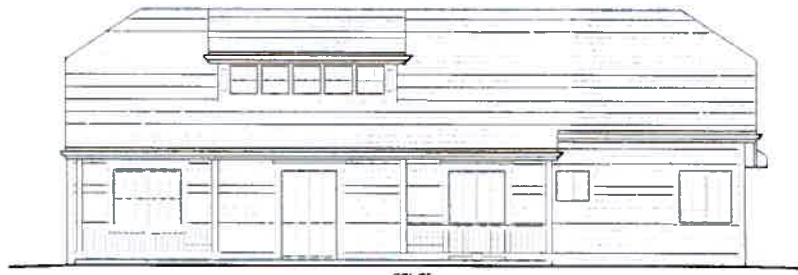
FRONT

LEFT

REAR

RIGHT

- 1) Roof : Flat, Handsplit Shake look, Concrete Tile
(Natural Wood Colors : Tan, Brown and Grey)
- 2) Siding : 8" "Handplank" Wood textured Lap Siding,
individually layered horizontal.
Typical all sides.
(Earthy colors : Cream, sand, slate and stone.)
- 3) Trim : 2 x 4 & 1x S4S wood trim.
(Color : primarily Swiss Coffee white)

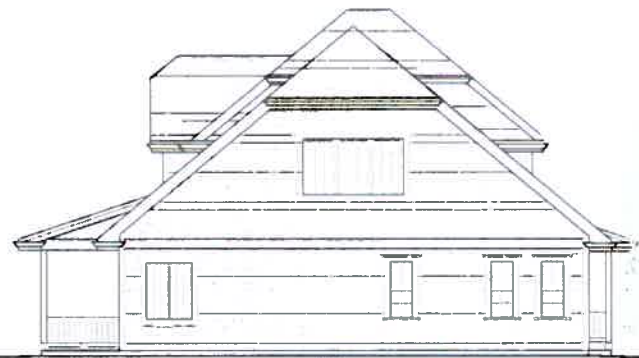
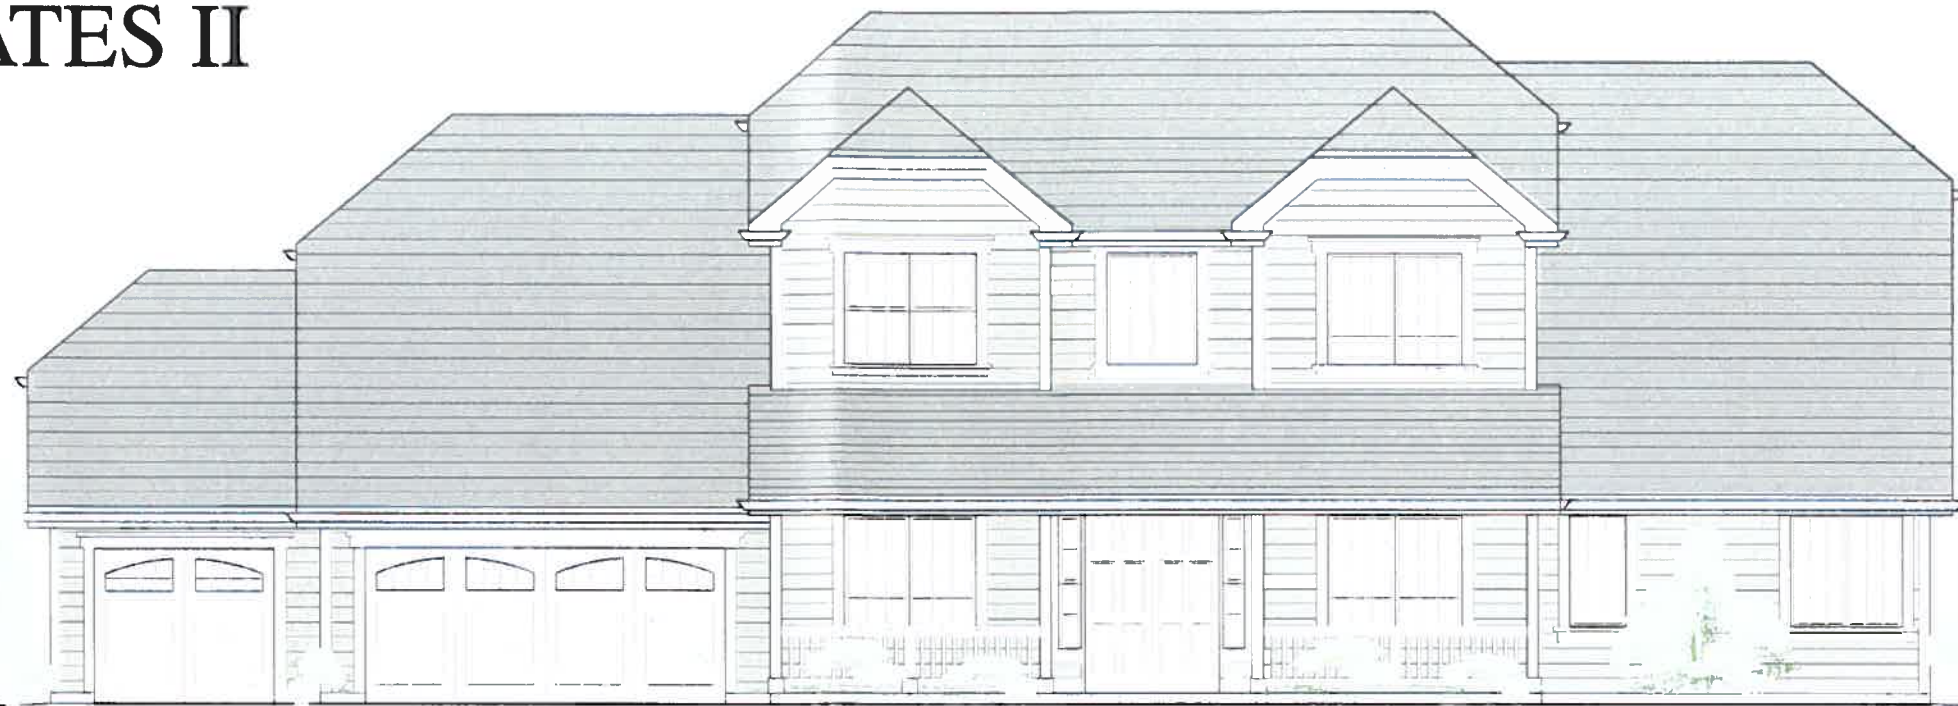
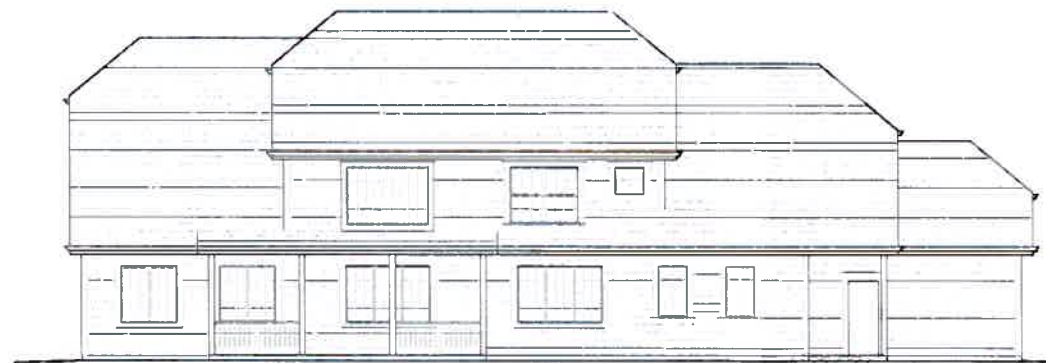
PLAN B ELEVATION B-1

51'-0"
B1 - RIGHT

84'-0"
B1 - FRONT

MAIN COLOR	Stone Gray
SIDING BODY	186 Keystone
GARAGE DOOR	KM3941-1 Wishing Star
FRONT DOOR	407 Carbon
TRIM	23 Swiss Coffee
ROOF	Eagle Lite
PRODUCT	903 Chiaroal
DESCRIPTION	Brown/Brown Straks

51'-0"
B1 - LEFT

84'-0"
B1 - REAR (B2 - REAR REVERSED)

- 1) Roof: Flat, Handsplit Shake look, Concrete Tile
(Natural Wood Colors: Tan, Brown and Grey)
- 2) Siding: 8" Hardiplank Wood textured Lap Siding, individually laid horizontal, Typical all sides.
(Earthtone colors: Cream, sand, slate and stone.)
- 3) Trim: 2 x & 4x S4S wood trim.
(Color: primarily Swiss Coffee white)

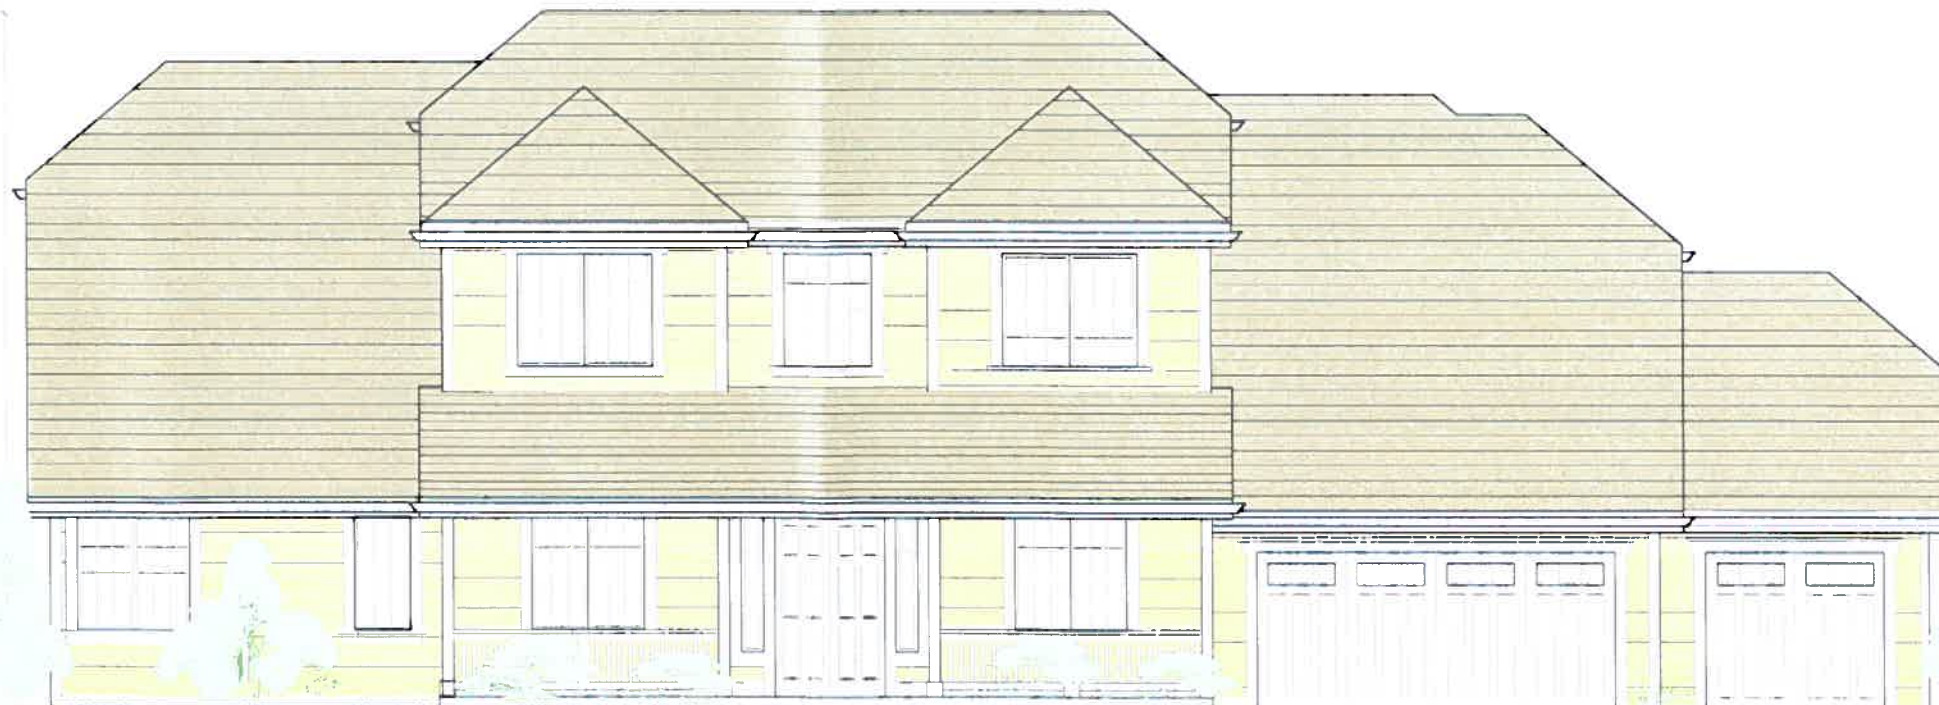
PLAN B ELEVATION B-2

51'-0"
B2 - LEFT

84'-0"
B2 - FRONT

MAIN COLOR	Cream Yellow
SIDING BODY	KM3531-1 Home & Hearth
GARAGE DOOR	KM3530-1 Sheddled Wheat
FRONT DOOR	73 Cortez
TRIM	23 Swiss Coffee
ROOF	Eagle Lite
PRODUCT	904 New Cedar
DESCRIPTION	Light Brown

51'-0"
B2 - RIGHT

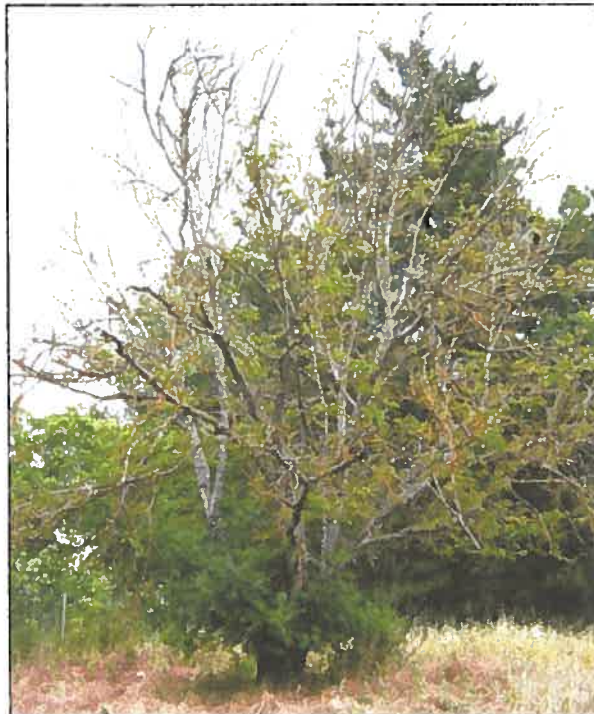
Photo 1: English walnut #26 was in poor condition, with a dead top. The black walnut root stock was sprouting vigorously from the base.

English walnut, with 22 trees or 34% of the population, was the most common species surveyed. In general, these were located in an open field on the northern half of the property. Average condition varied from poor (20 trees, or 91%), to moderate (2 trees, or 9%). None of the English walnuts were in good condition. The trees had not been maintained in several years and appeared to be suffering from a lack of adequate irrigation, as many had thin canopies.

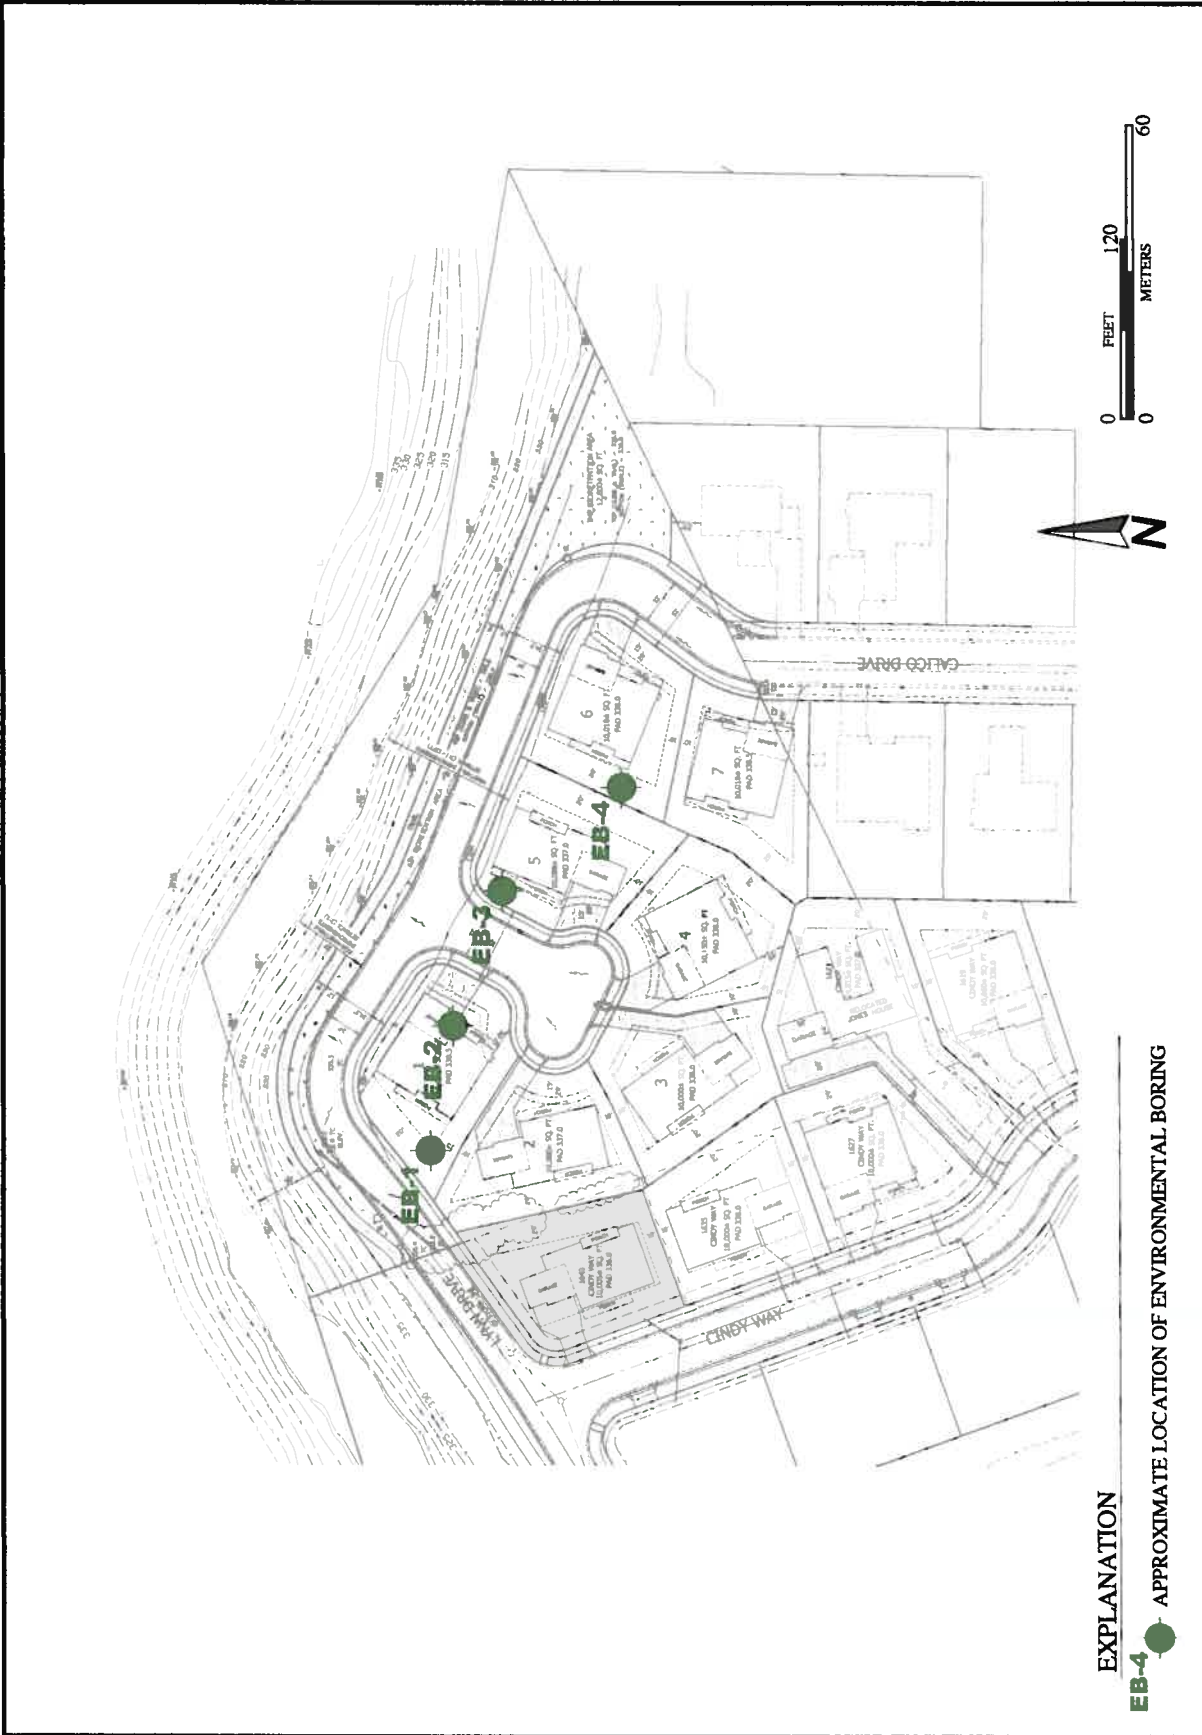
Figure 1 – Site Plan

EXPLANATION

- EB-4** - APPROXIMATE LOCATION OF ENVIRONMENTAL BORING

- A total of four samples were recovered from depths of 3 to 9 inches below the ground surface (Figure 1).
